**RE: PROGRESS REPORT, OCTOBER THROUGH DECEMBER 2017
REMEDIAL INVESTIGATION MONITORING AND FEASIBILITY STUDY
CAPITAL INDUSTRIES, INC., SEATTLE, WASHINGTON
AGREED ORDER NO. DE 10402
FARALLON PN: 457-008**

**ATTACHMENT A
SITE DIAGRAM**

PROGRESS REPORT, OCTOBER THROUGH DECEMBER 2017
Capital Industries, Inc.
Seattle, Washington

**ATTACHMENT B
GROUNDWATER DATA FIGURES**

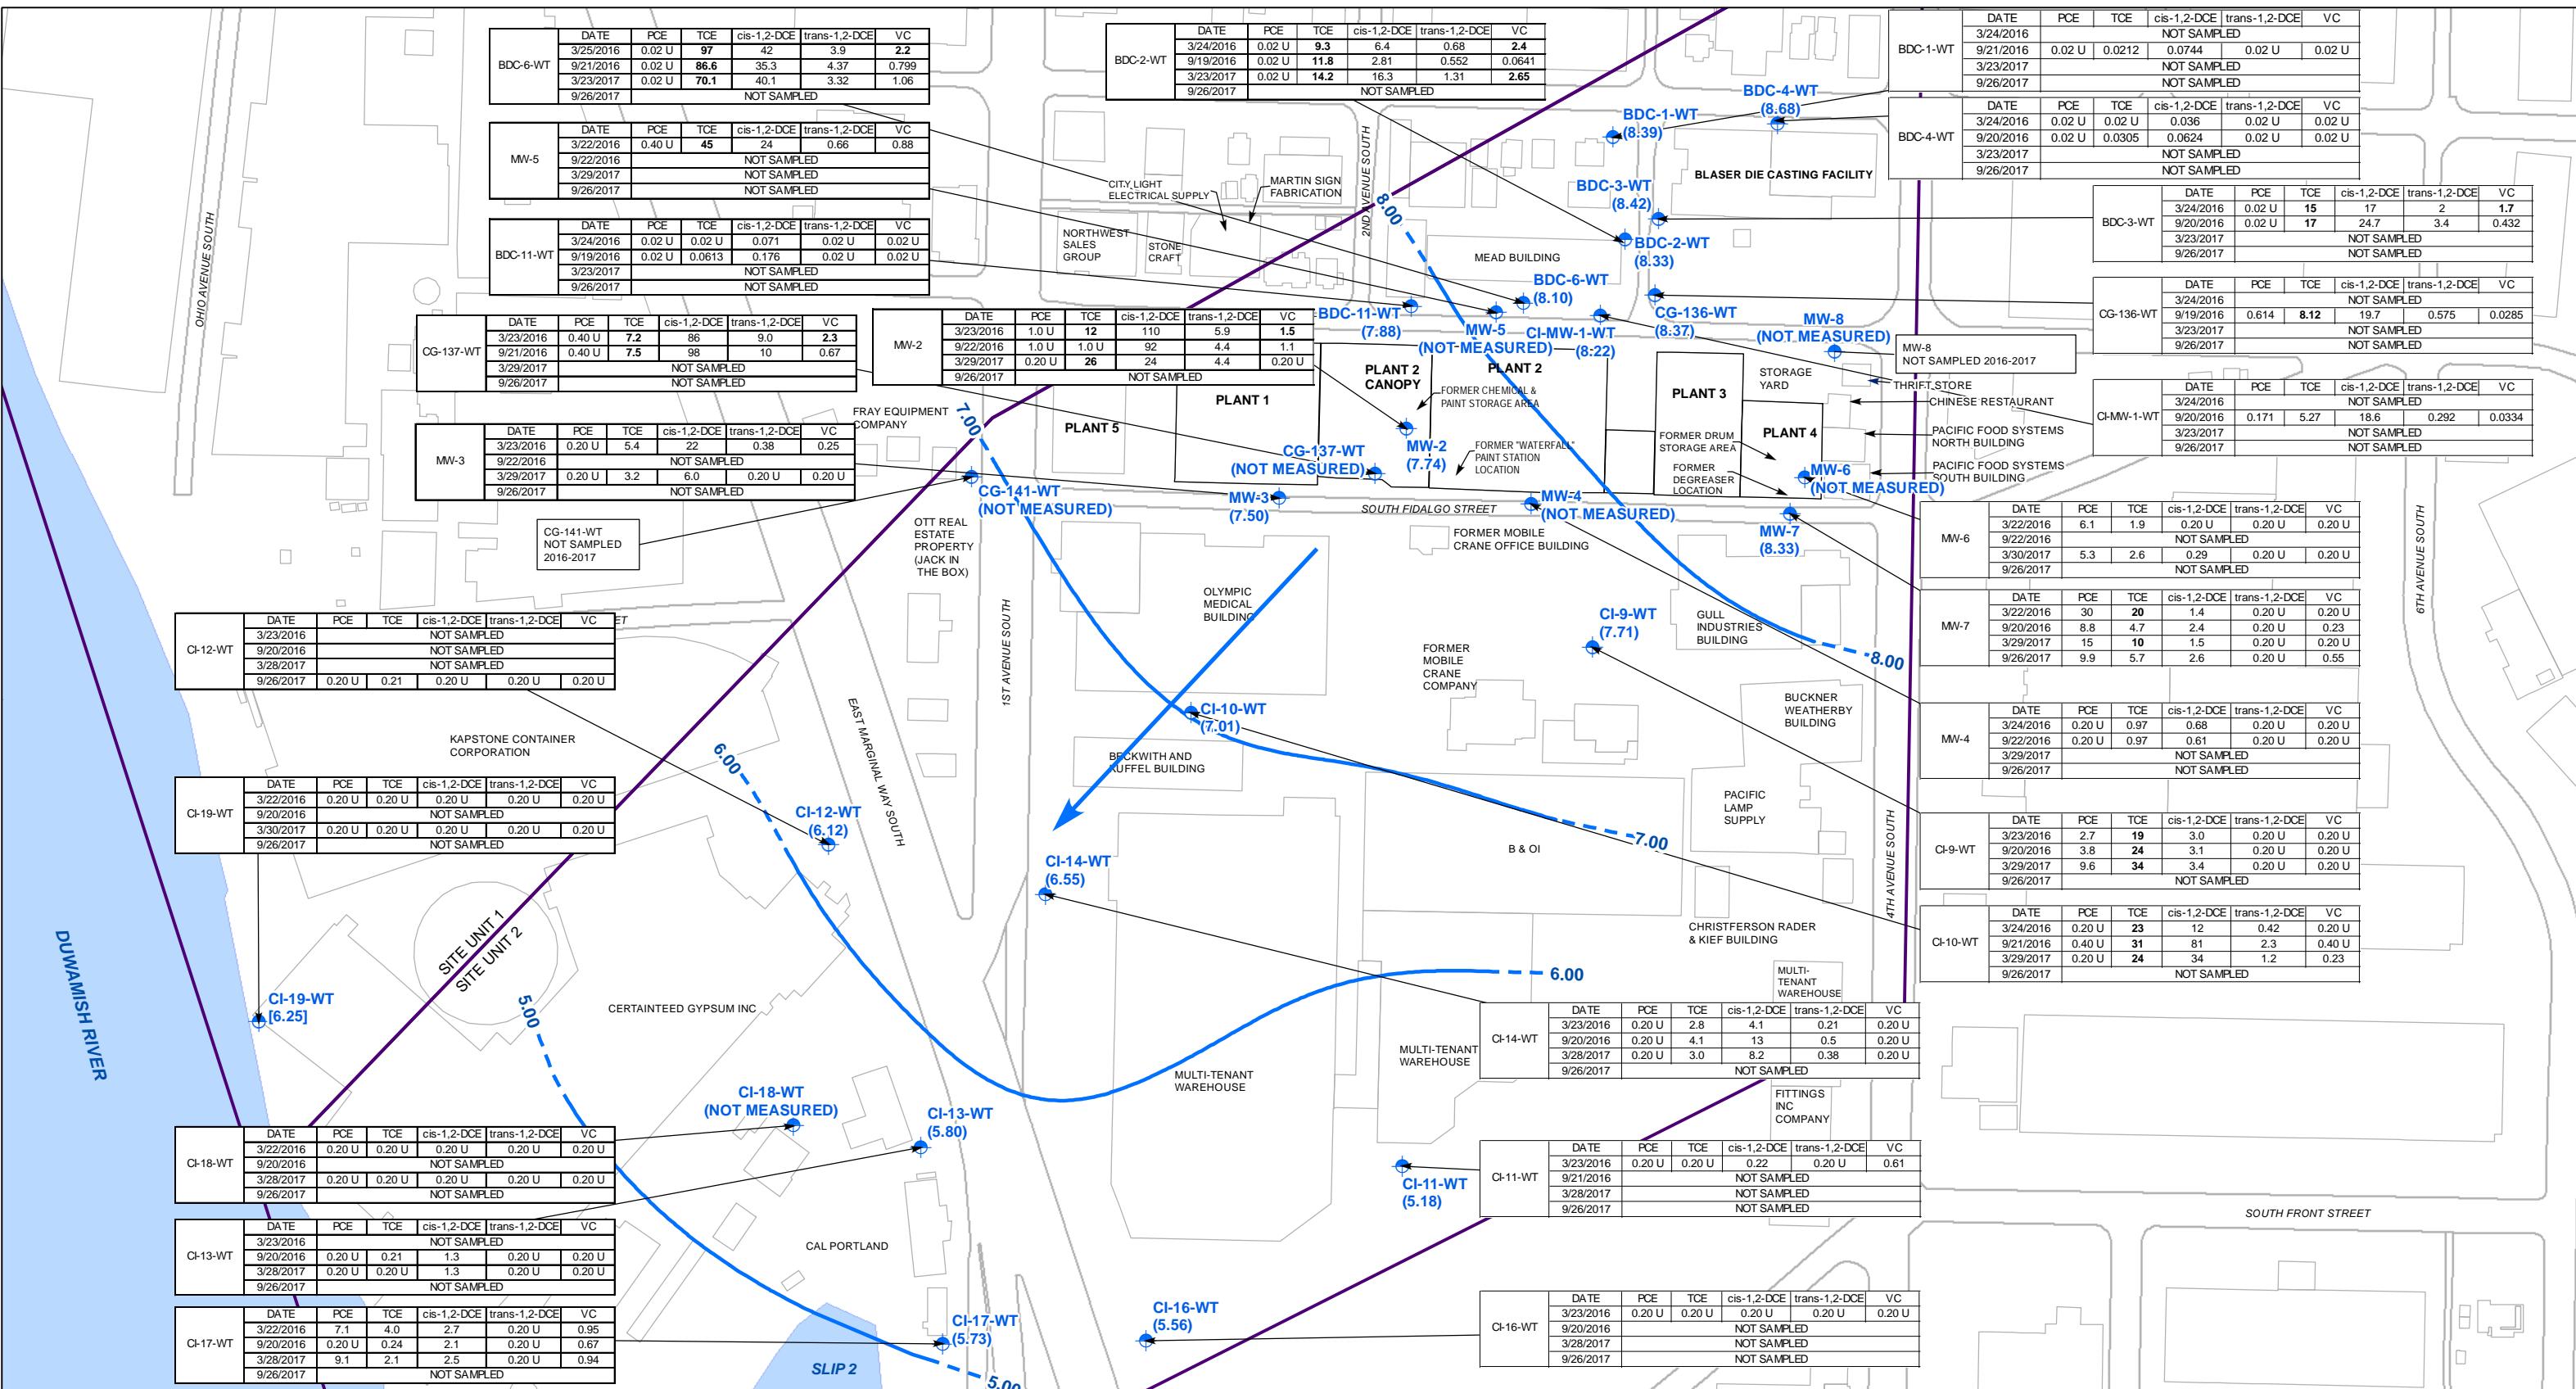
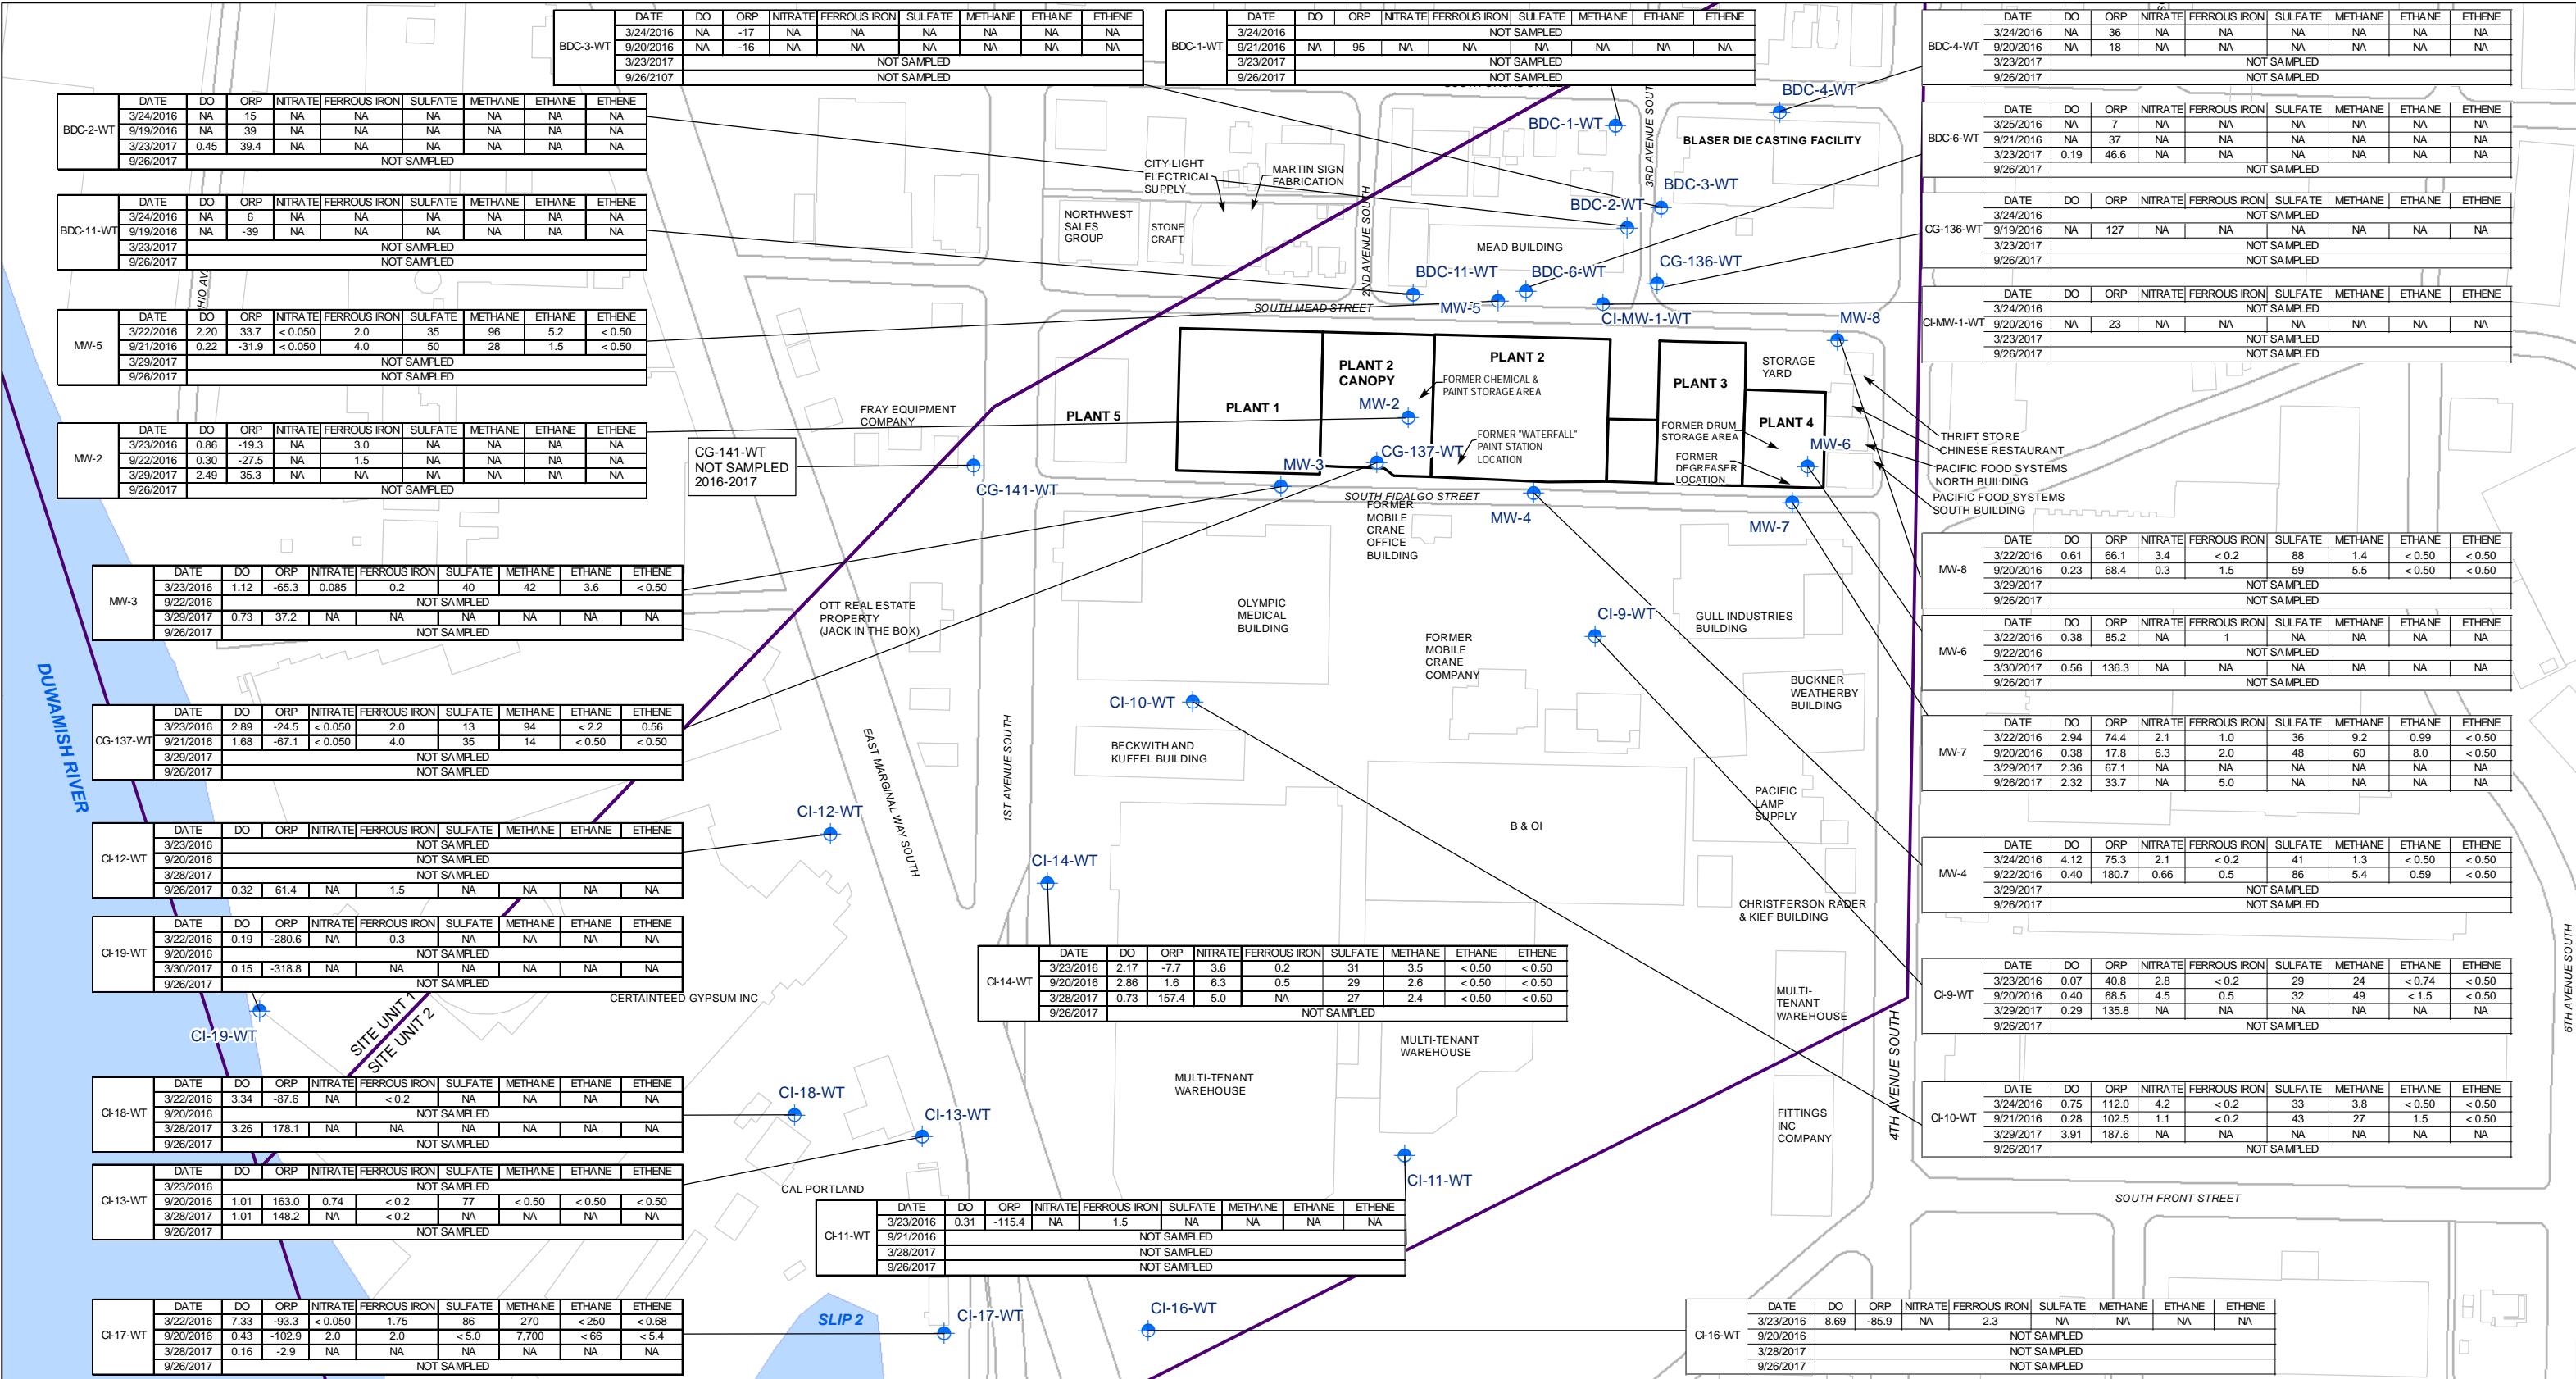
FIGURE 1A
NATURAL ATTENUATION PARAMETER RESULTS FOR
WATER TABLE ZONE: 2016 - 2017
REMEDIAL INVESTIGATION
CAPITAL INDUSTRIES, INC.
SEATTLE, WASHINGTON
FARALLON PN: 457-007
Drawn By: jjones
Checked By: JK
Date: 1/2/2018
Document Path: Q:\Projects\457 CapitalIndust\007 RemInvMonitoring\2017Q3_GW\Fig1A_201709_NatAttenu_WaterTableZone.mxd
Disc Reference:

Groundwater monitoring and sampling was performed during the week of September 25, 2017 in accordance with the technical memorandum regarding FINAL West of 4th Groundwater Monitoring Program Plan, 2017 through Draft Cleanup Action Plan, W4 Joint Deliverable, Agreed Order No. DE 10402 dated March 21, 2017 from Ms. Janet Knox of Pacific Groundwater Group to Mr. Jones of Ecology. Groundwater samples were collected from monitoring wells MW-7, CI-12-WT, CI-12-60, CI-14-35, CI-14-70, CI-15-60, CI-19-30, CG-141-40, and CG-141-50. All samples were analyzed for chlorinated volatile organic compounds. Samples collected from monitoring wells CI-15-60, CG-141-40, and CG-141-50 were analyzed also for natural attenuation parameters, including nitrate, ferrous iron, sulfate, methane, total organic carbon, and ethane/ethene. The groundwater data are included on summary figures provided in Attachment B.

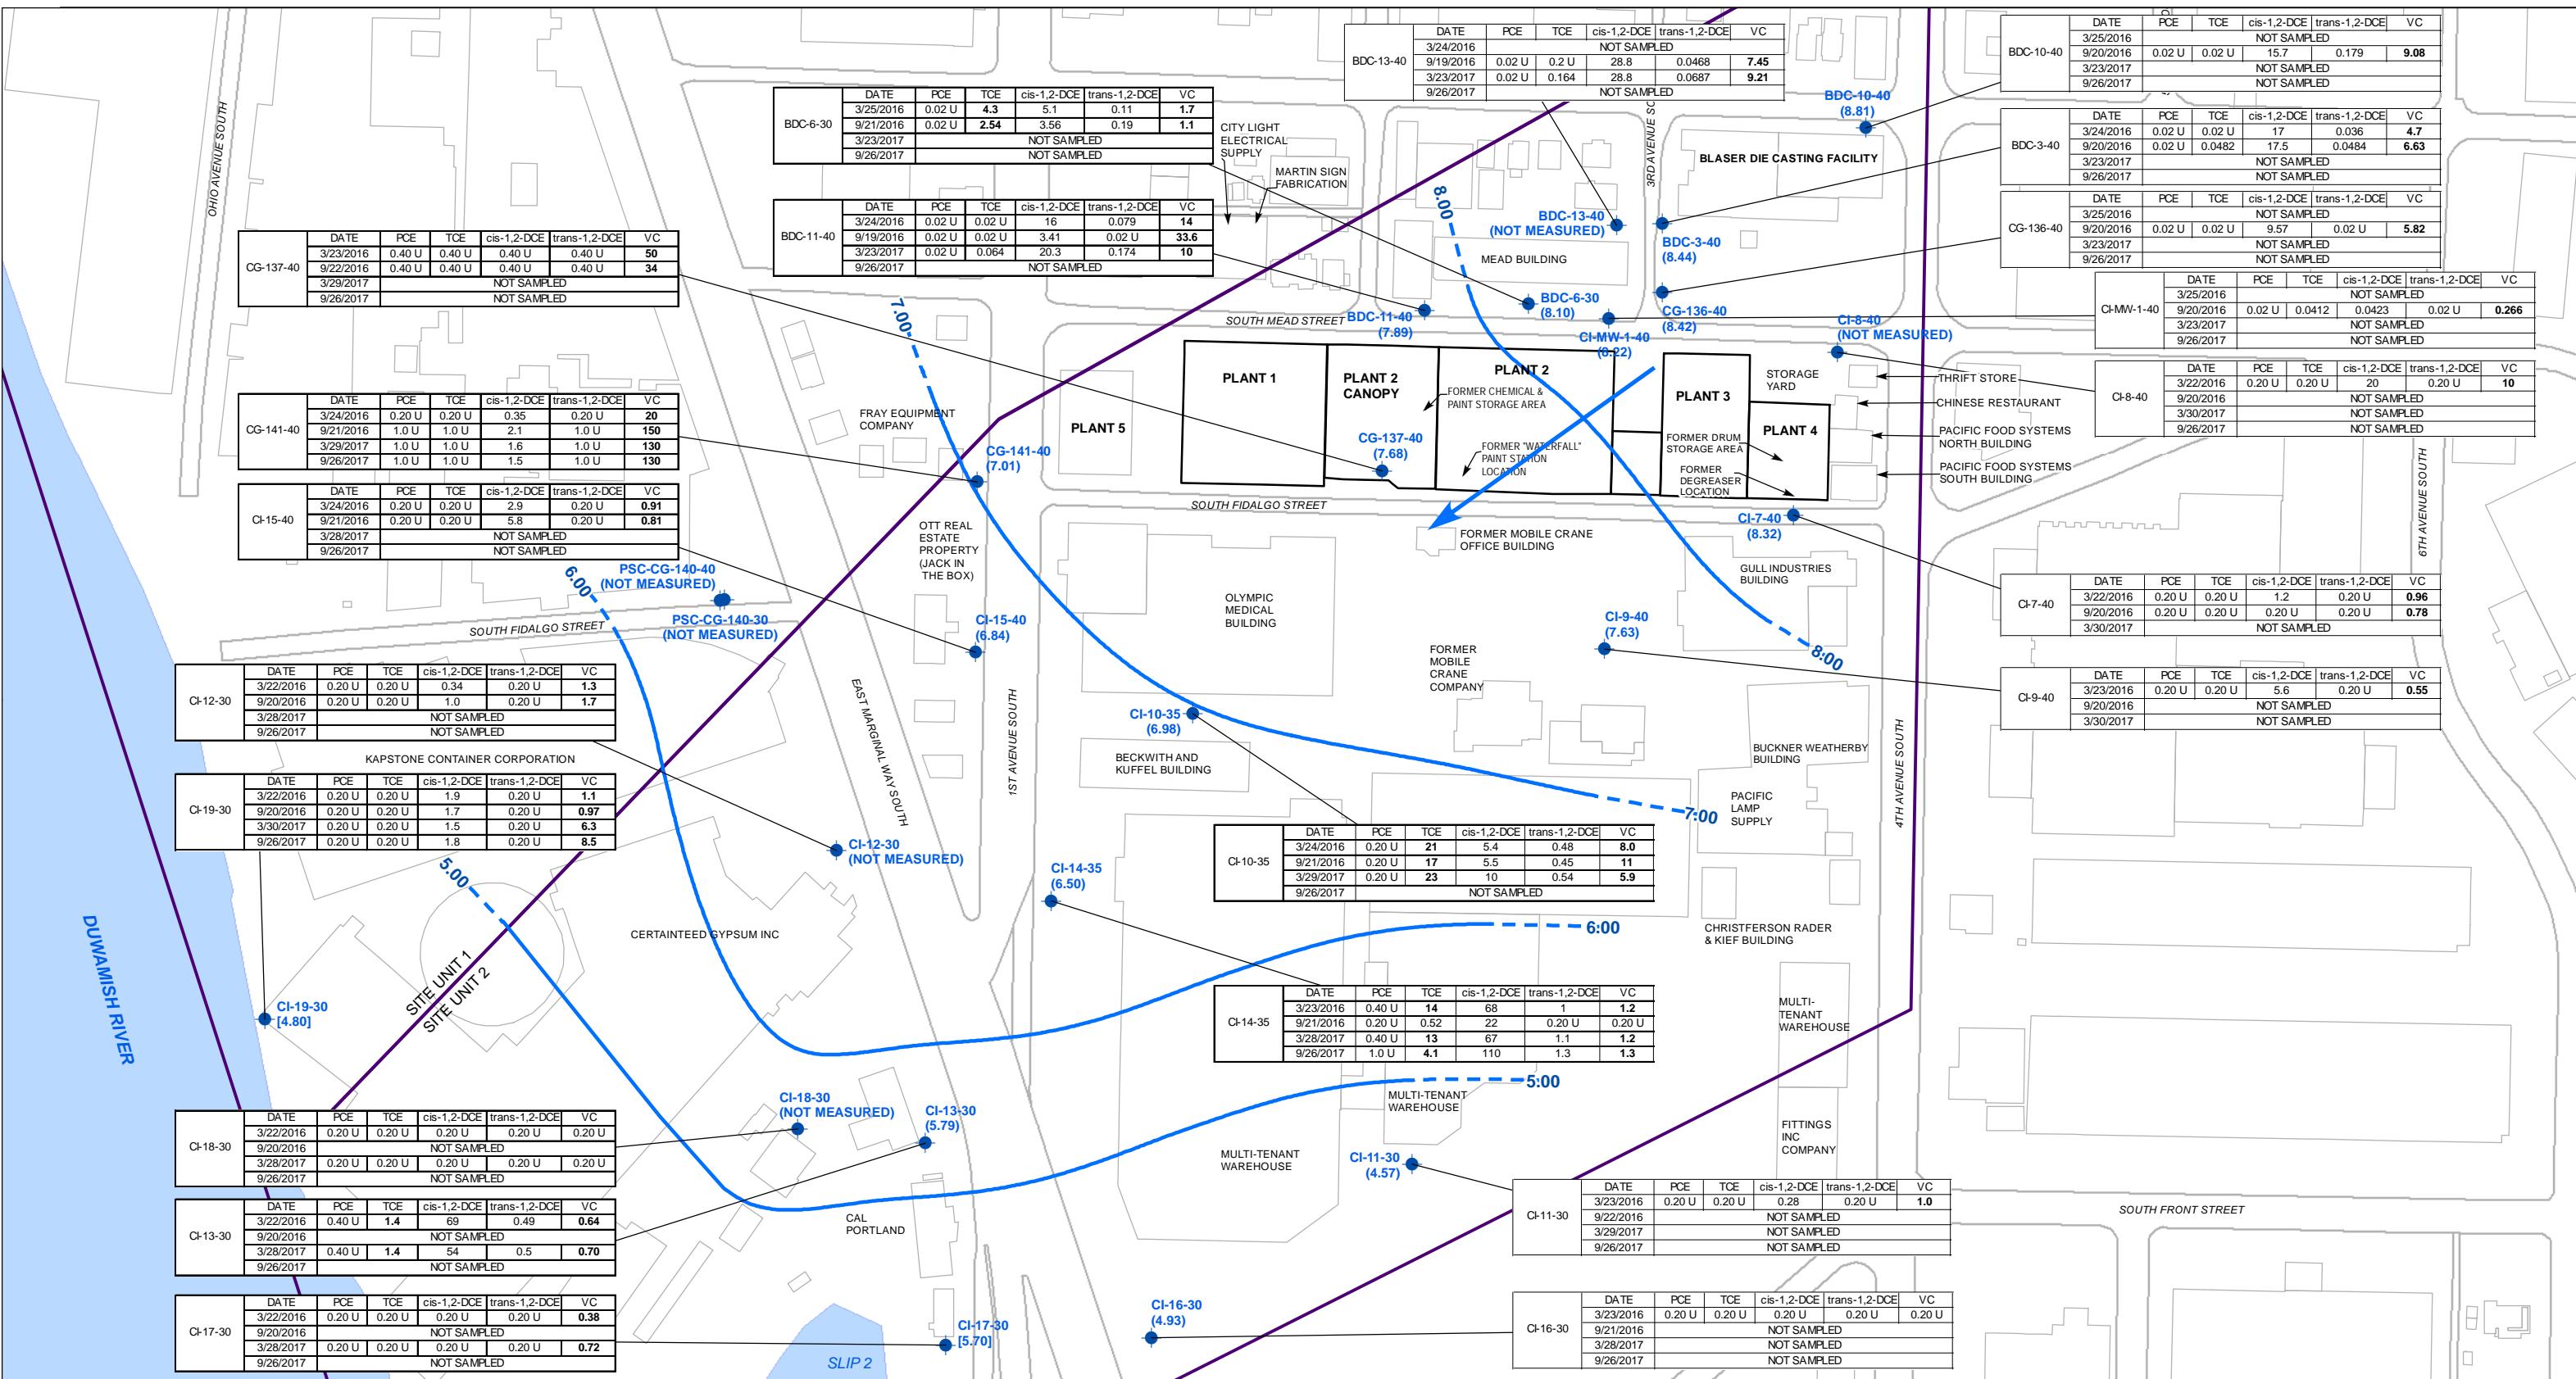
ALL ANALYTICAL RESULTS IN MICROGRAMS PER LITER, SAMPLE DATES LISTED

FIGURE 2
GROUNDWATER ANALYTICAL RESULTS FOR SHALLOW ZONE: 2016 - 2017
REMEDIATION INVESTIGATION
CAPITAL INDUSTRIES, INC.
SEATTLE, WASHINGTON
FARALLON PN: 457-007
Disc Reference:
Drawn By: jjones Checked By: JK Date: 1/8/2018
Document Path: Q:\Projects\457 CapitalIndust\007 RemInvMonitoring\2017Q3_GWHVOC_ShallowZone.mxd

In general, the groundwater results continue to demonstrate that the Capital area plumes associated with the commingled Capital Plant 2/Blaser Die Casting sources, and the Capital Plant 4 source are stable to decreasing. However, the 2016/2017 data for monitoring well CI-19-30, proximate to the Lower Duwamish River, at the CertainTeed Gypsum, Inc. property (Attachment B Figure 2) indicates an increasing trend in vinyl chloride concentrations. The West of 4th Group is jointly conducting work in 2018 to refine the conceptual site model and fate and transport characteristics of the source(s) of elevated concentrations of vinyl chloride up-gradient of the CertainTeed Gypsum, Inc. property. Monitoring well CI-19-30 will continue to be monitored in 2018 to evaluate the status of vinyl chloride.

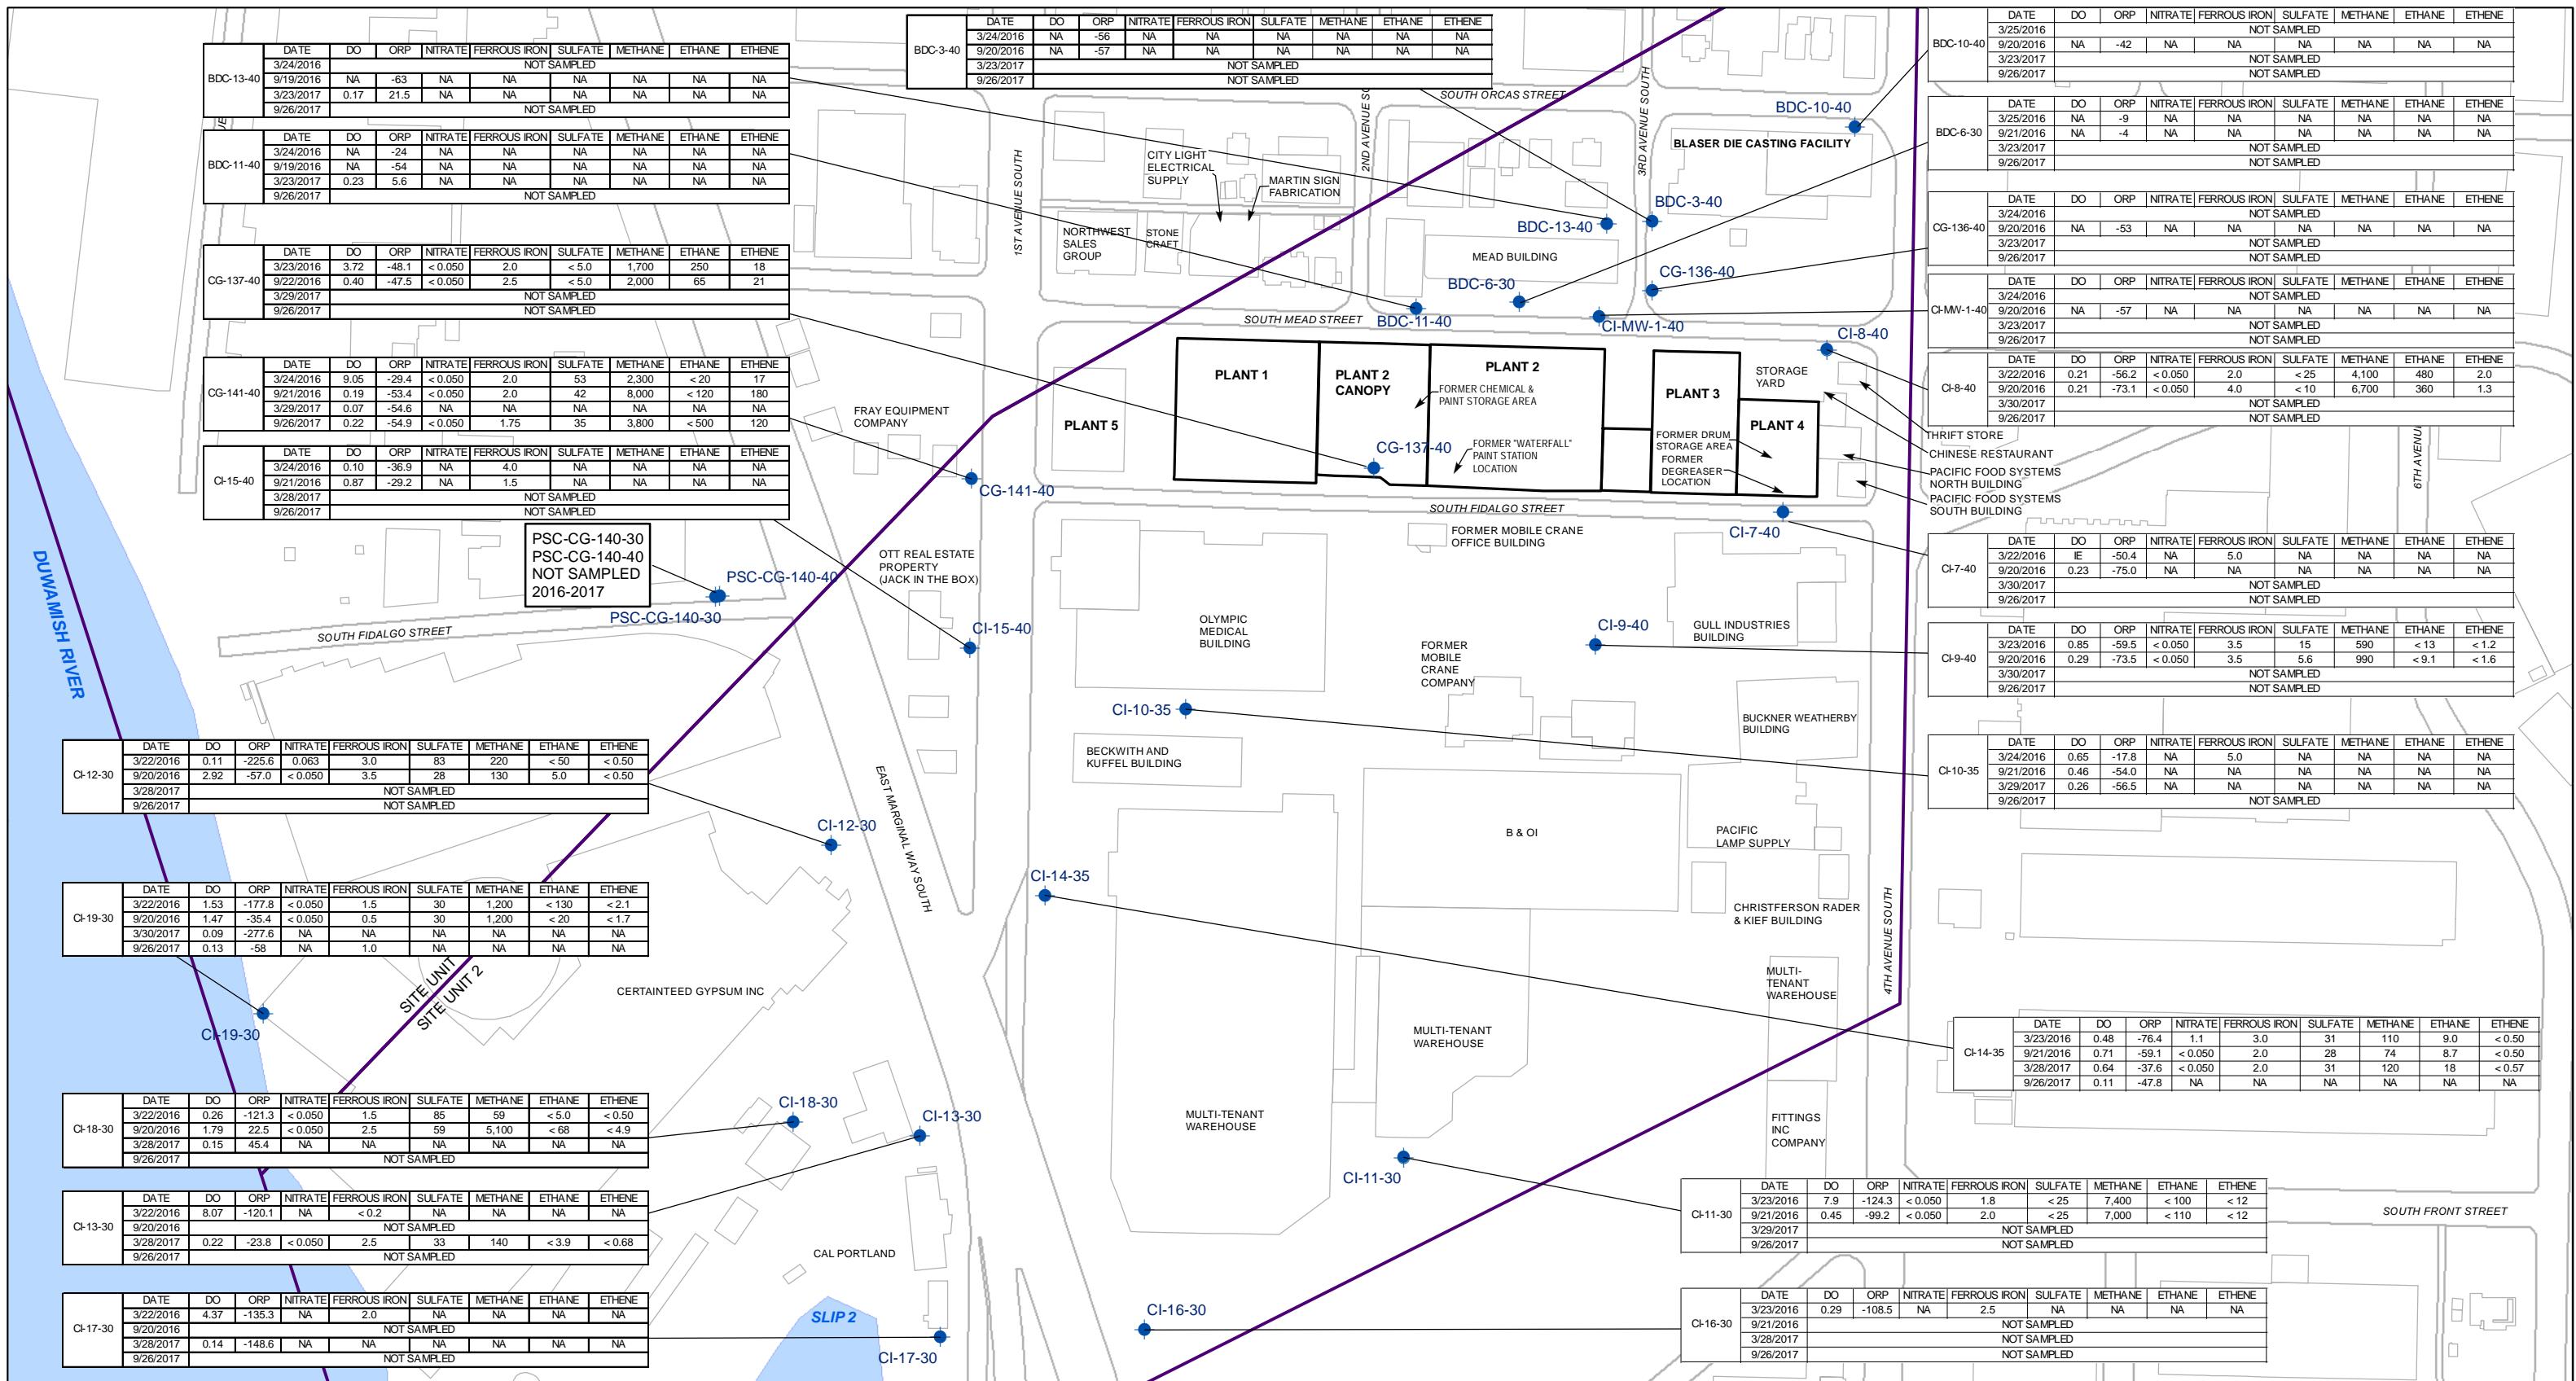
FIGURE 2A

NATURAL ATTENUATION PARAMETERS RESULTS FOR
SHALLOW ZONE: 2016 - 2017
REMEDIAL INVESTIGATION
CAPITAL INDUSTRIES, INC.
SEATTLE, WASHINGTON

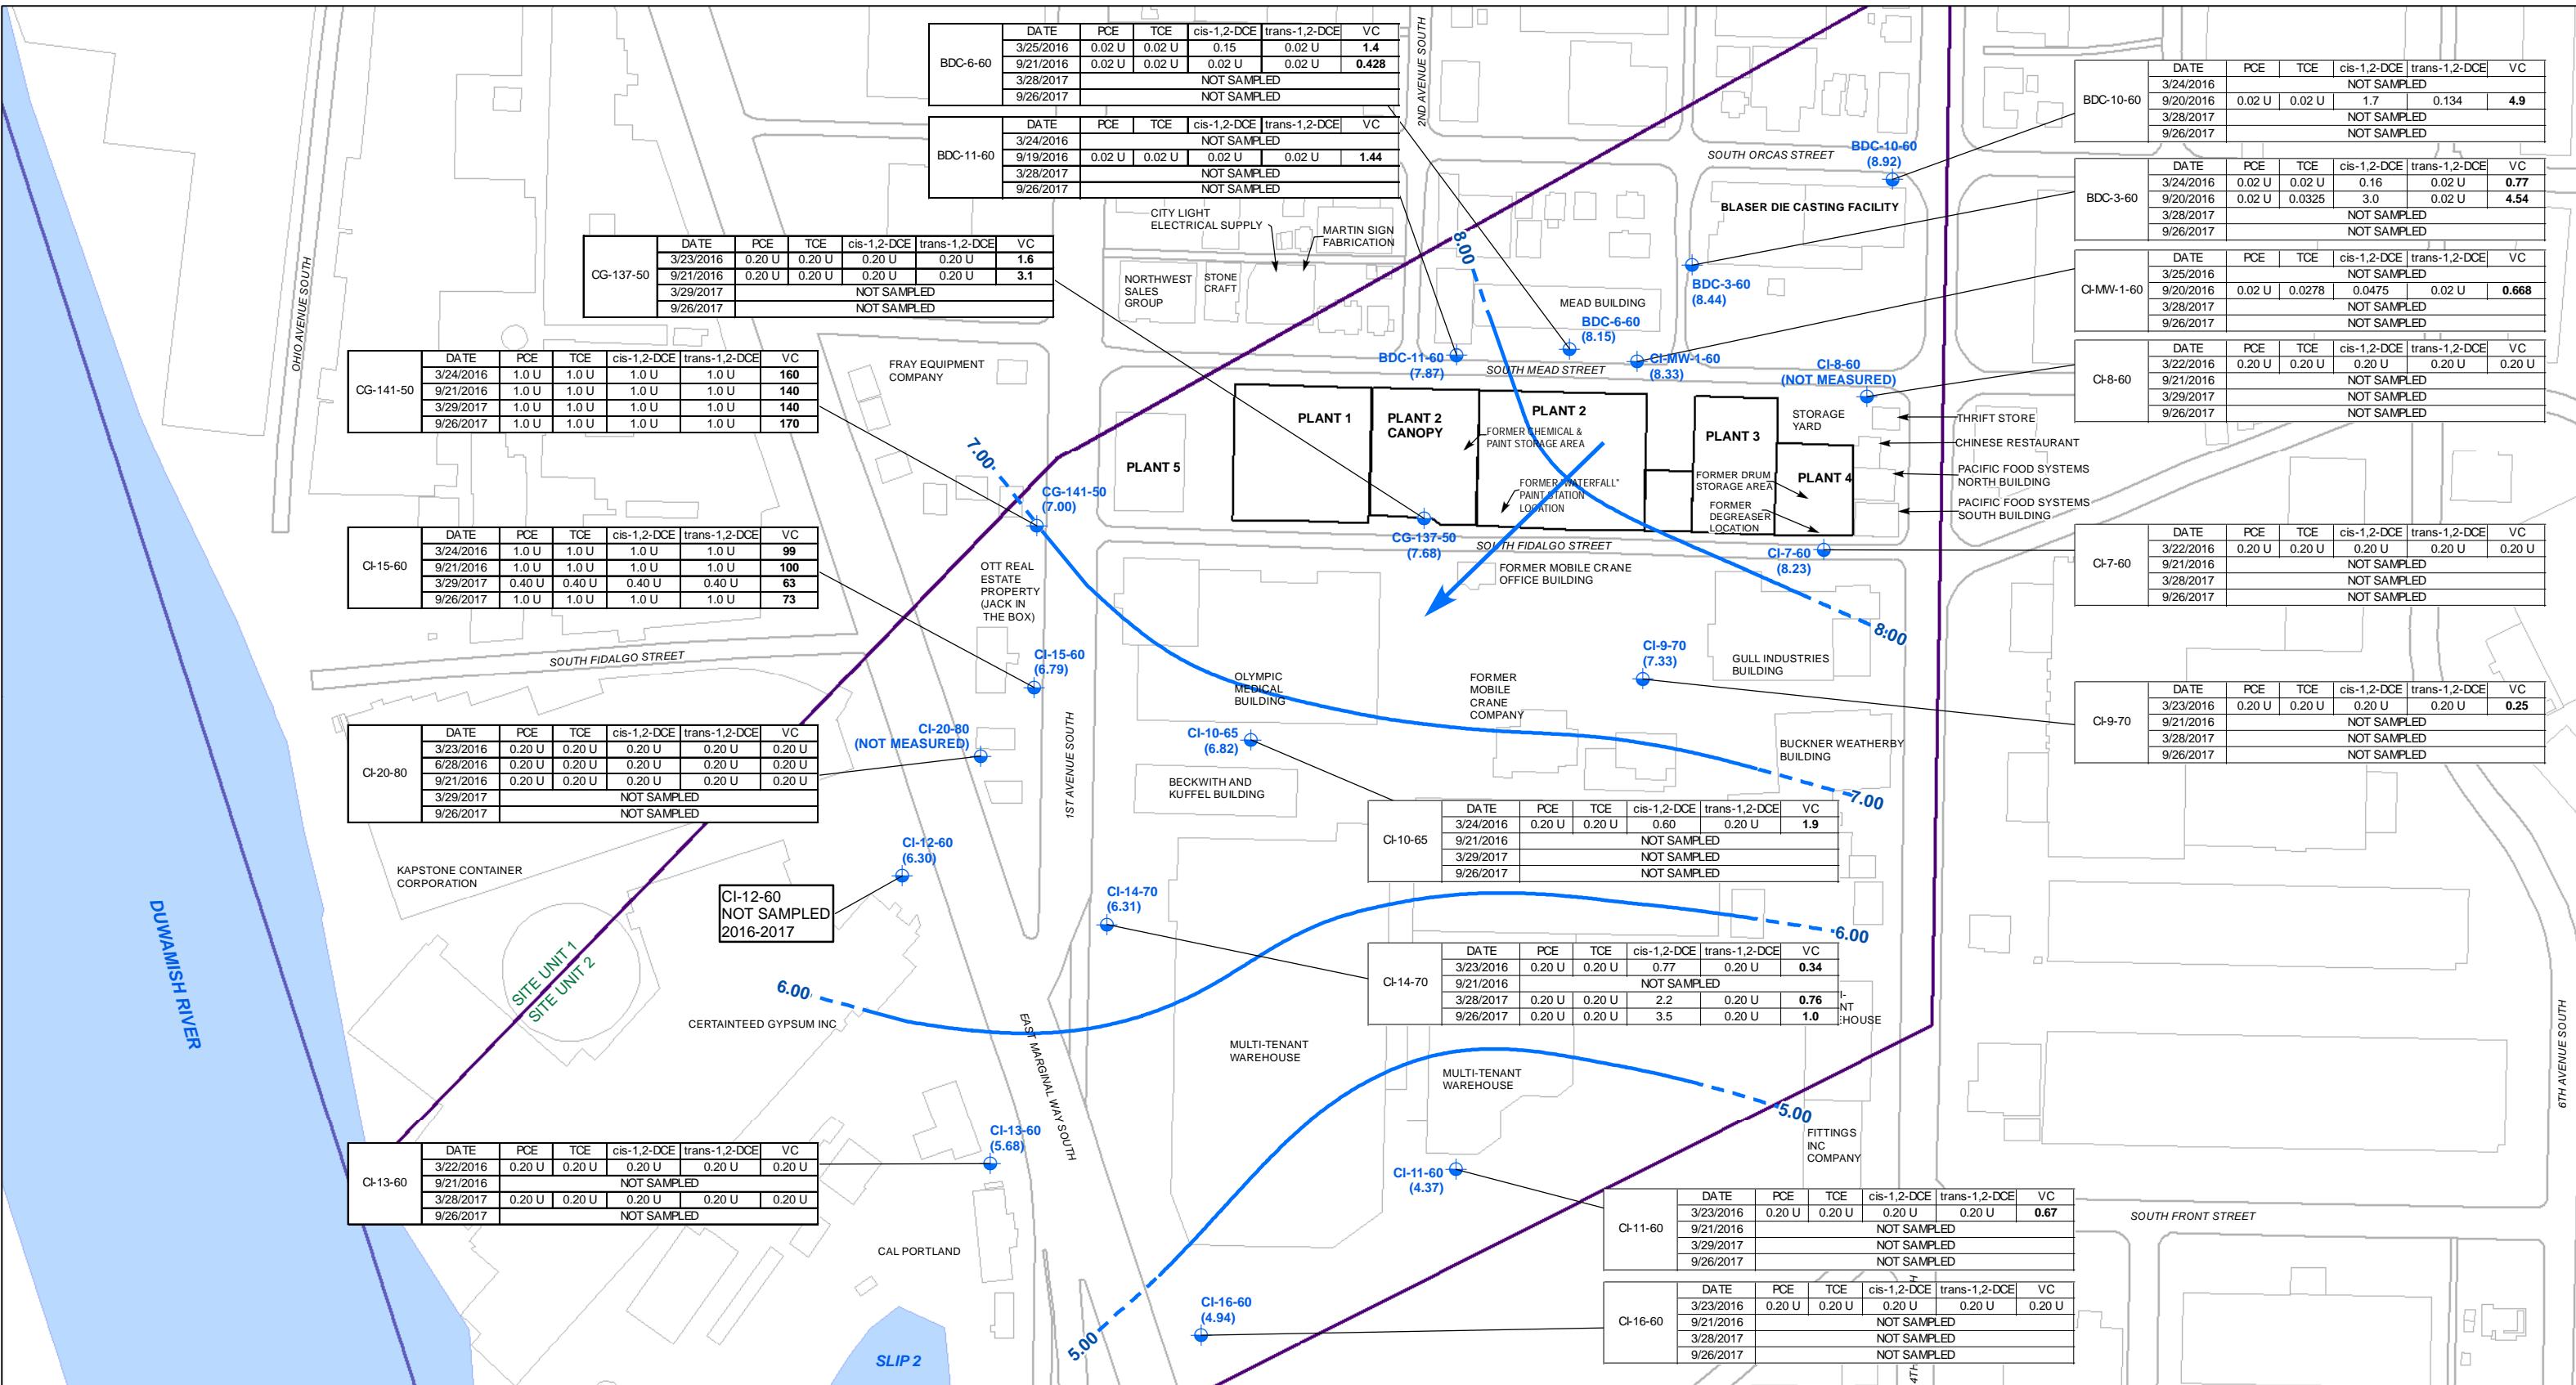
ALL ANALYTICAL RESULTS IN MICROGRAMS PER LITER, SAMPLE DATES LISTED

FIGURE 3
GROUNDWATER ANALYTICAL RESULTS FOR
INTERMEDIATE ZONE: 2016 - 2017
REMEDIATION
CAPITAL INDUSTRIES, INC.
SEATTLE, WASHINGTON
FARALLON PN: 457-007
Disc Reference:
Drawn By: jjones Checked By: JK Date: 1/2/2018
Document Path: Q:\Projects\457 CapitalIndus\007 RemInvMonitoring\2017Q3_GW\Fig3_201709_GWHVOC_IntermedZone.mxd

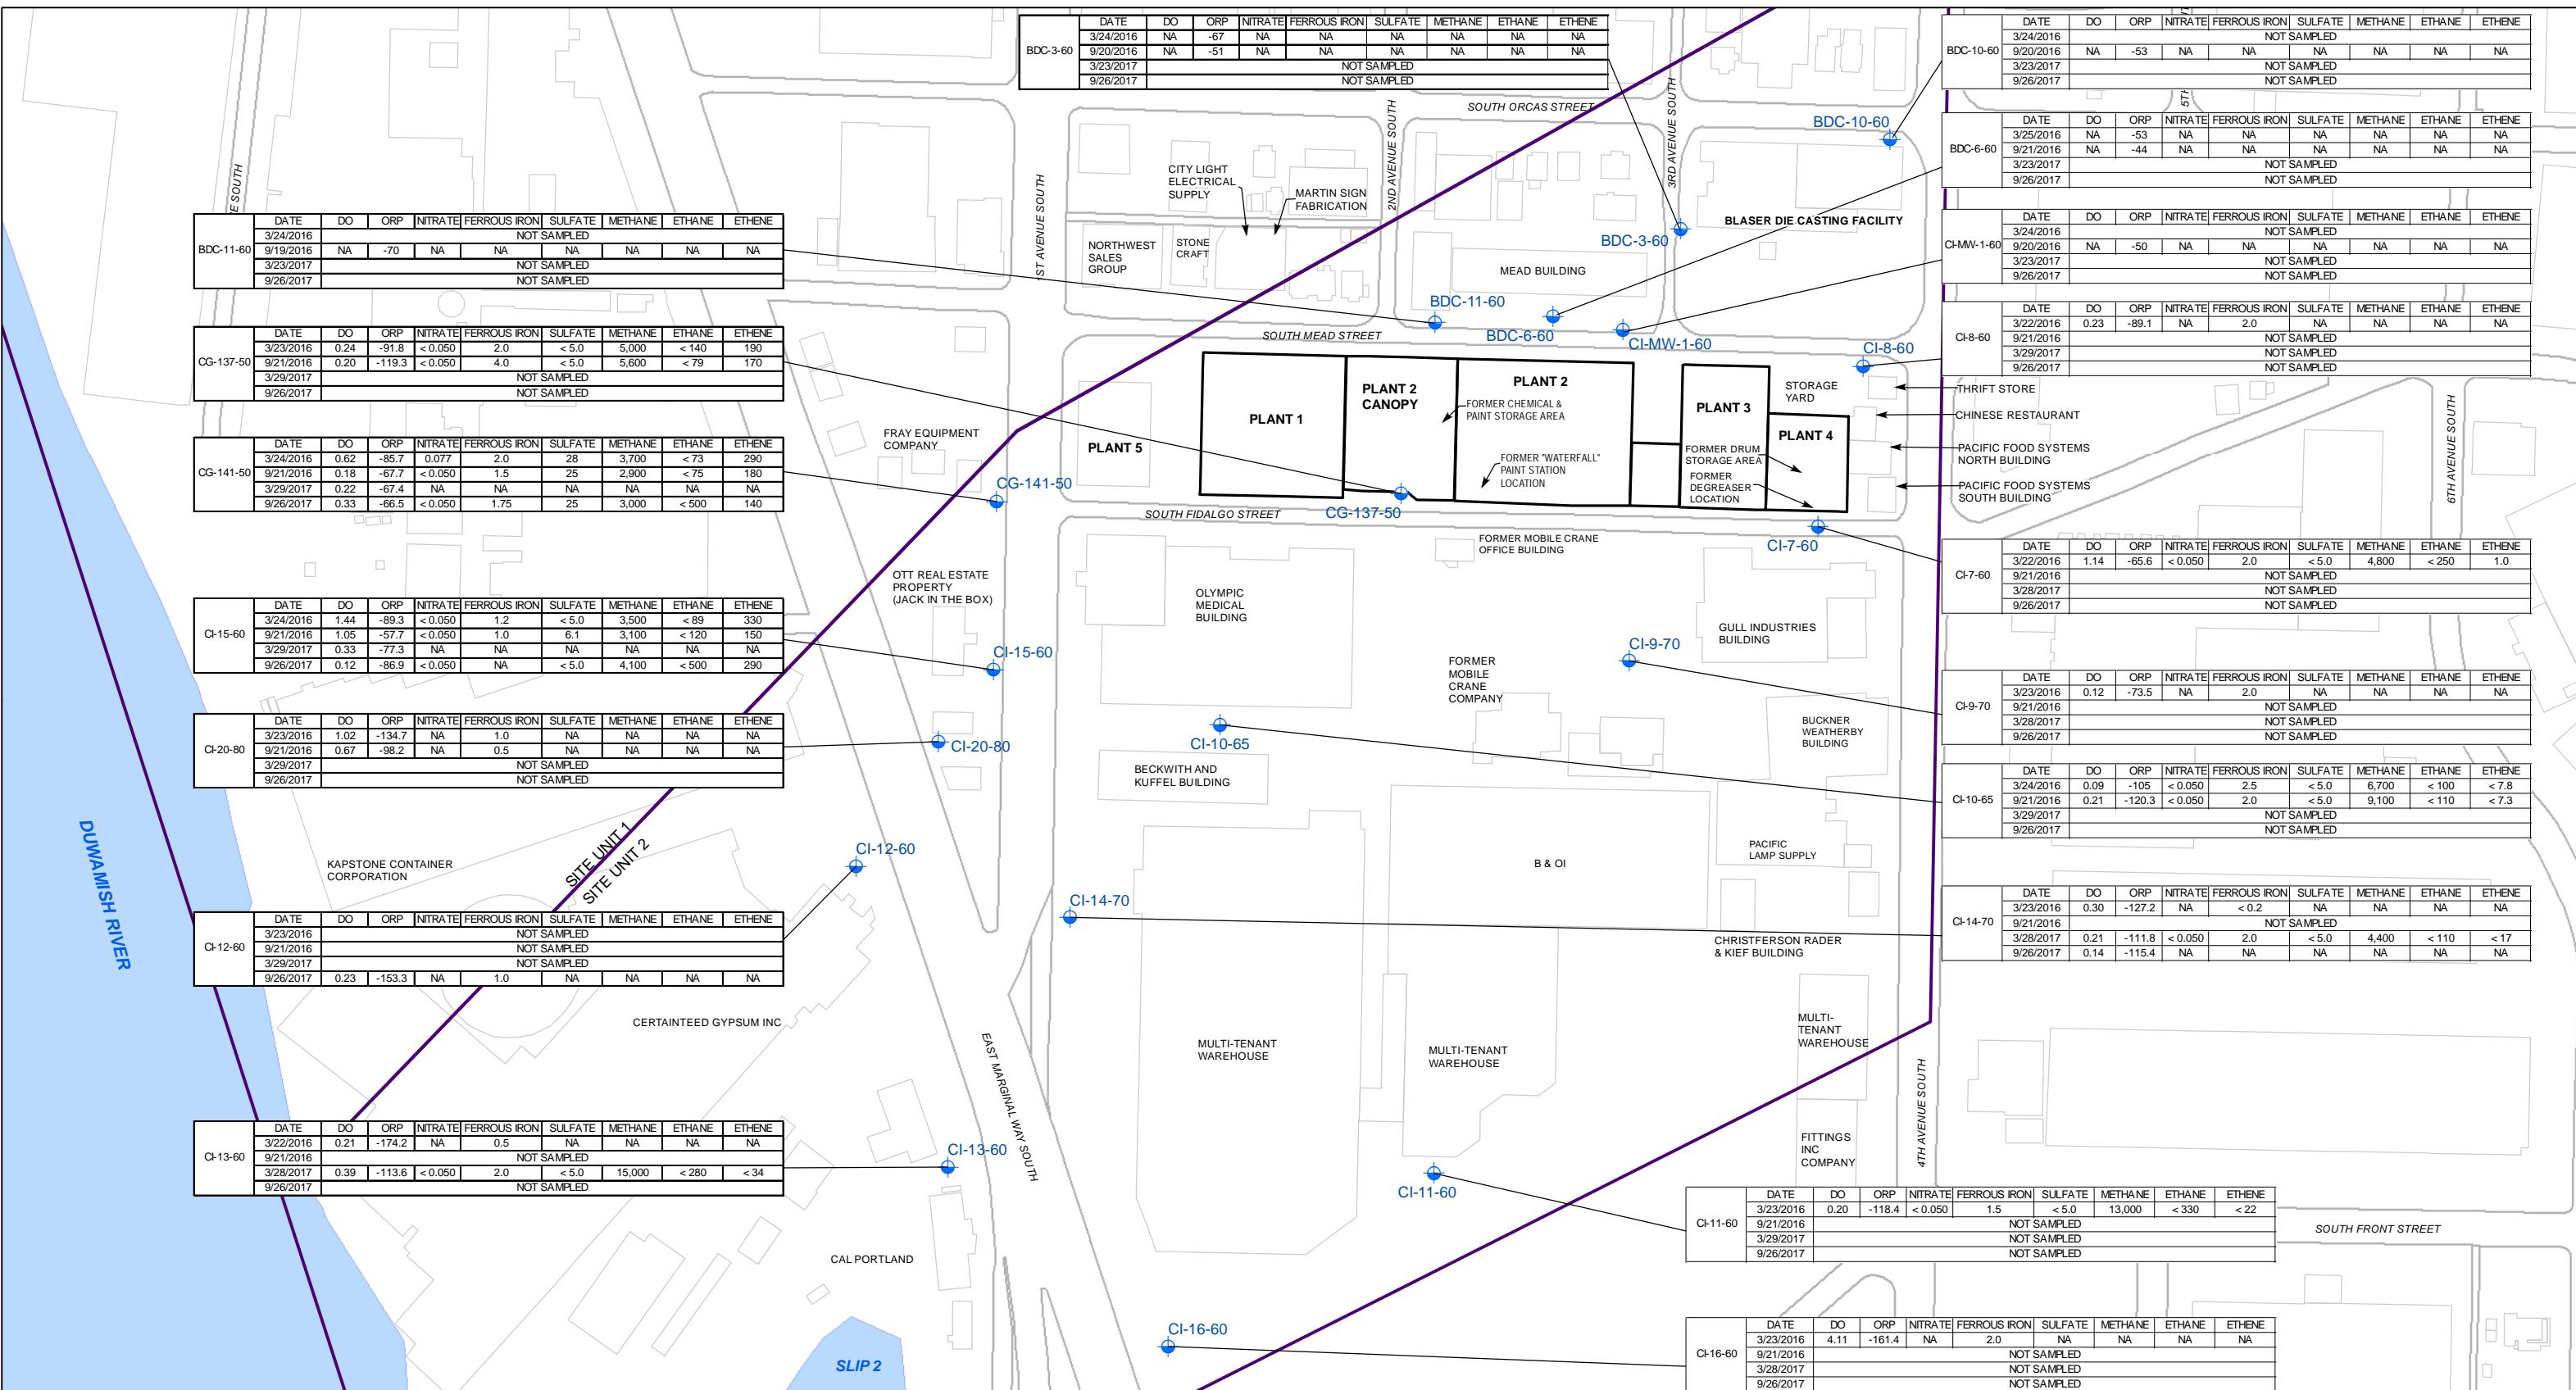
FIGURE 3A

NATURAL ATTENUATION PARAMETERS RESULTS FOR
INTERMEDIATE ZONE: 2016 - 2017
REMEDIATION
CAPITAL INDUSTRIES, INC.
SEATTLE, WASHINGTON
FARALLON PN: 457-007
