**RE: PROGRESS REPORT, OCTOBER THROUGH DECEMBER 2015
REMEDIAL INVESTIGATION MONITORING AND FEASIBILITY STUDY
CAPITAL INDUSTRIES, INC., SEATTLE, WASHINGTON
AGREED ORDER NO. DE 10402
FARALLON PN: 457-008**

PROGRESS REPORT, OCTOBER THROUGH DECEMBER 2015
Capital Industries, Inc.
Seattle, Washington

Site Diagram

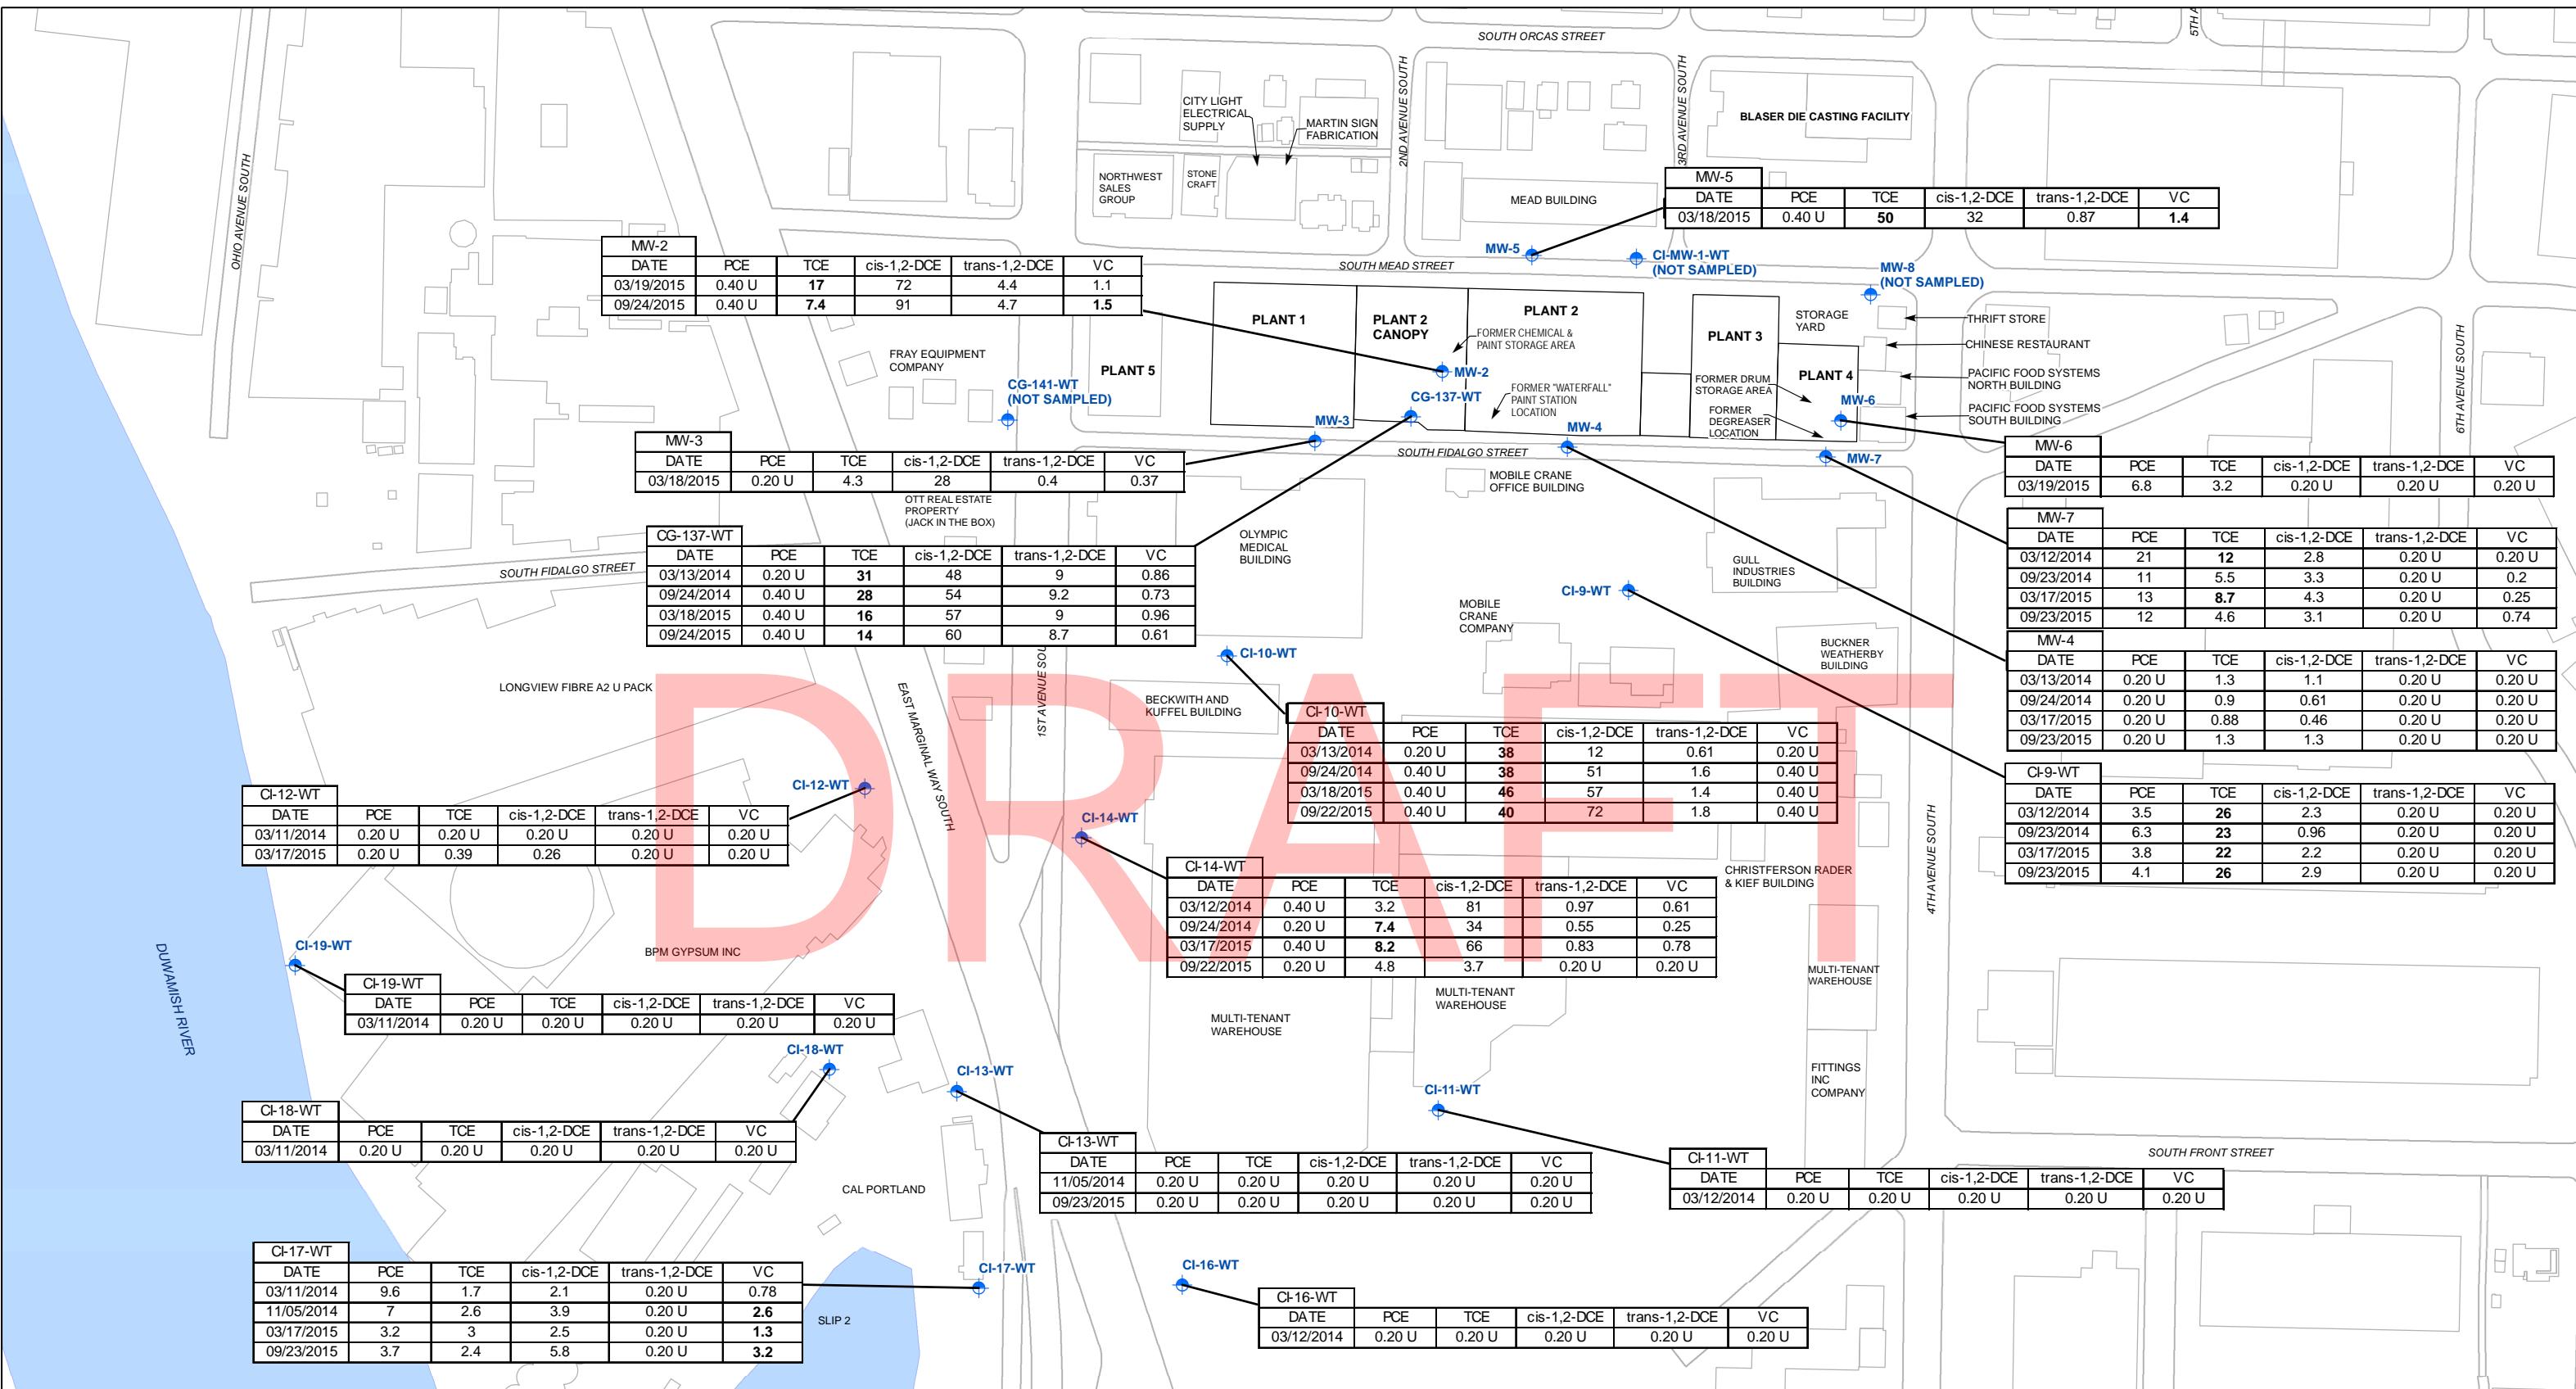
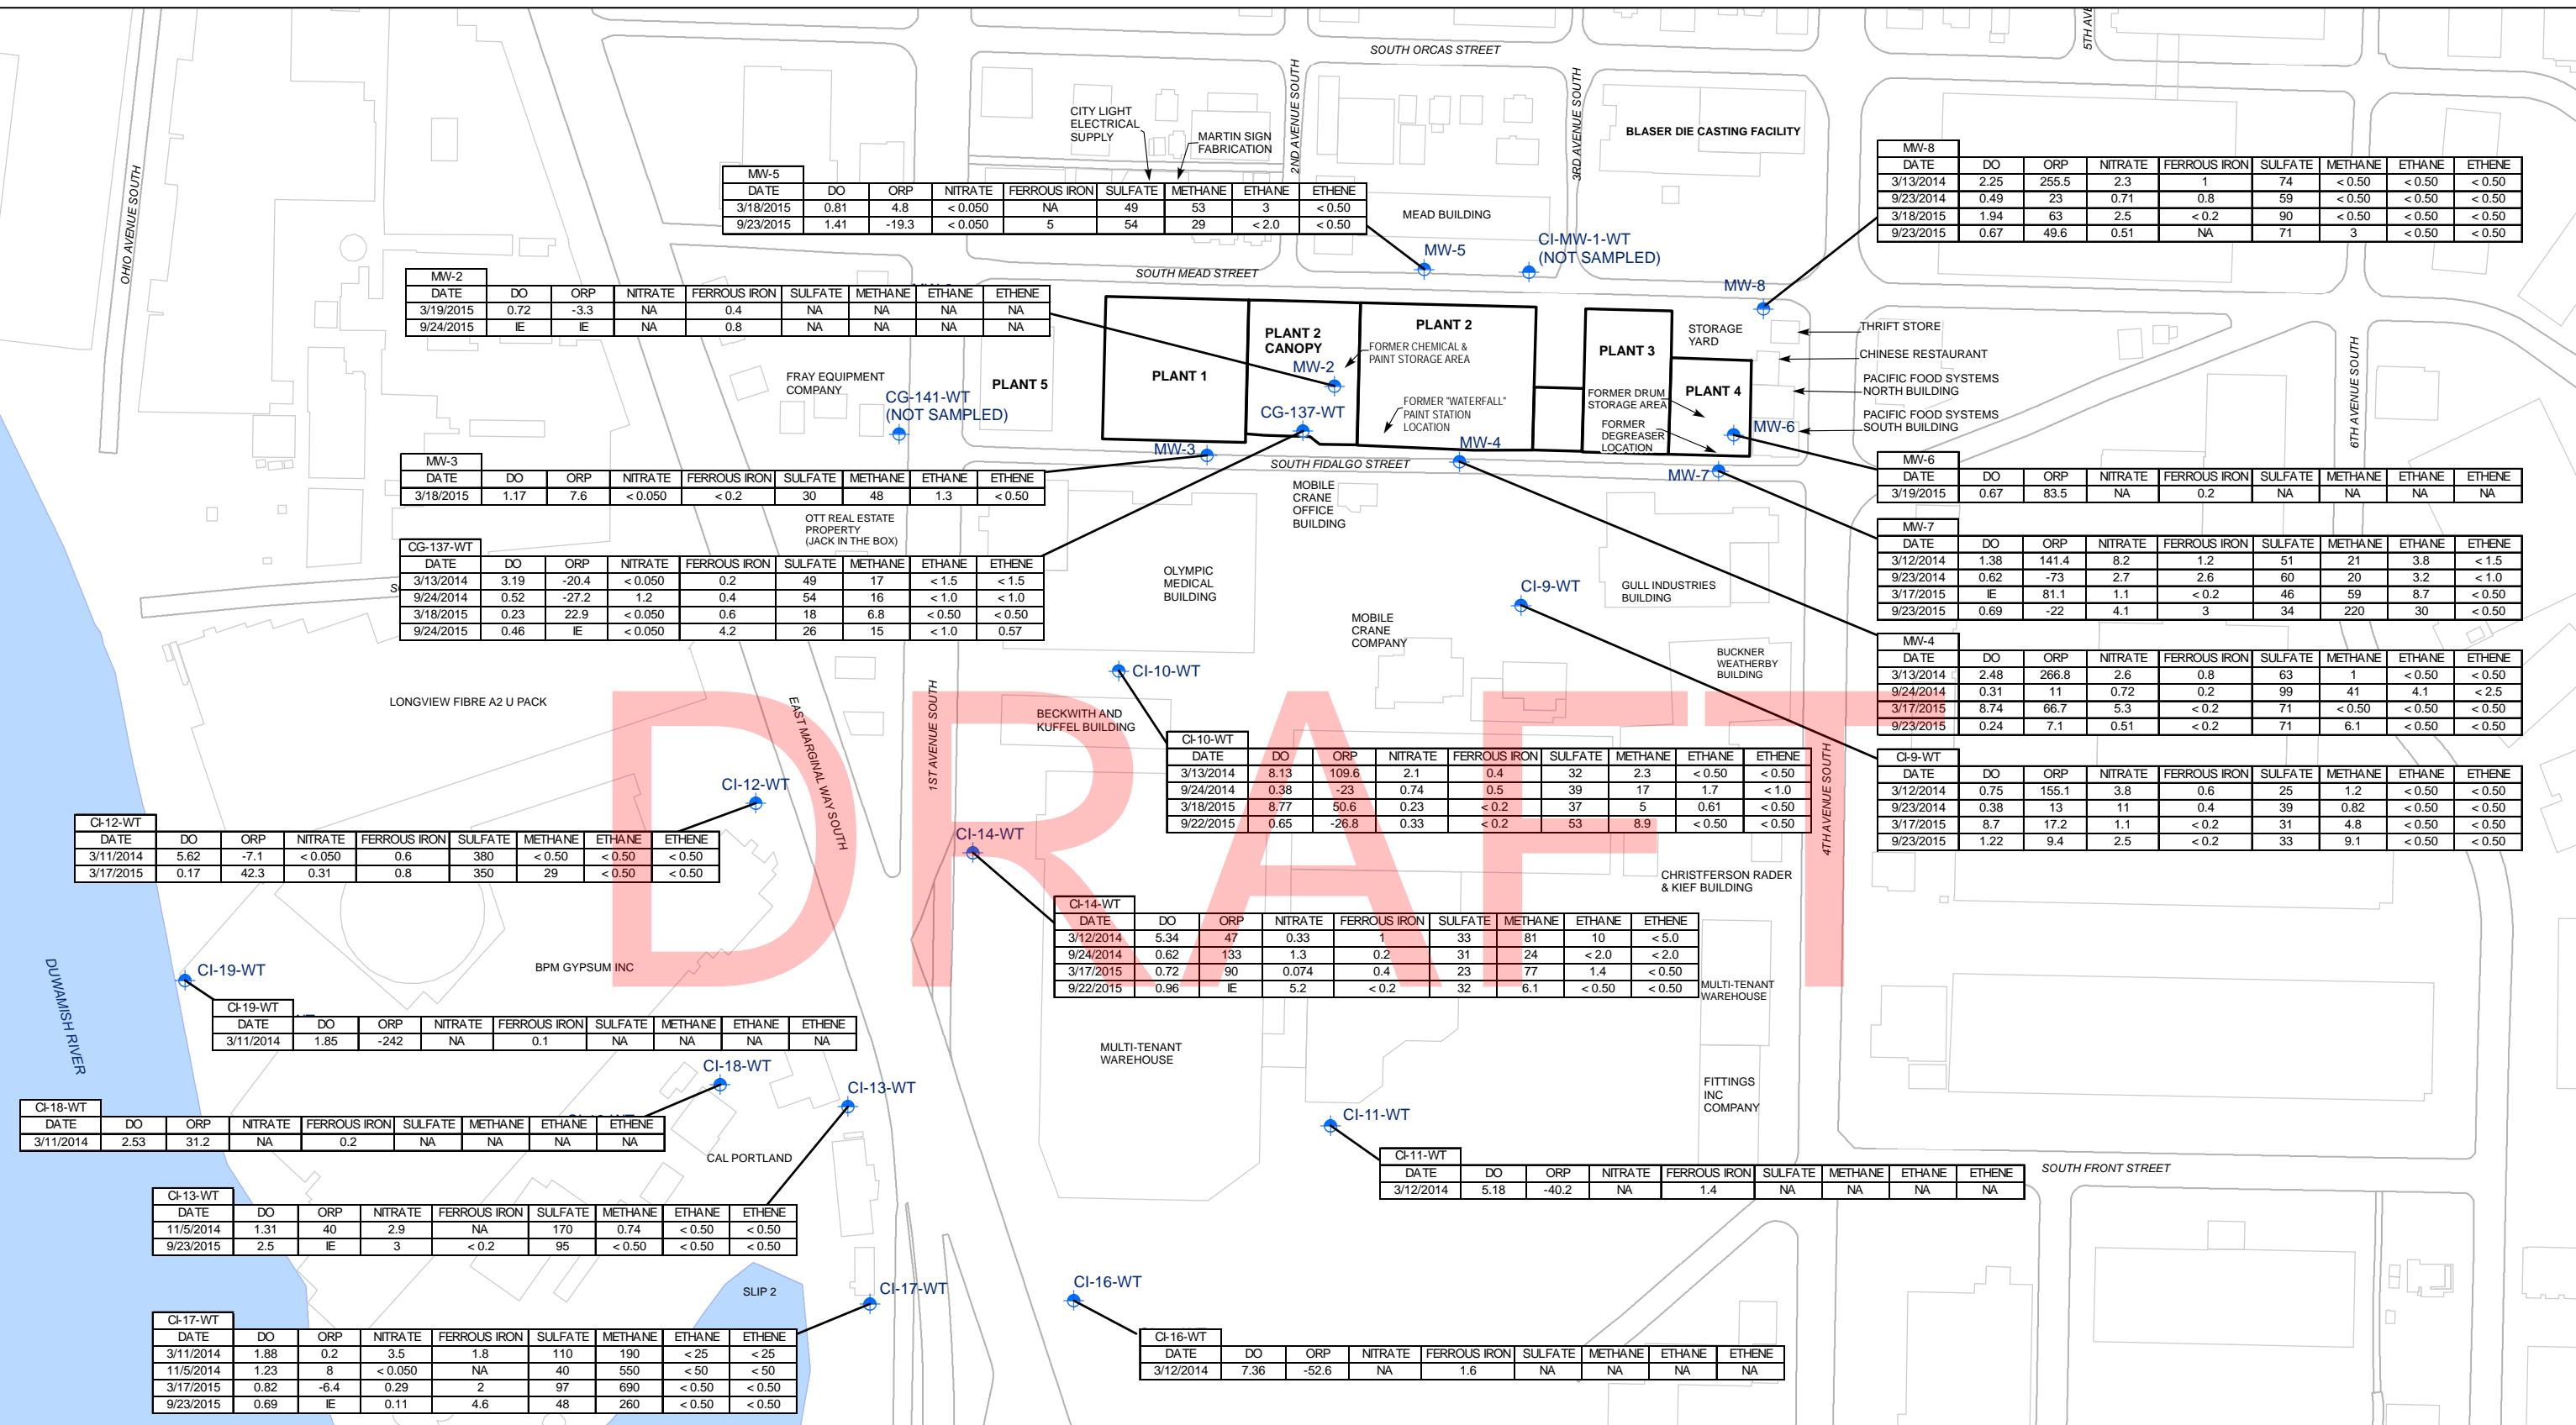
FIGURE 1A
NATURAL ATTENUATION PARAMETERS RESULTS FOR
WATER TABLE ZONE: 2014 - 2015
REMEDIAL INVESTIGATION
CAPITAL INDUSTRIES, INC.
SEATTLE, WASHINGTON
 FARALLON PN: 457-007
 Drawn By: tperrin Checked By: JK Date: 11/24/2015
 Document Path: G:\Projects\457 Capital Indust\457010 West of 4th - Site Unit 2\GIS\GW_Q42015\Figure1A_NatAttenuWaterTableZone - fix.mxd
 Disc Reference:

Groundwater monitoring and sampling was performed in September 2015 in accordance with the memorandum regarding Revised West of 4th Groundwater Monitoring Program Plan dated December 23, 2014, prepared by Pacific Groundwater Group. The results of the sampling have been summarized and are included on summary figures attached to this report in Attachment B.

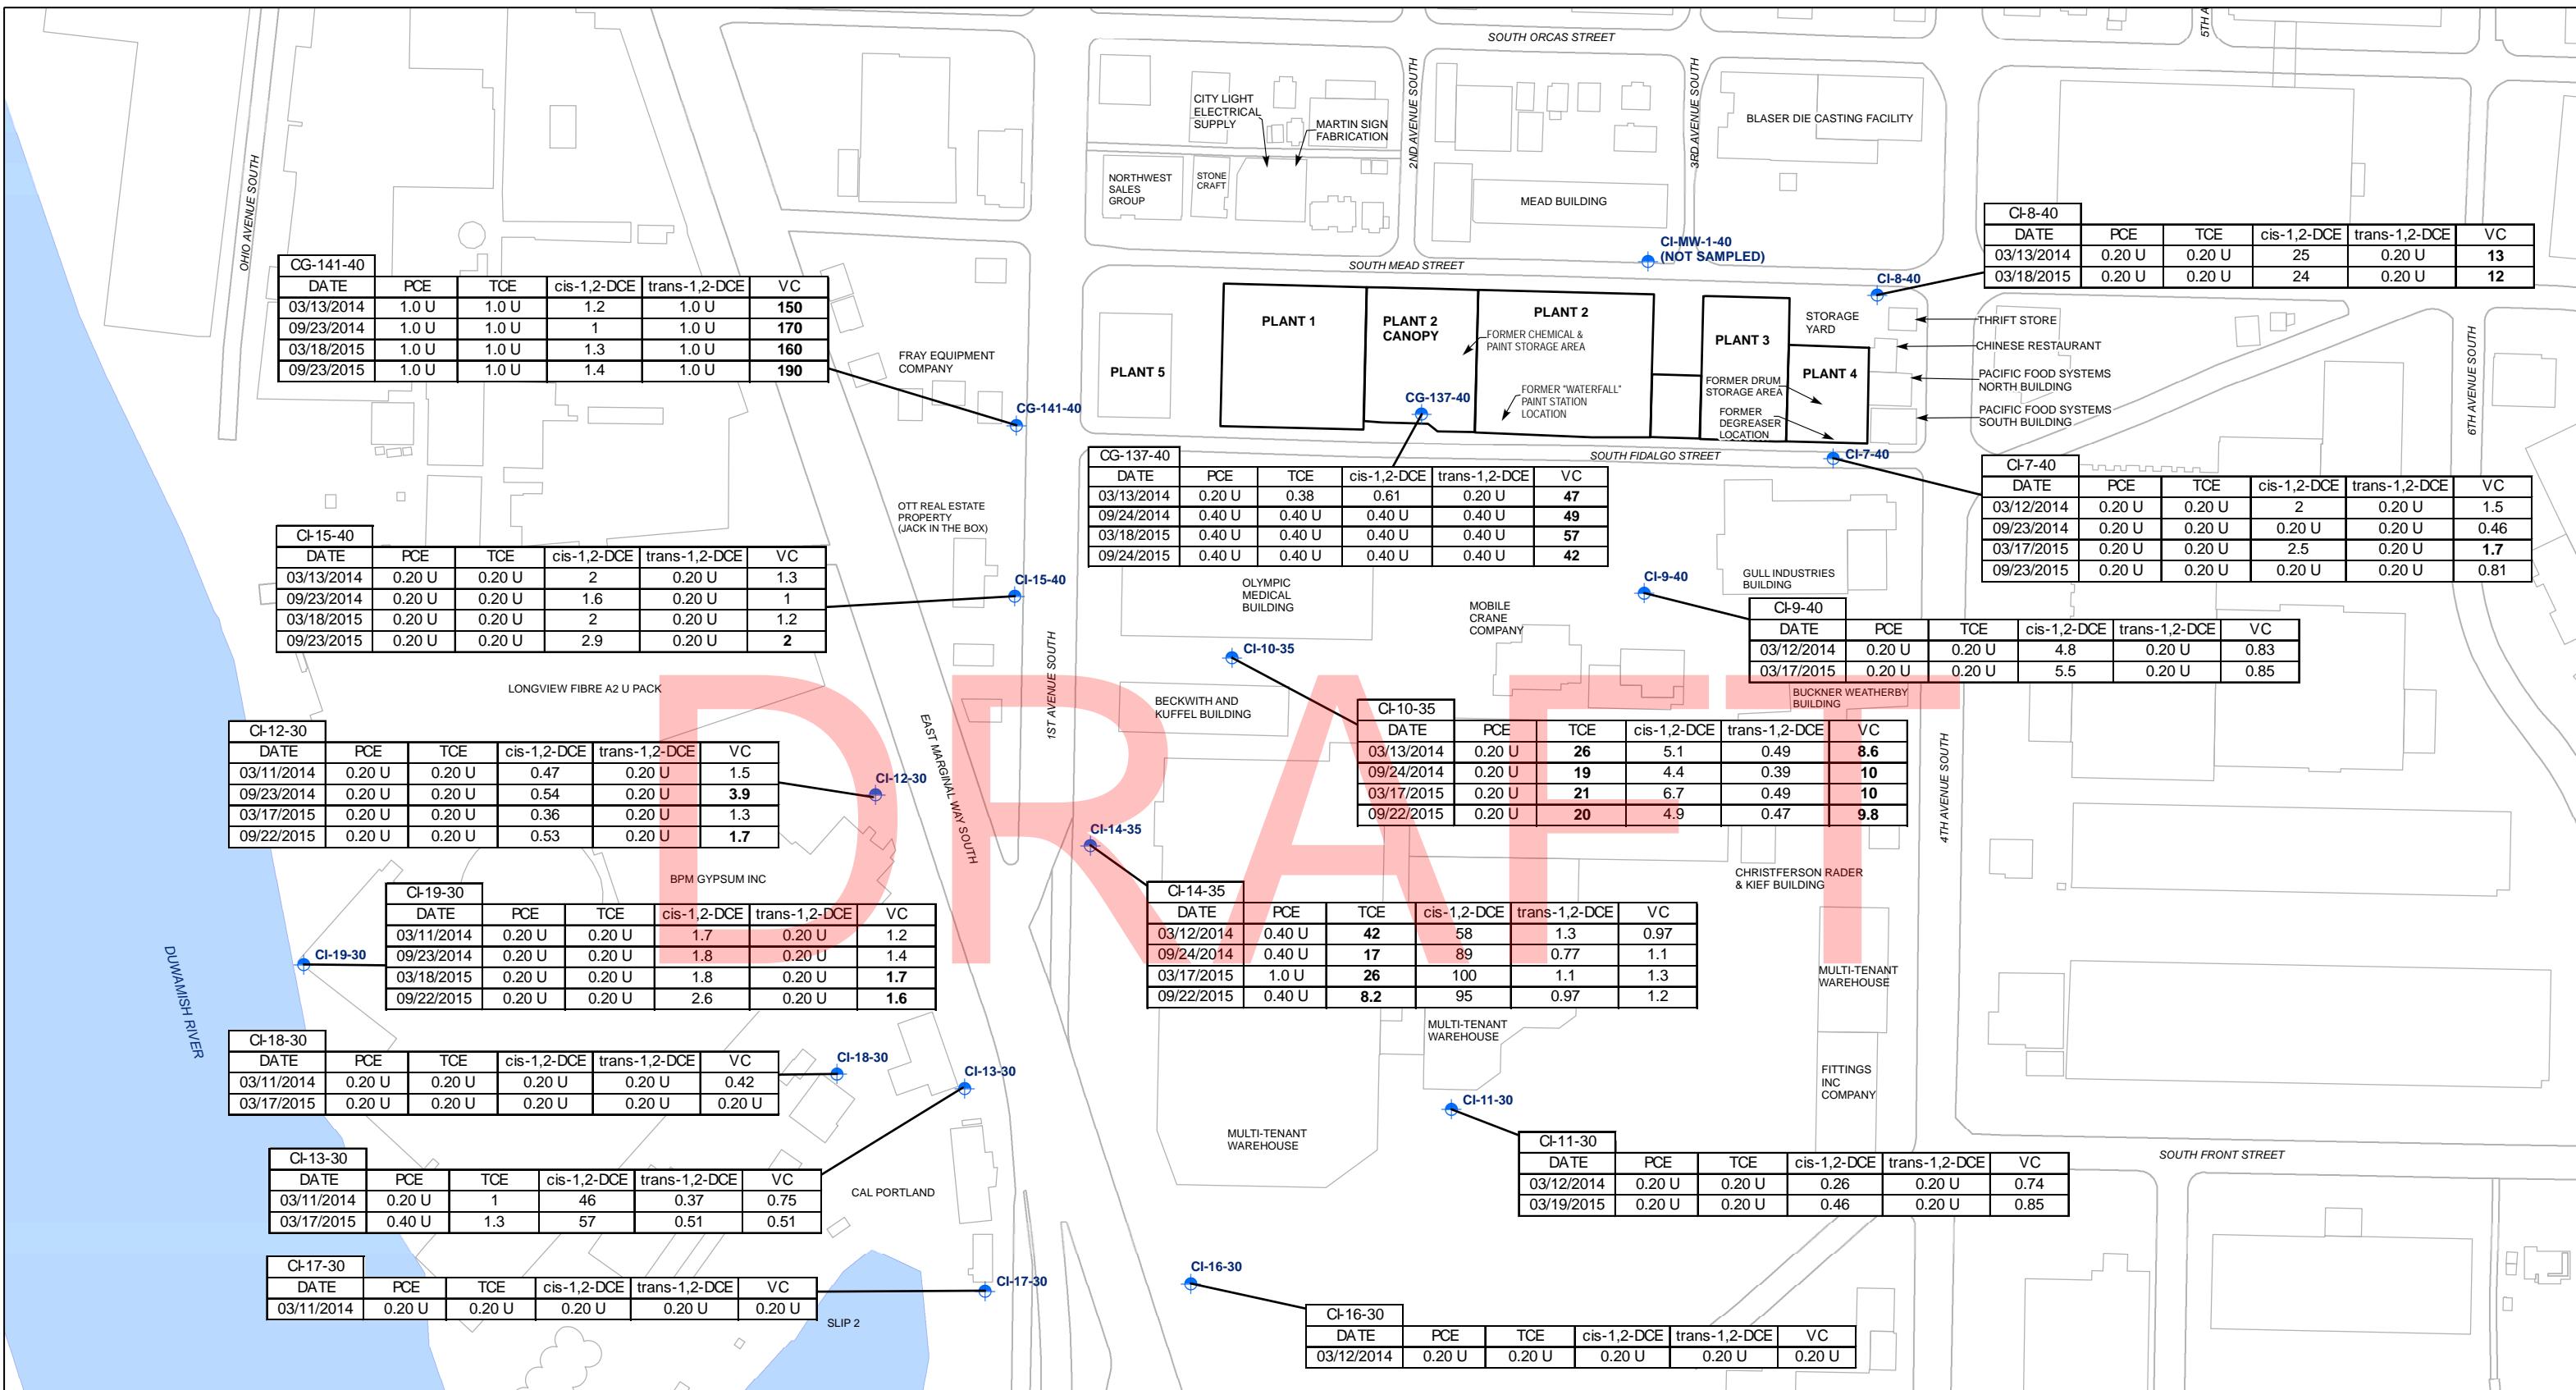
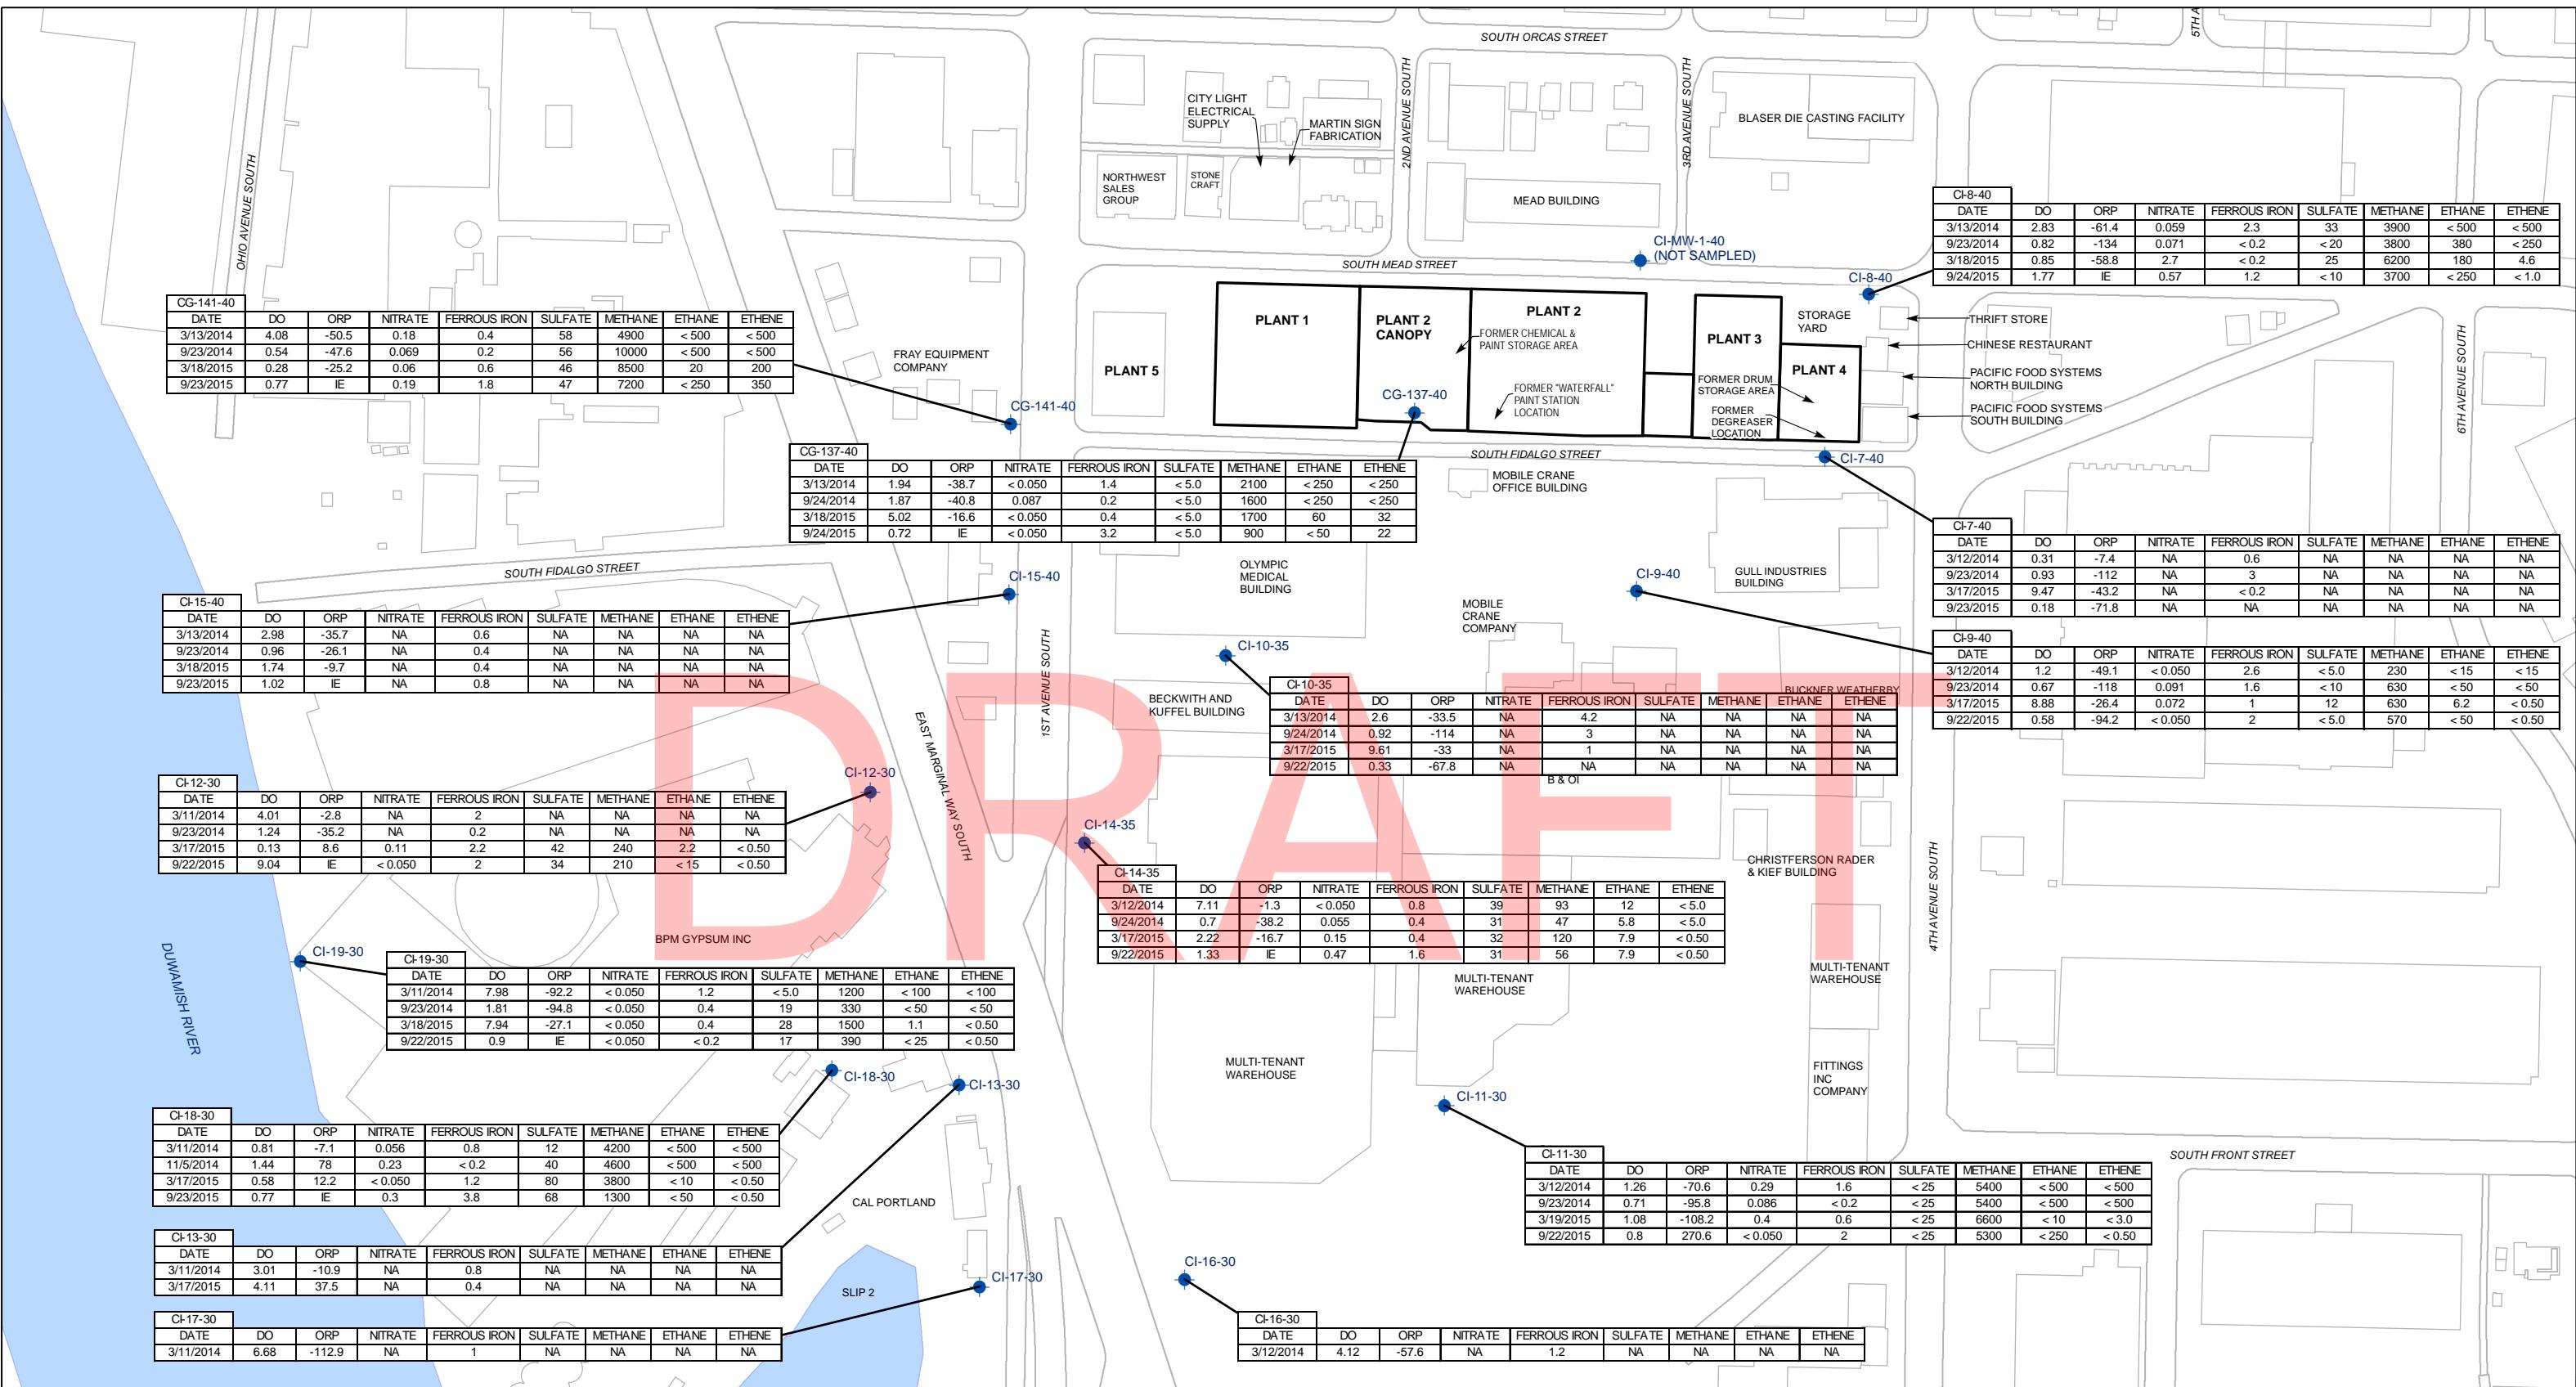
FIGURE 2A
 NATURAL ATTENUATION PARAMETERS RESULTS FOR
 SHALLOW ZONE: 2014 - 2015
 REMEDIAL INVESTIGATION
 CAPITAL INDUSTRIES, INC.
 SEATTLE, WASHINGTON
 FARALLON PN: 457-007
 Drawn By: tperrin Checked By: JK Date: 11/24/2015
 Document Path: G:\Projects\457 Capital Indust\457010 West of 4th - Site Unit 2\GIS\GW_Q42015\Figure2A NatAttenu ShallowZone - fix.mxd
 Disc Reference:

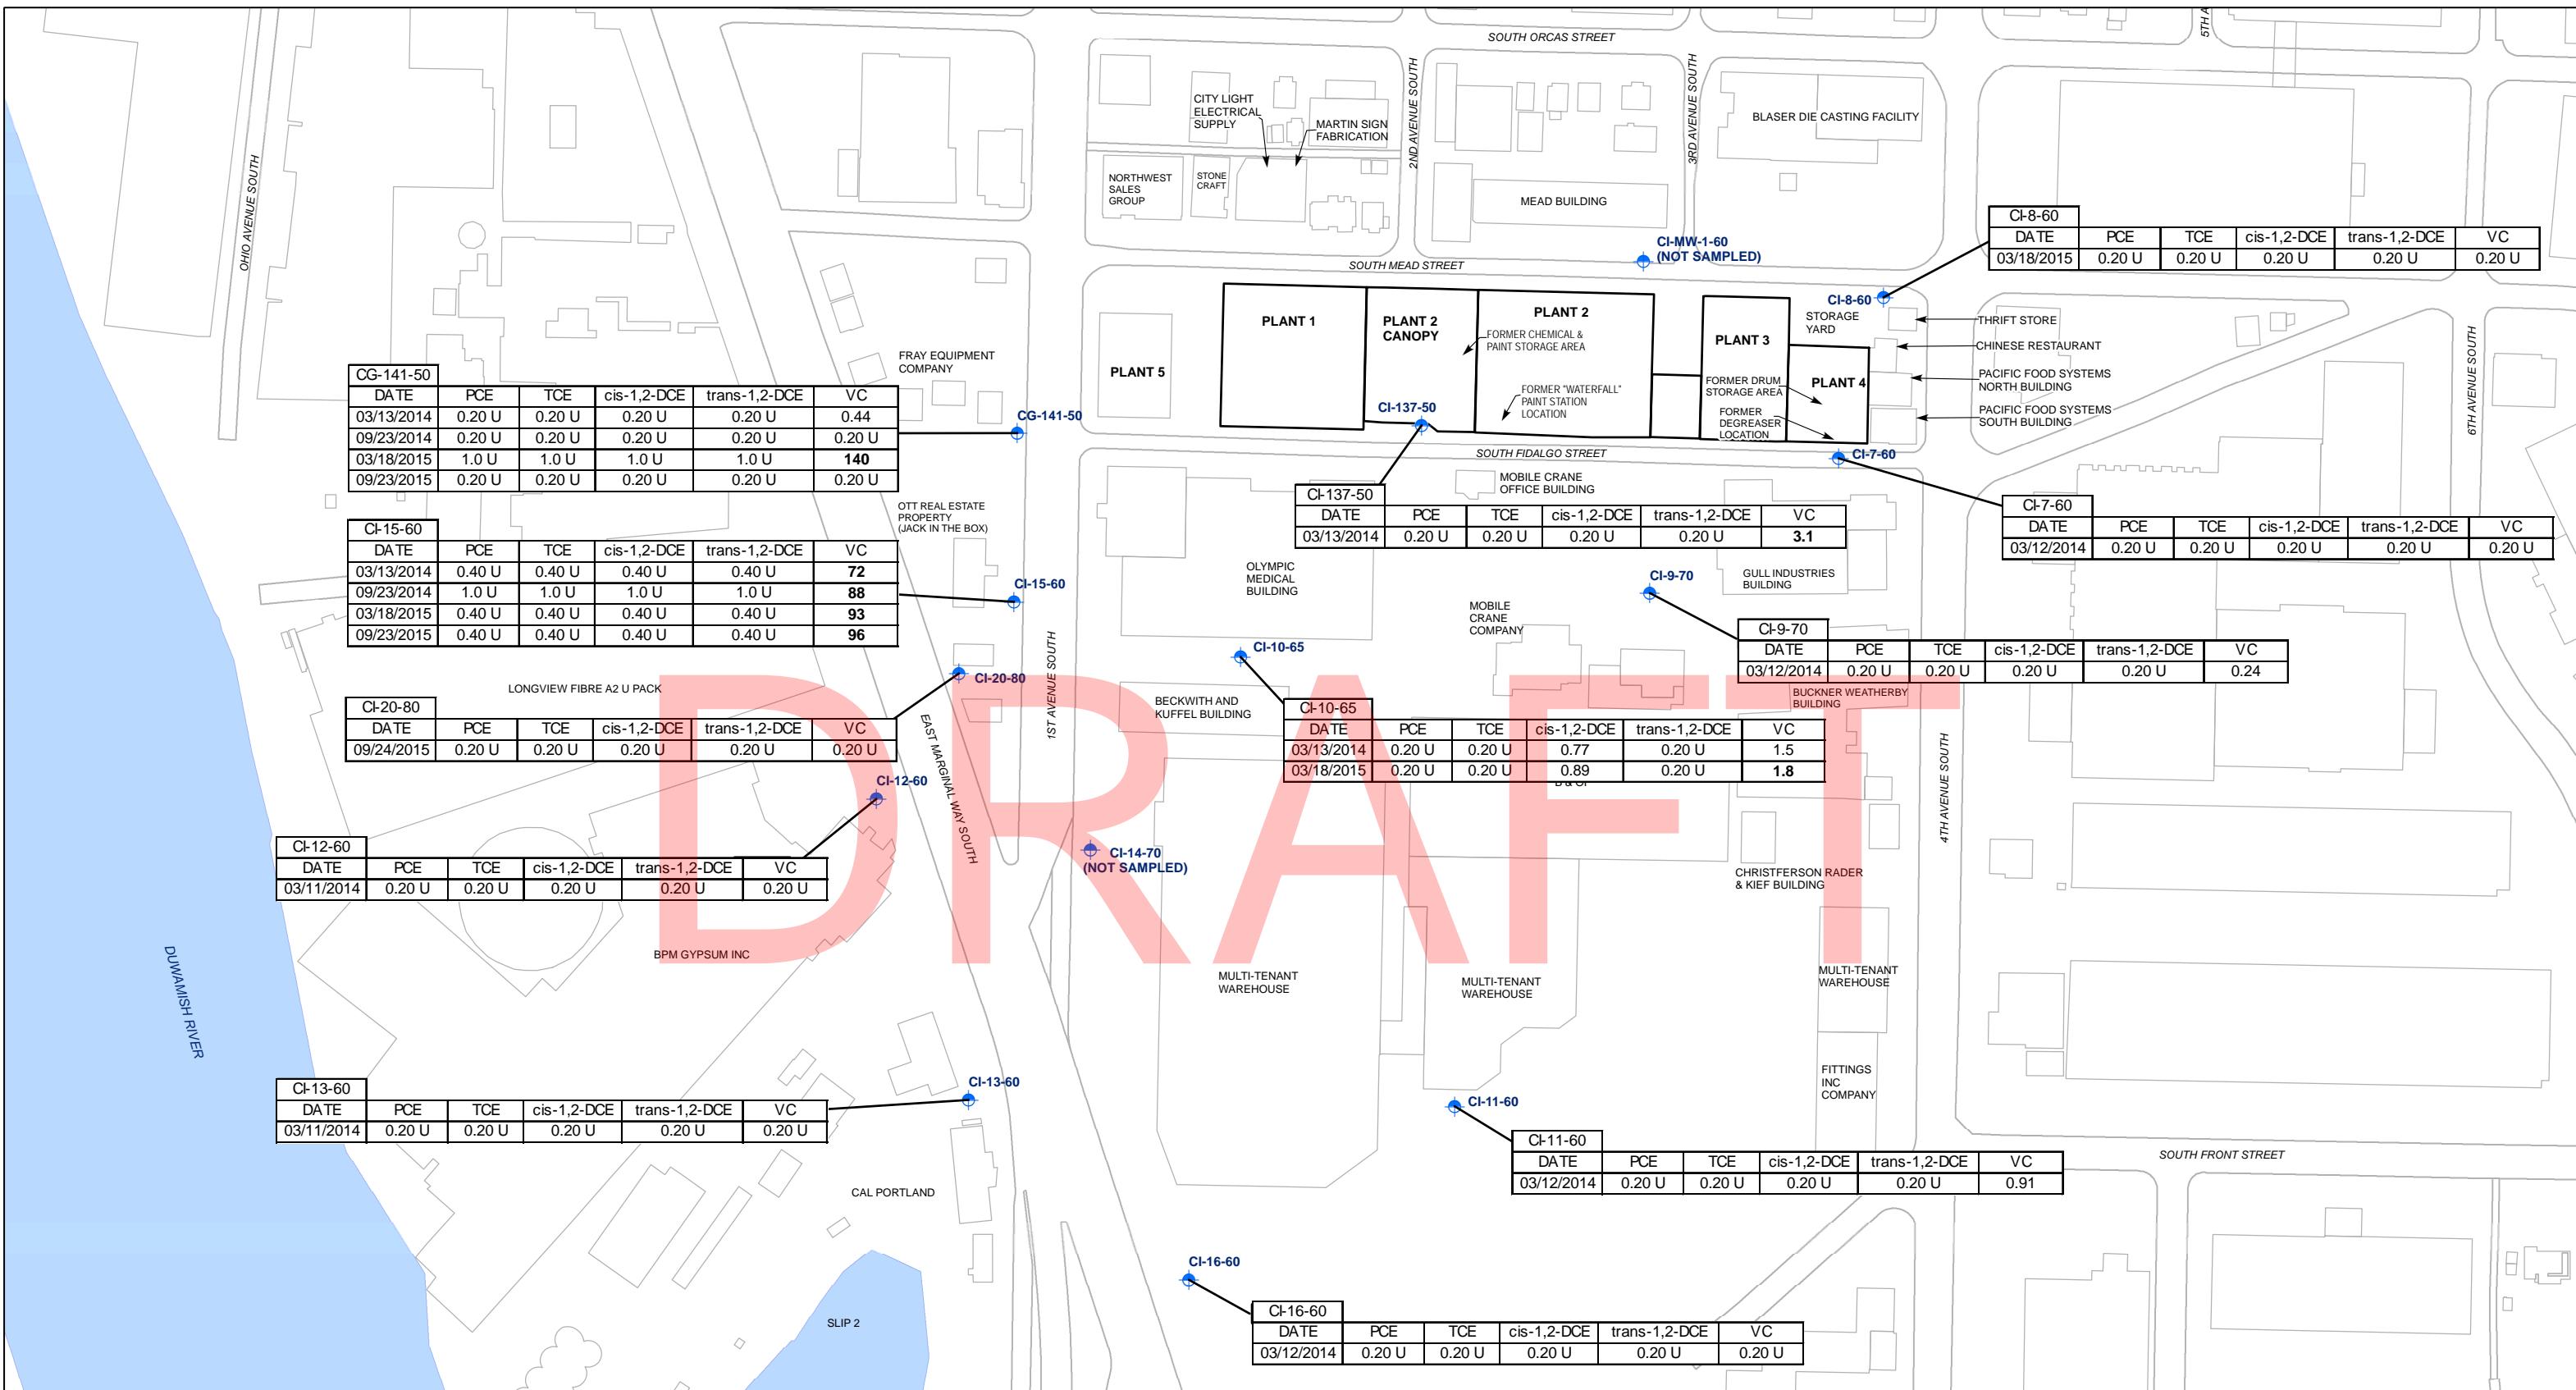
FIGURE 3
GROUNDWATER ANALYTICAL RESULTS FOR
INTERMEDIATE ZONE: 2014 - 2015
REMEDIAL INVESTIGATION
CAPITAL INDUSTRIES, INC.
SEATTLE, WASHINGTON
FARALLON PN: 457-007
Disc Reference:
Checked By: JK Date: 11/24/2015
Document Path: G:\Projects\457 Capital Indust\457010 West of 4th - Site Unit 2\GIS\GW_Q42015\Figure3 GWHVOC IntermedZone.mxd
Drawn By: tperrin

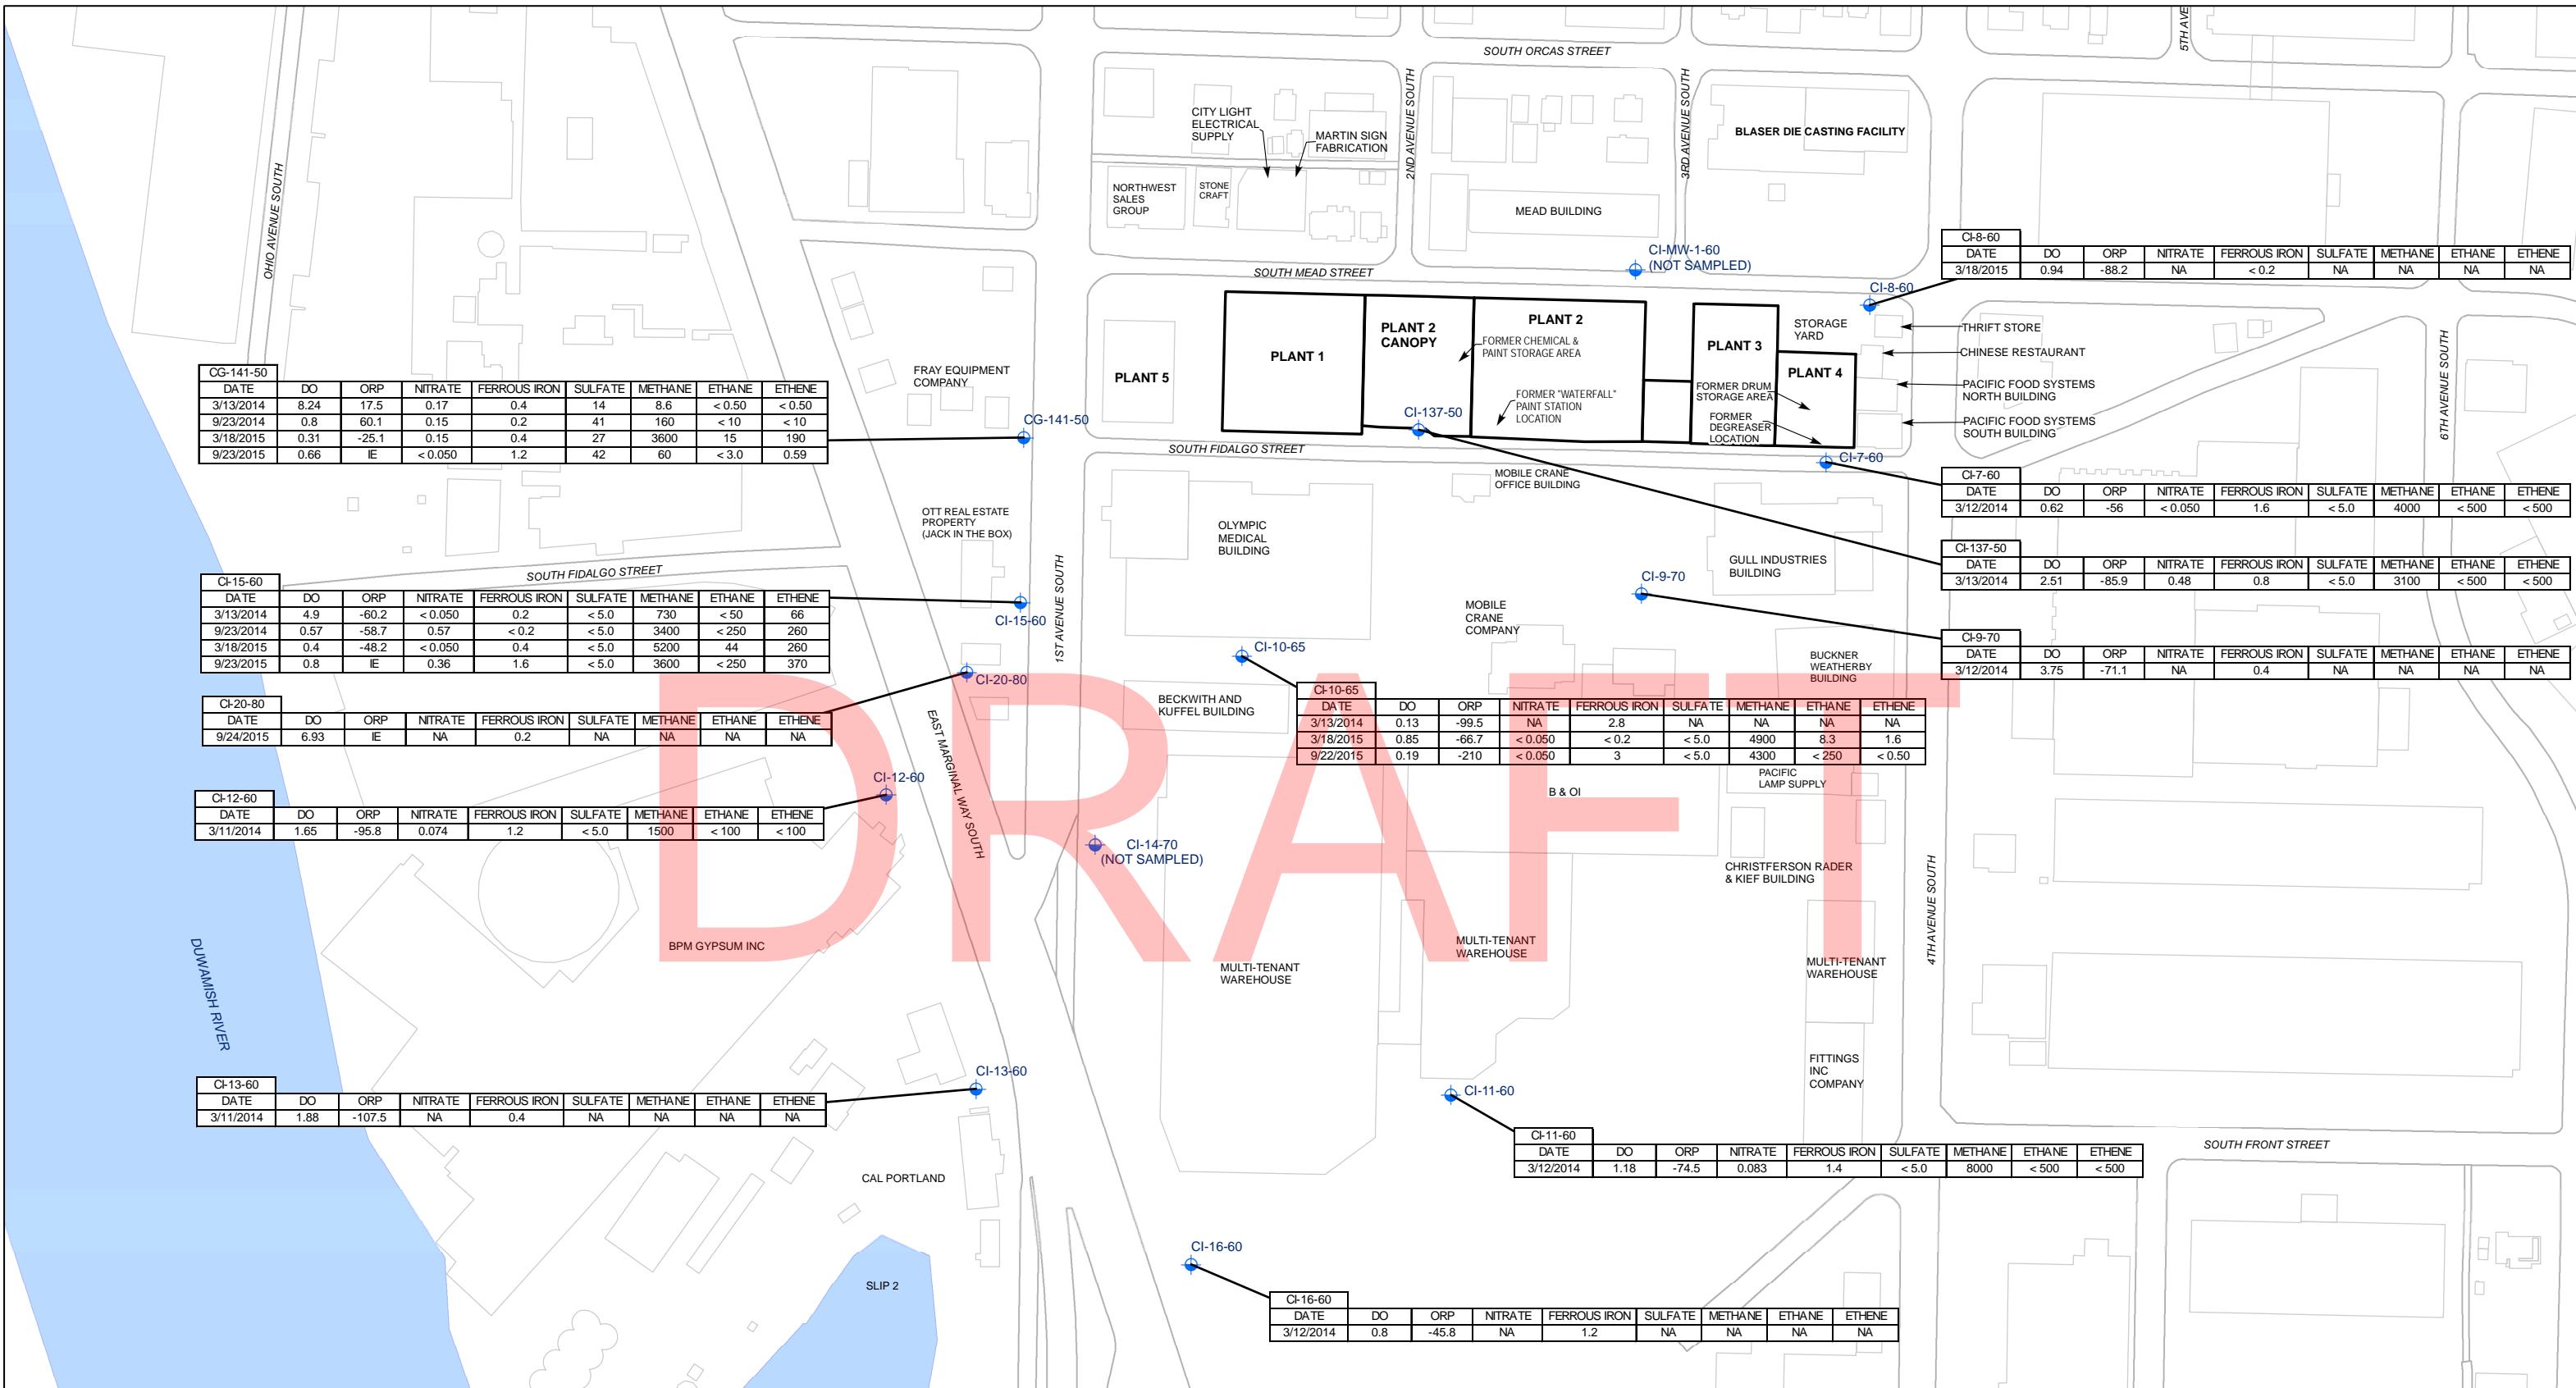
FIGURE 3A
NATURAL ATTENUATION PARAMETERS RESULTS FOR
INTERMEDIATE ZONE: 2014 - 2015
REMEDIAL INVESTIGATION
CAPITAL INDUSTRIES, INC.
SEATTLE, WASHINGTON
FARALLON PN: 457-007
Disc Reference:
Drawn By: tperrin Checked By: JK Date: 11/24/2015
Document Path: G:\Projects\457 Capital Indust\457010 West of 4th - Site Unit 2\GIS\GW_Q42015\Figure3A_NatAttenuIntermedZone - fix.mxd
