**RE: PROGRESS REPORT, OCTOBER THROUGH DECEMBER 2015
REMEDIAL INVESTIGATION MONITORING AND FEASIBILITY STUDY
CAPITAL INDUSTRIES, INC., SEATTLE, WASHINGTON
AGREED ORDER NO. DE 10402
FARALLON PN: 457-008**

PROGRESS REPORT, OCTOBER THROUGH DECEMBER 2015
Capital Industries, Inc.
Seattle, Washington

Site Diagram

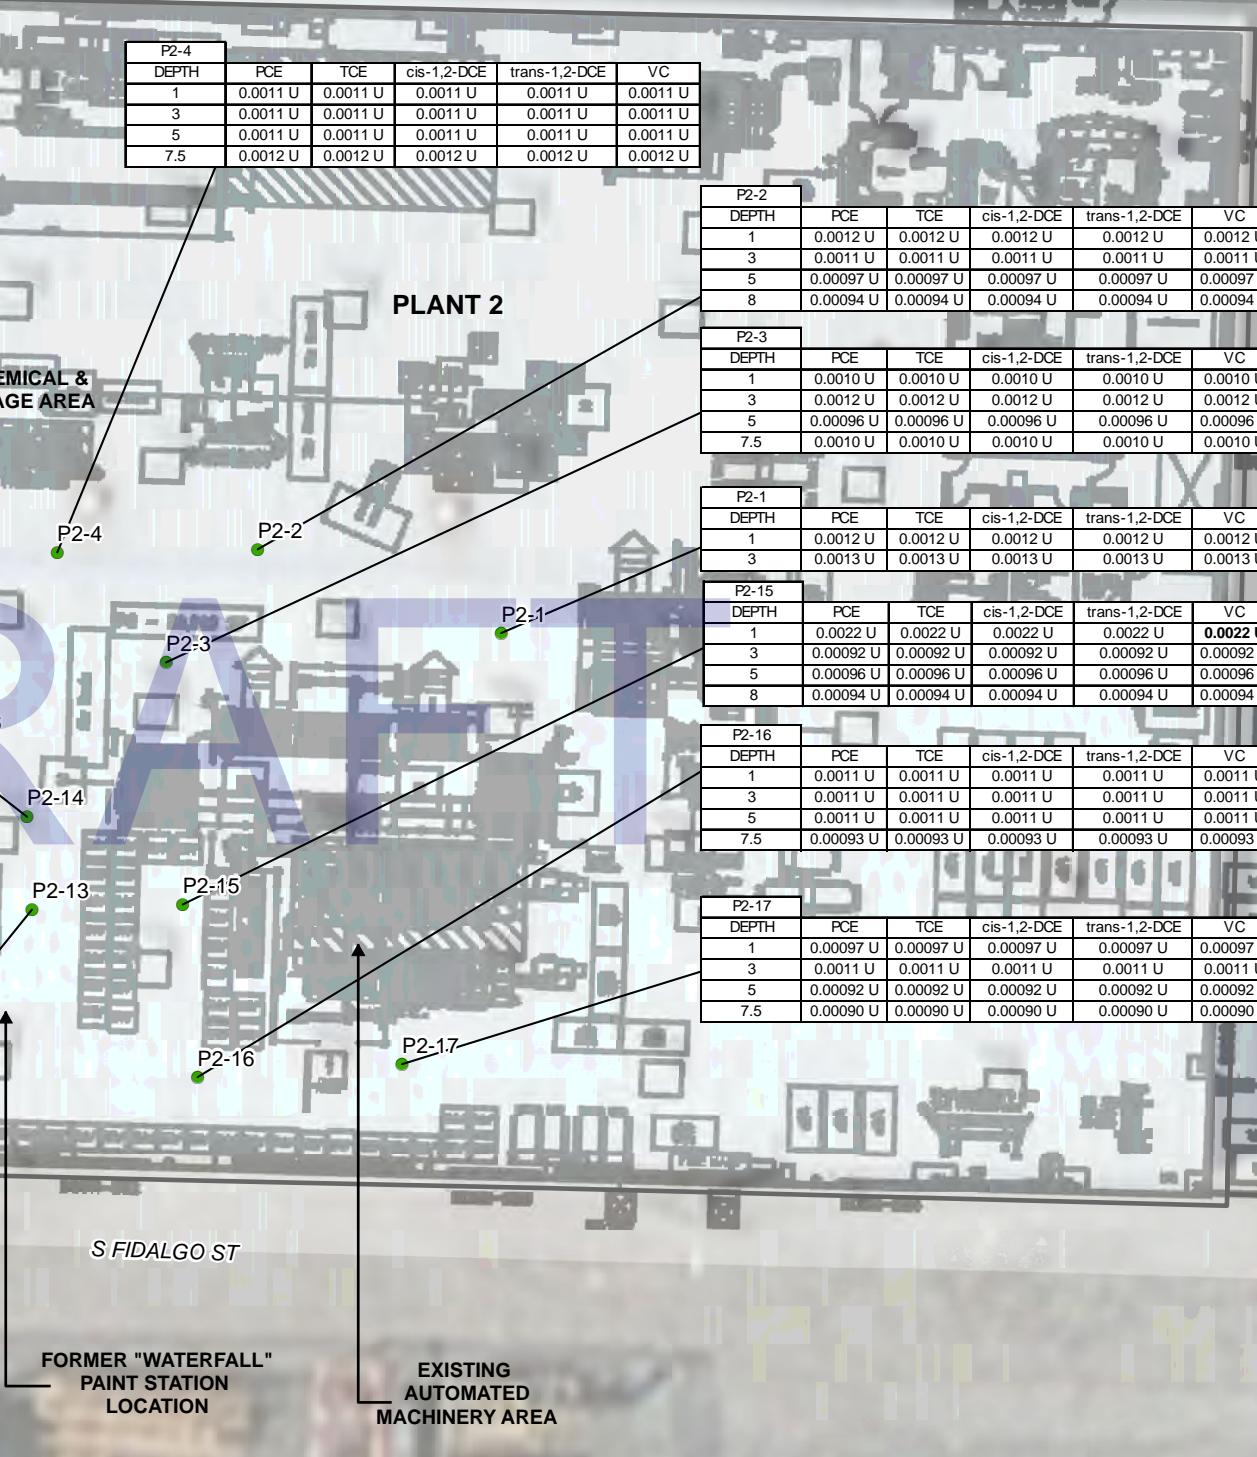
P2-5	DEPTH	PCE	TCE	cis-1,2-DCE	trans-1,2-DCE	VC
1	0.0011 U	0.0011 U	0.0011 U	0.0011 U	0.0011 U	
3	0.0015 U	0.0015 U	0.0015 U	0.0015 U	0.0015 U	
5	0.00099 U	0.00099 U	0.00099 U	0.00099 U	0.00099 U	
7.5	0.0010 U	0.0010 U	0.0010 U	0.0010 U	0.0010 U

P2-7	DEPTH	PCE	TCE	cis-1,2-DCE	trans-1,2-DCE	VC
1	0.0024 U	0.0024 U	0.0024 U	0.0024 U	0.0024 U	
3	0.0021 U	0.0021 U	0.0021 U	0.0021 U	0.0021 U	
5	0.0012 U	0.0015	0.0063	0.0012 U	0.0012 U	
7.5	0.00096 U	0.0042	0.0081	0.0013	0.00096 U

Soil investigation work also was conducted at Capital Plant 2 on October 10 and 11, 2015 in accordance with the scope of work presented in the Revised Soil Investigation Plan submitted to Ecology on August 10, 2015 and conditionally approved by Ecology on August 17, 2015. Seventeen borings were completed at Capital Plant 2 and 46 soil samples were submitted for

The results of the sampling at Capital Plants 2 and 4 are included on draft summary tables and figures attached to this report. The sampling results will be reported and included as an appendix to the *Revised Draft Remedial Investigation Report* dated October 2012, prepared by Farallon on behalf of Capital, as discussed with Ecology.

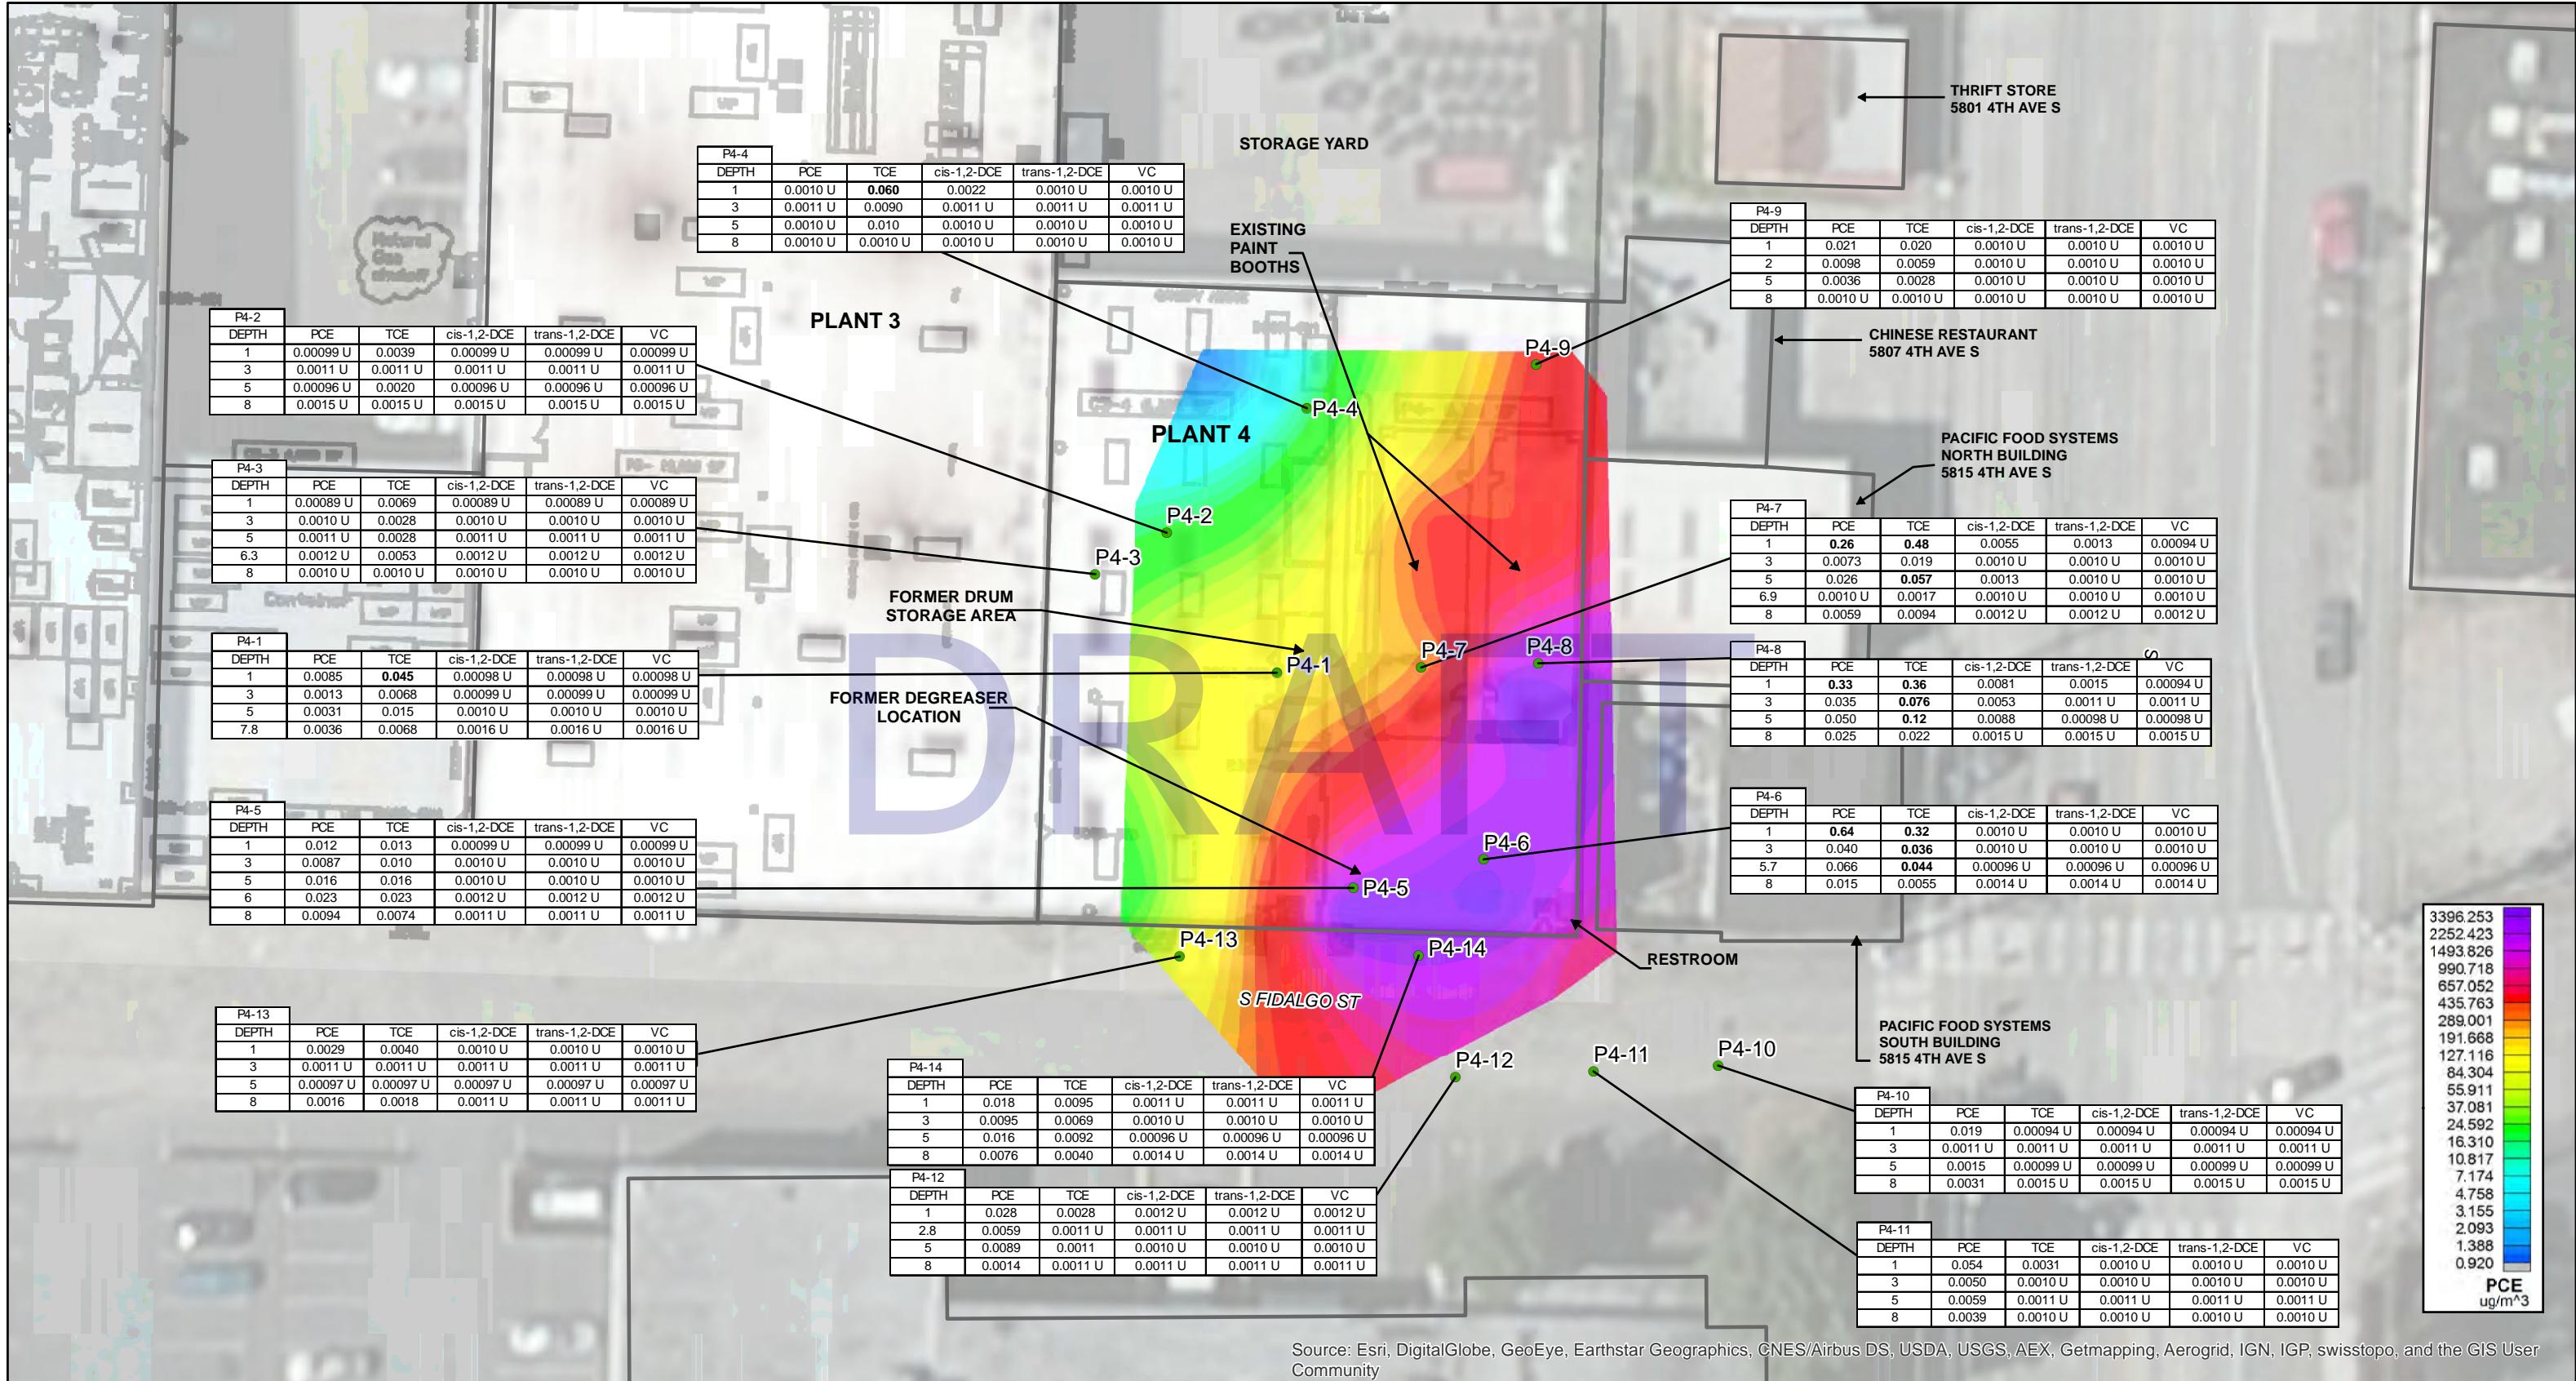
FIGURE
PLANT 4 SOIL SAMPLING LOCATIONS AND TRICHLOROETHENE WEST OF FOURTH GROUP SITE
5815 FOURTH AVENUE SOUTH CAPITAL INDUSTRIES SEATTLE, WASHINGTON
FARALLON PN: 457-13B

A passive soil gas survey at Capital Plant 4 was conducted in September 2015 in accordance with the scope of work presented in the *Revised Soil Investigation Work Plan* dated August 1-, 2015, prepared by Farallon, which was submitted to Ecology on August 10, 2015 and conditionally approved by Ecology on August 17, 2015. A purpose of the soil gas survey is to evaluate prospective boring locations for collecting soil samples required to refine the understanding of soil contamination limits beneath Capital Plant 4. Fourteen borings were completed at Capital Plant 4 on October 17, 2015 and 37 soil samples were submitted for laboratory analysis for the constituents of concern. The supplemental soil data has provided data sufficient to proceed with evaluation of cleanup alternatives for the Feasibility Study.

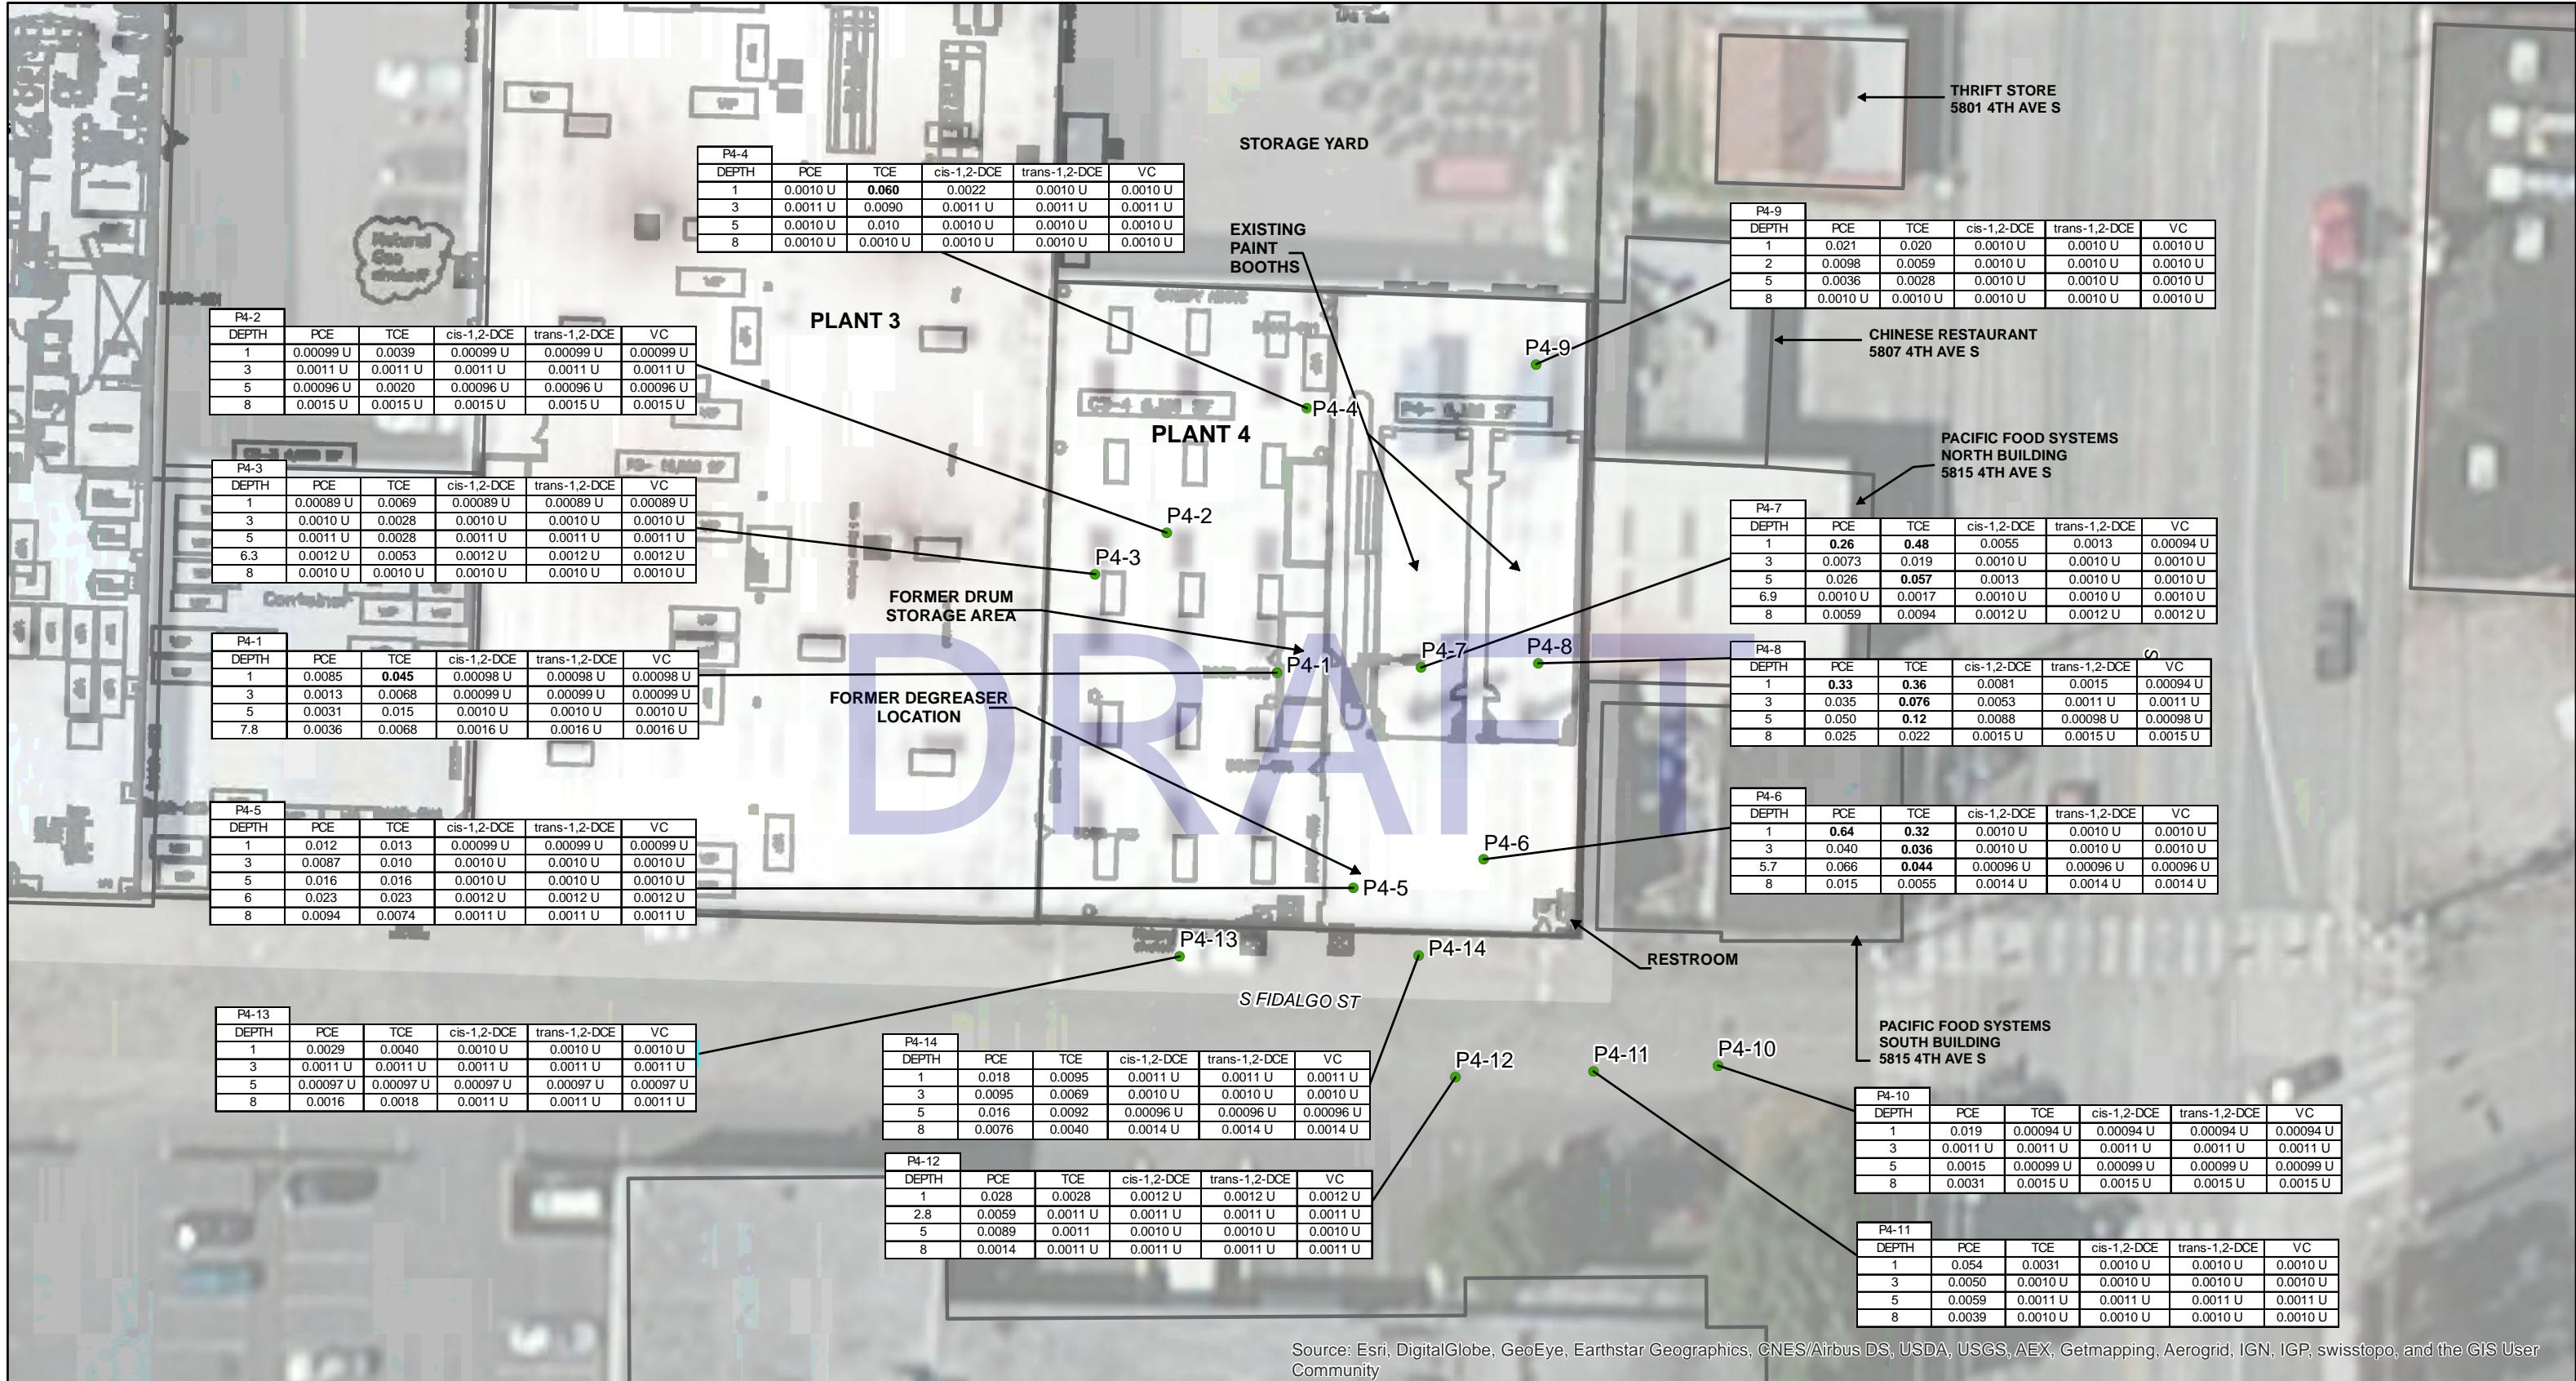
PLANT 4 SOIL SAMPLING LOCATIONS
WEST OF FOURTH GROUP SITE
5815 FOURTH AVENUE SOUTH
CAPITAL INDUSTRIES
SEATTLE, WASHINGTON
FARALLON PN: 457-13B
