VAPOR INTRUSION MITIGATION REPORT

**OLYMPIC MEDICAL FACILITY
5900 1st AVENUE SOUTH
SEATTLE, WASHINGTON**

**In Accordance with
AGREED ORDER NO. DE 5348**

**Submitted by:
Farallon Consulting, L.L.C.
975 5th Avenue Northwest
Issaquah, Washington 98027
Farallon PN: 457-004**

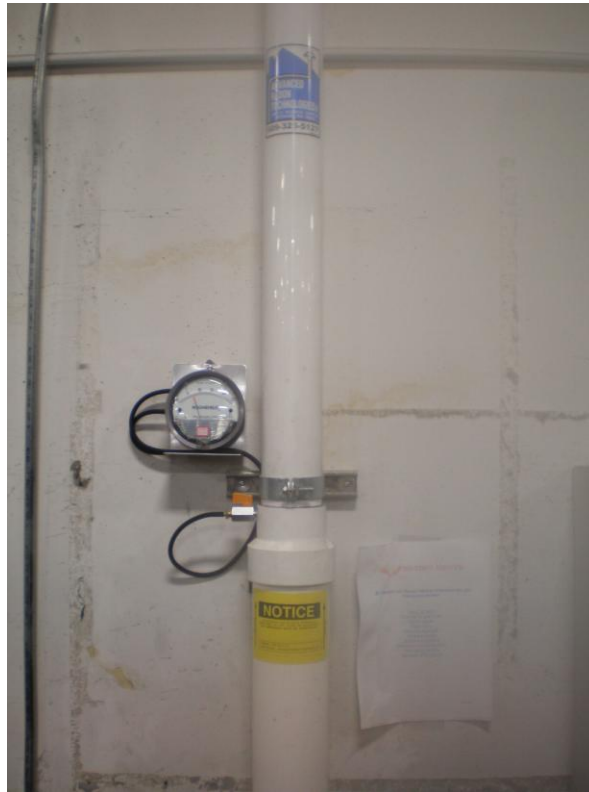
Photograph 1: Riser leading to roof network with gauge.

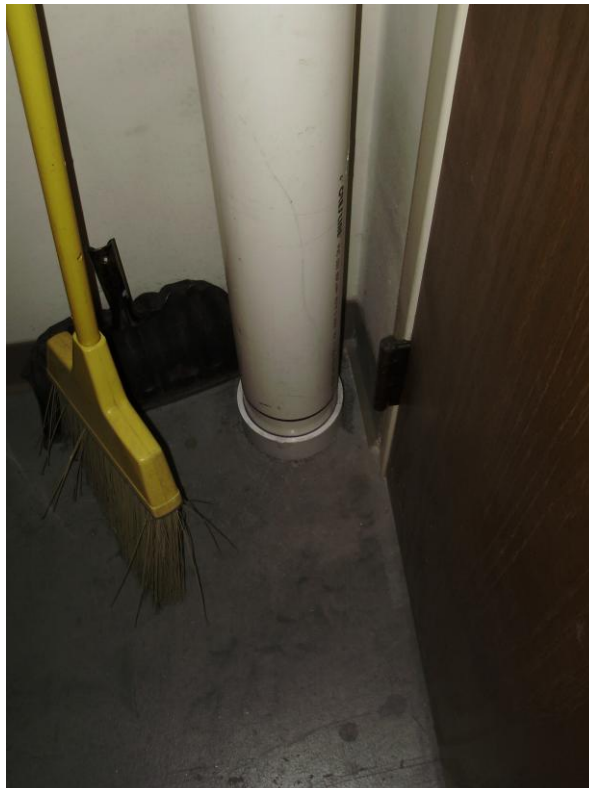
Photograph 2: Visible portion of sump.

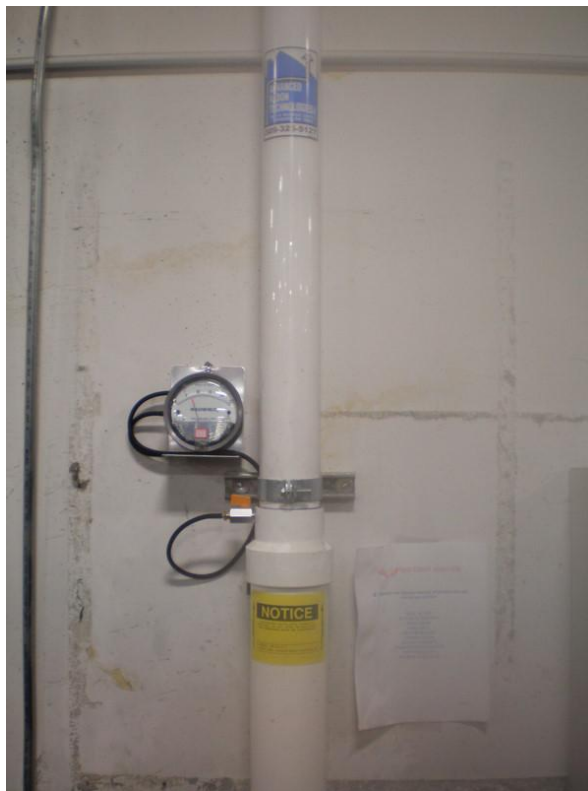
Photograph 3: Depressurization leg and gauge.

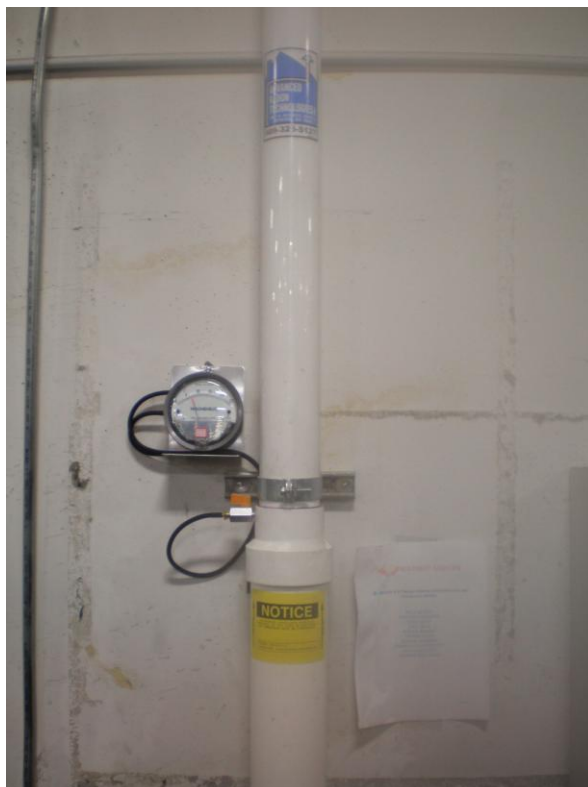
Photograph 4: System gauge and polyvinyl chloride tubing leading to roof network.

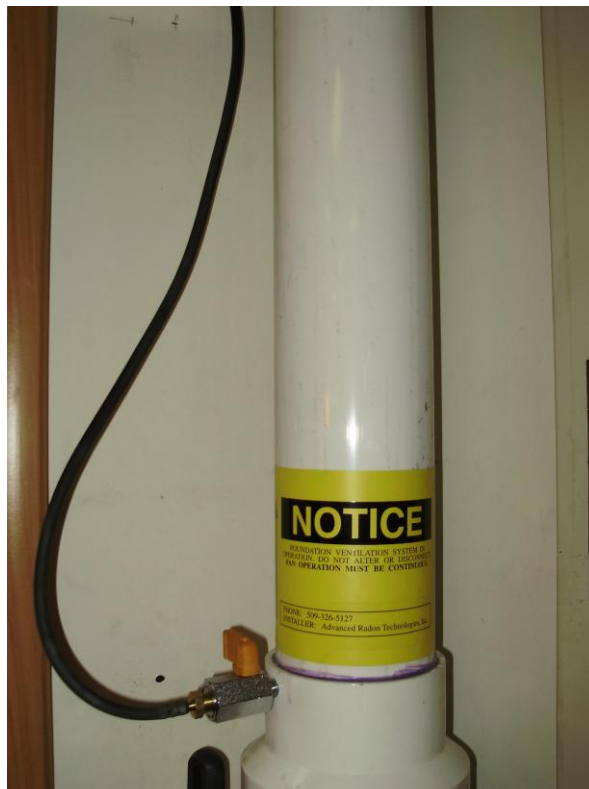
Photograph 5: Pressure hose leading from depressurization leg to gauge.

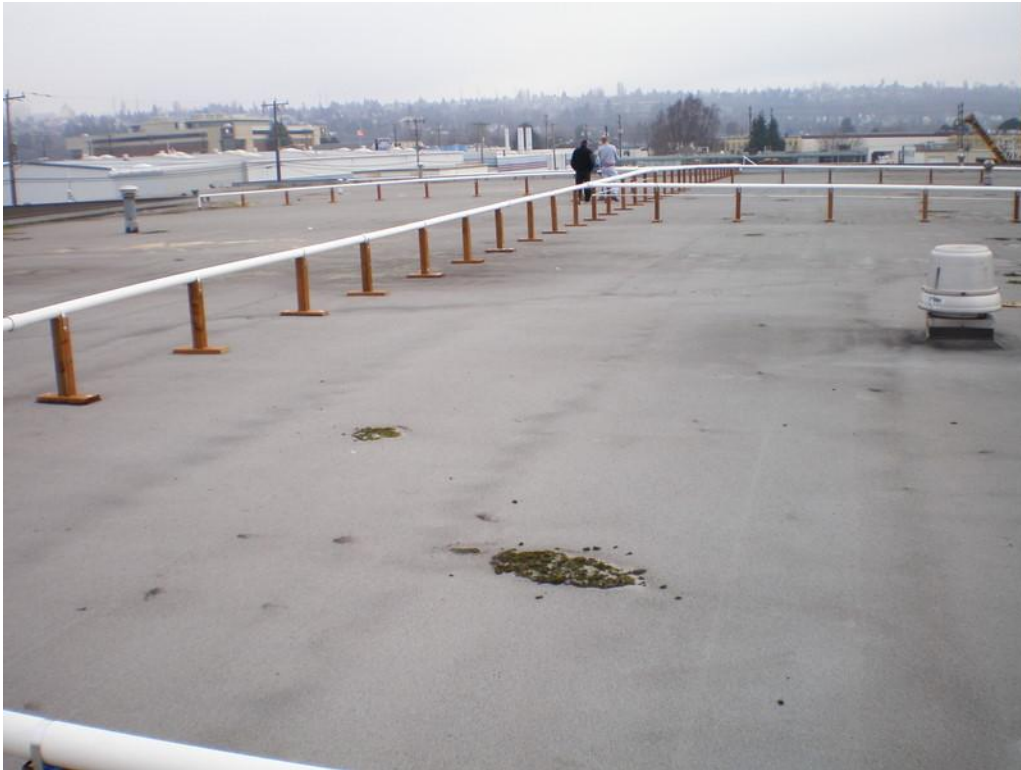
Photograph 7: Roof network.

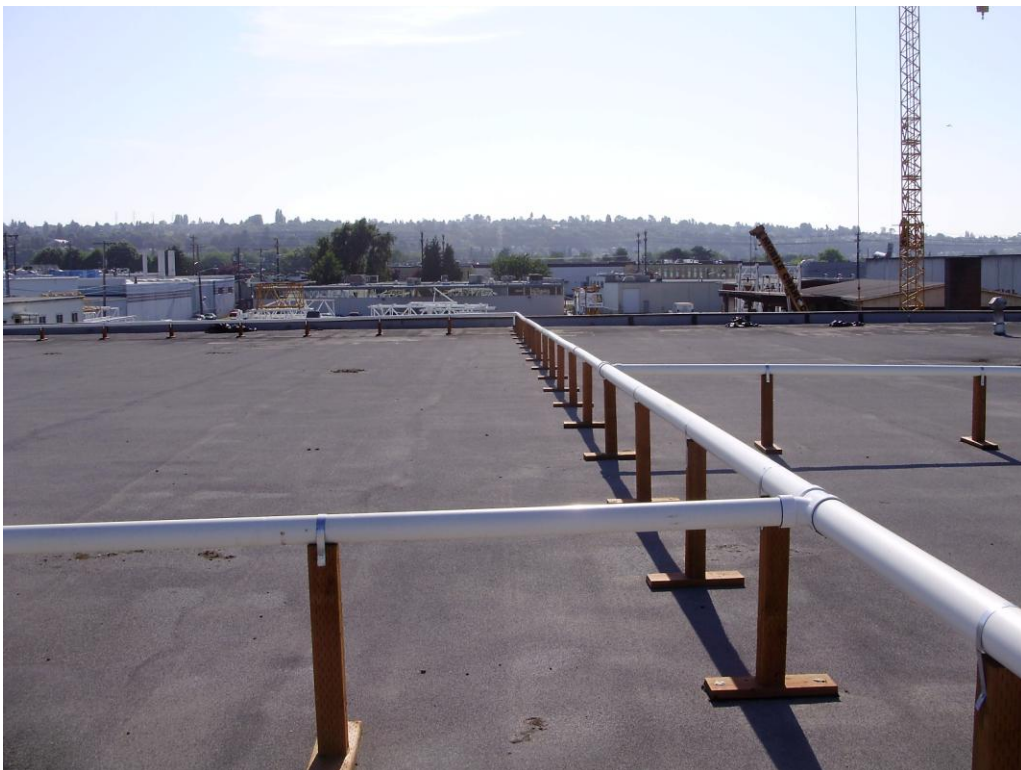
Photograph 8: Roof network looking east from blower.

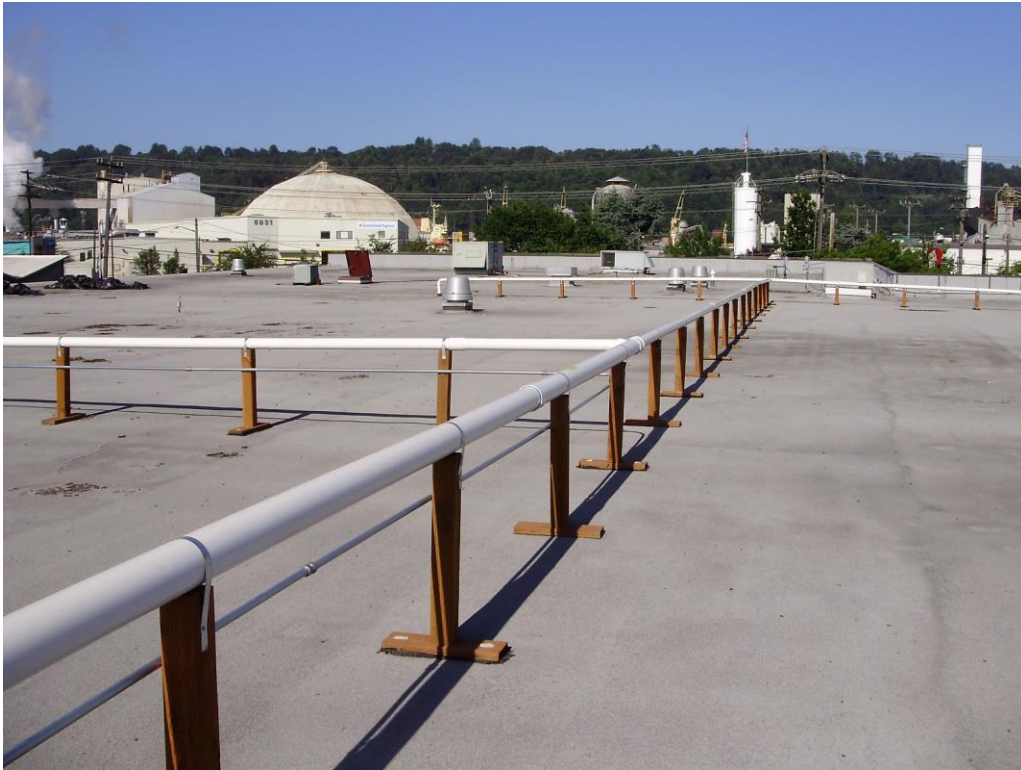
Photograph 9: Roof network looking west from blower.

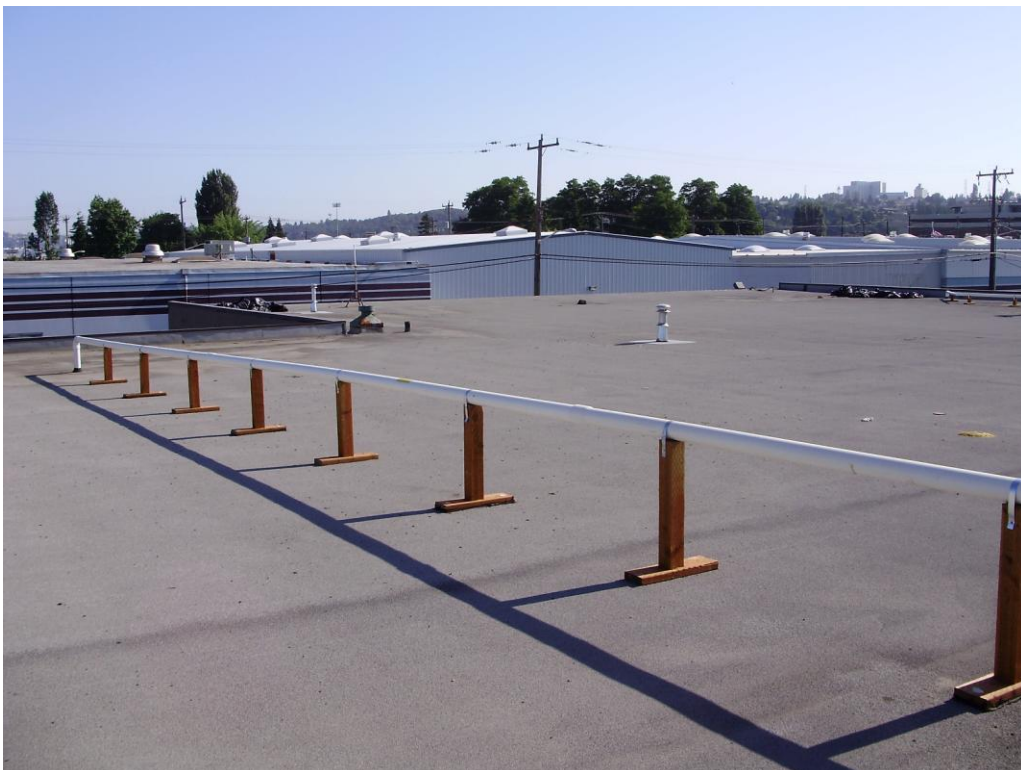
Photograph 10: Roof network looking northeast.

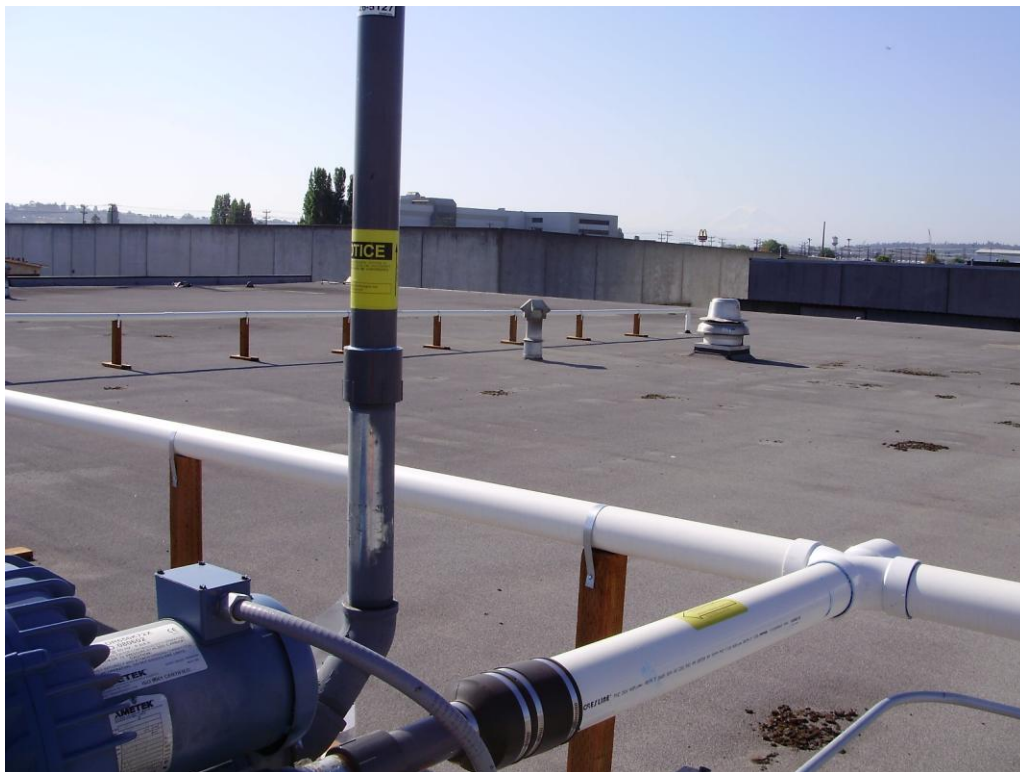
Photograph 11: Roof network and stack.

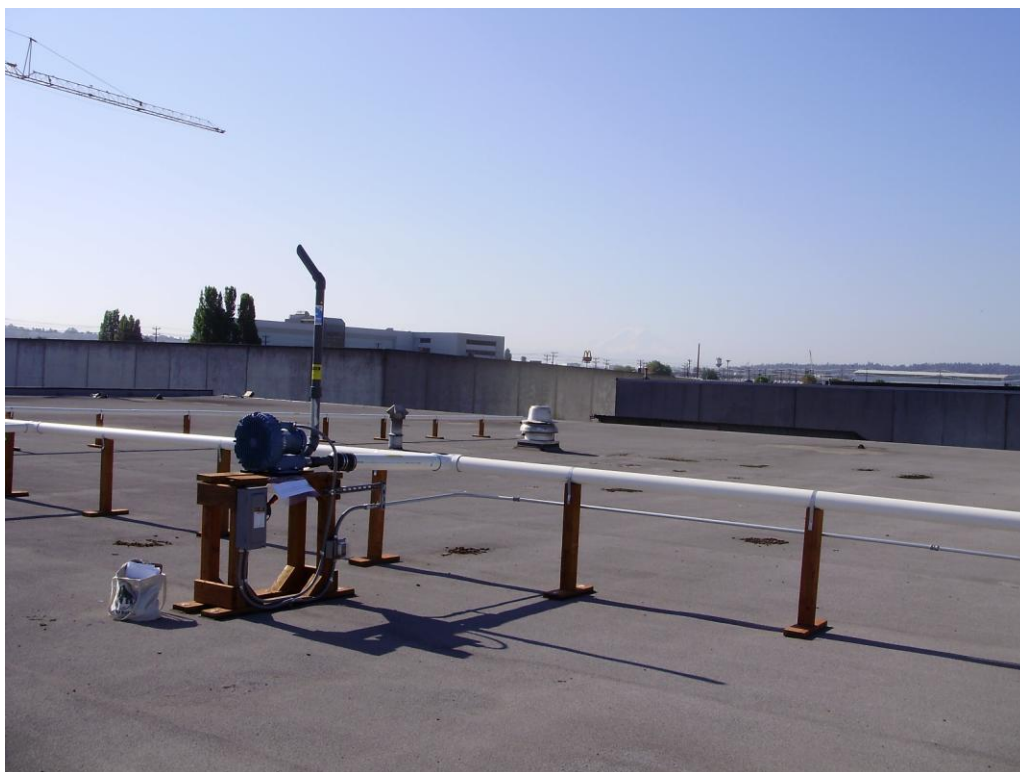
Photograph 12: Blower and stack looking south. Air intake is approximately 40 feet away.

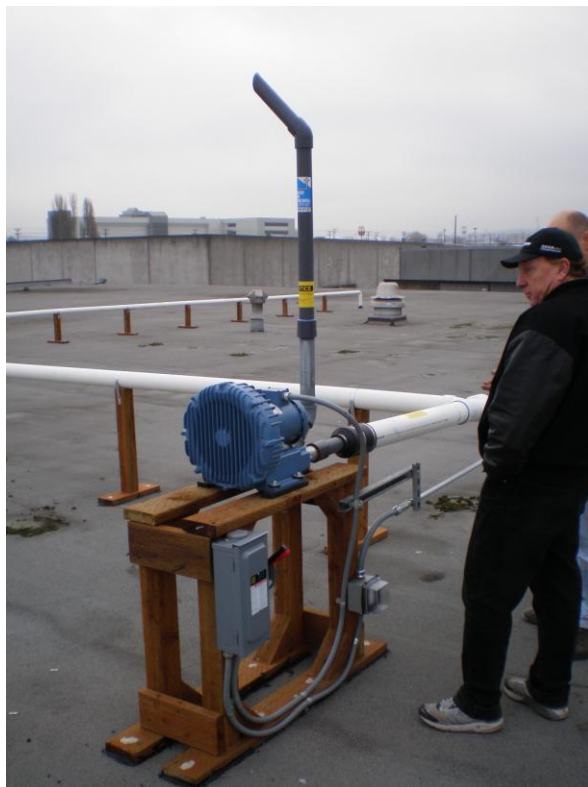
Photograph 13: SSES System 004.

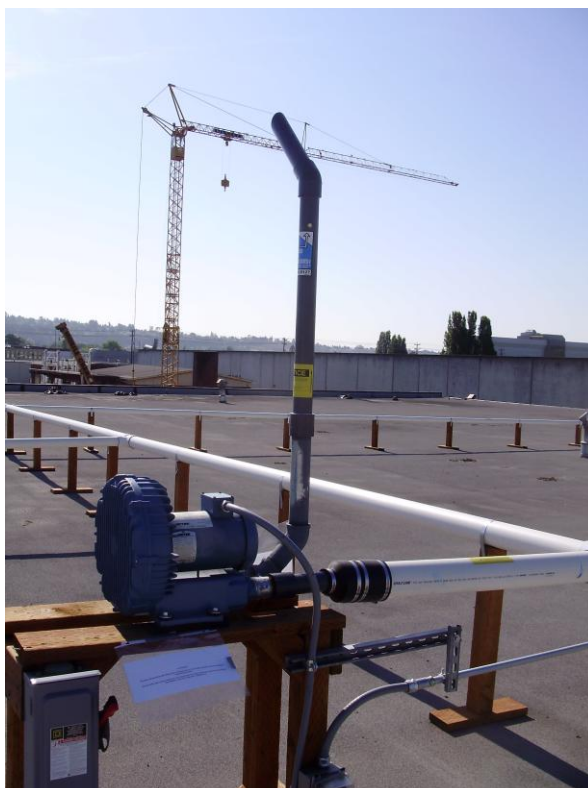
Photograph 14: Blower and stack looking southeast.

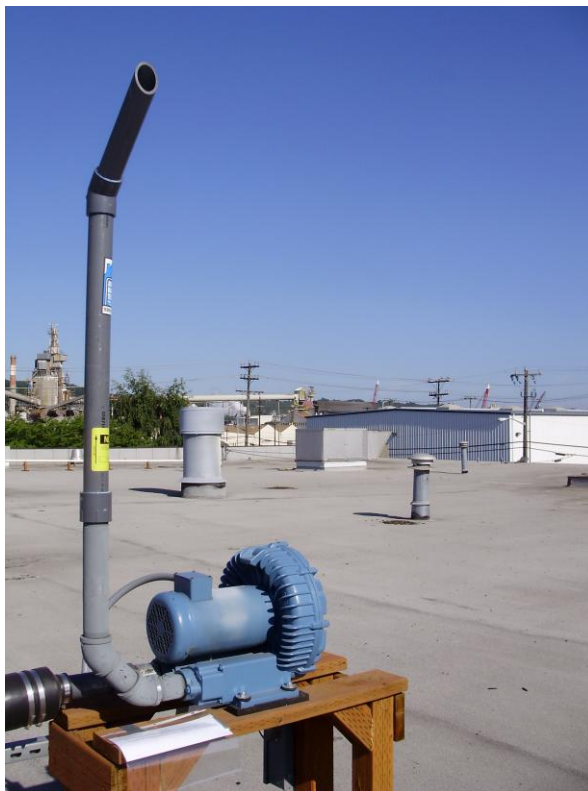
Photograph 15: Blower and stack with nearest air intake in the distance, approximately 36 feet away.

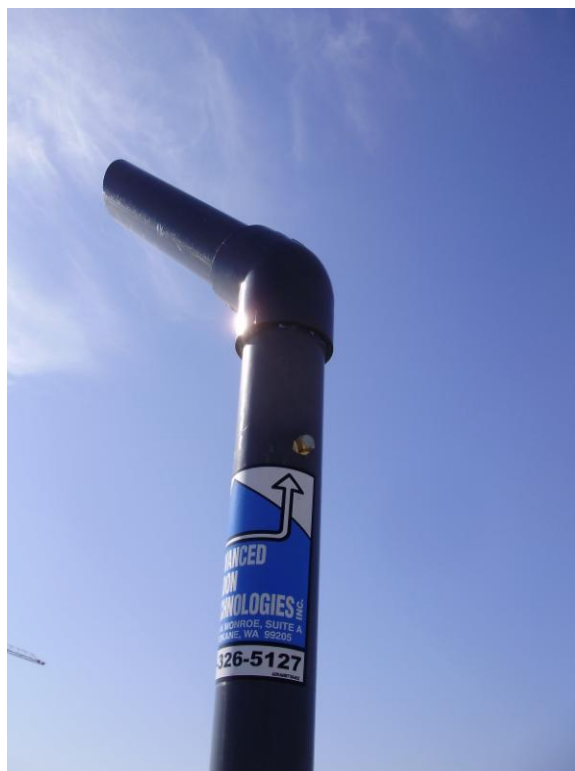
Photograph 16: Stack with air sampling port (plugged).

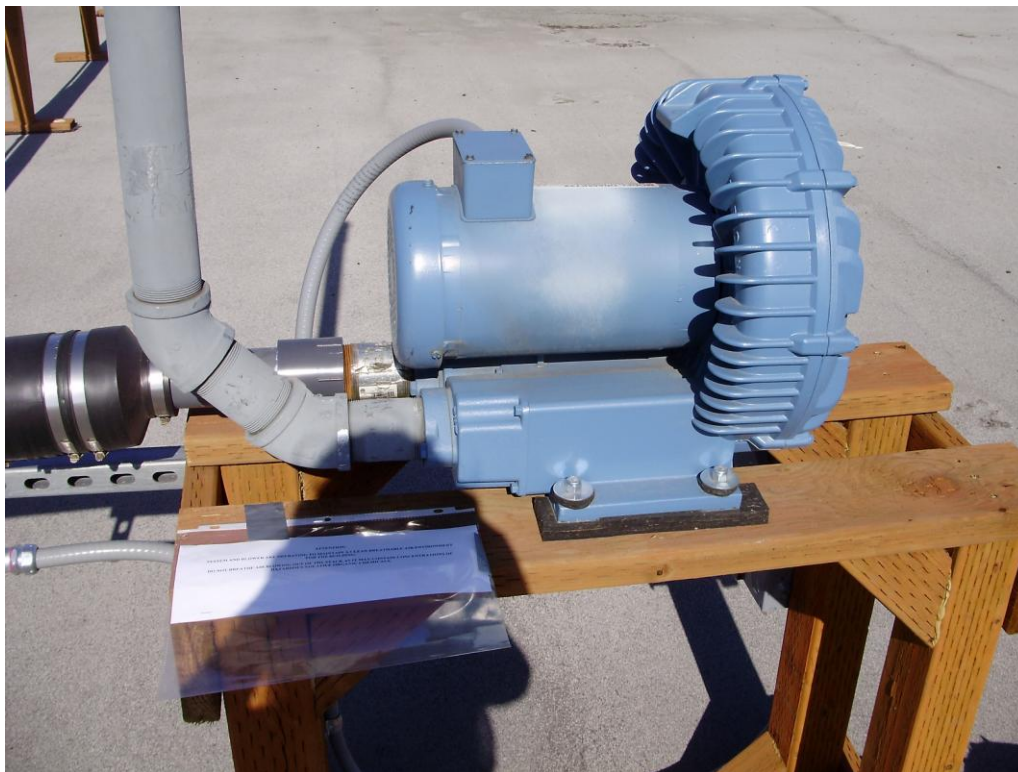
Photograph 17: Blower with warning signs.

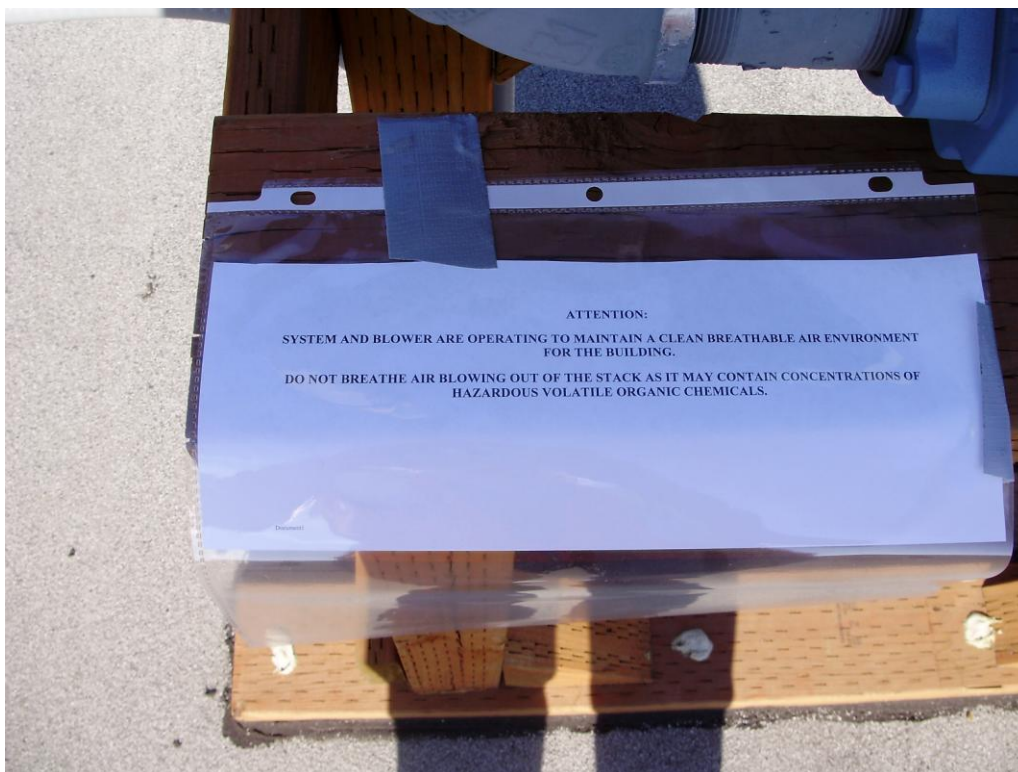
Photograph 18: Warning signs posted by blower and stack.

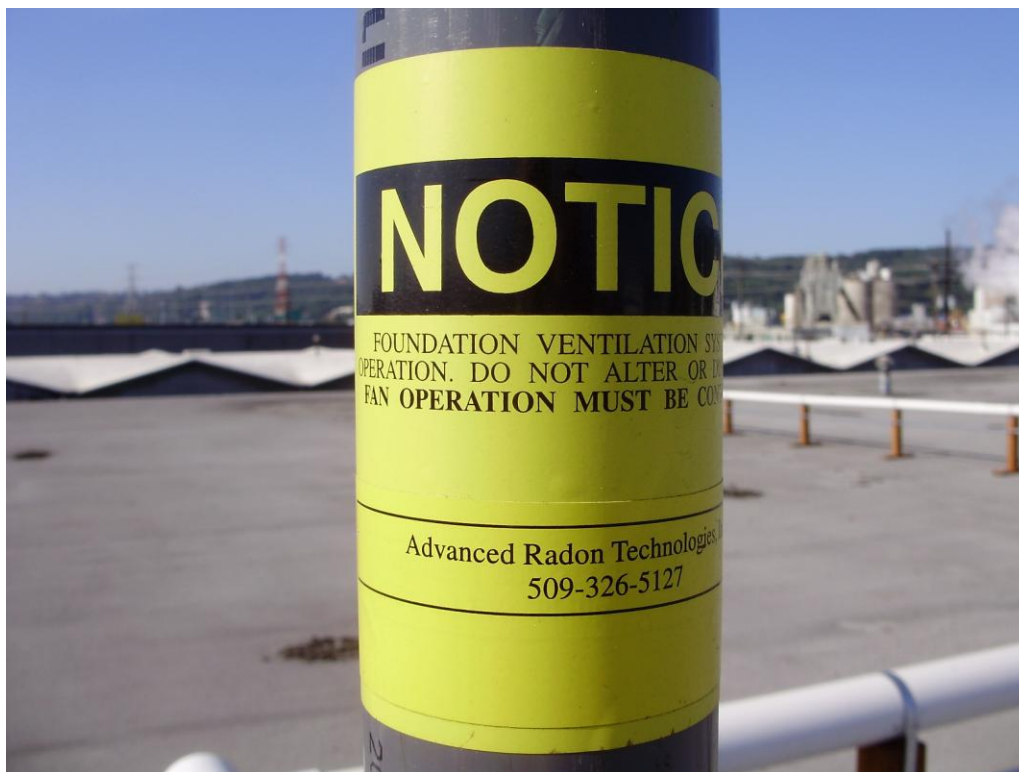
Photograph 19: Stack signage, left side.

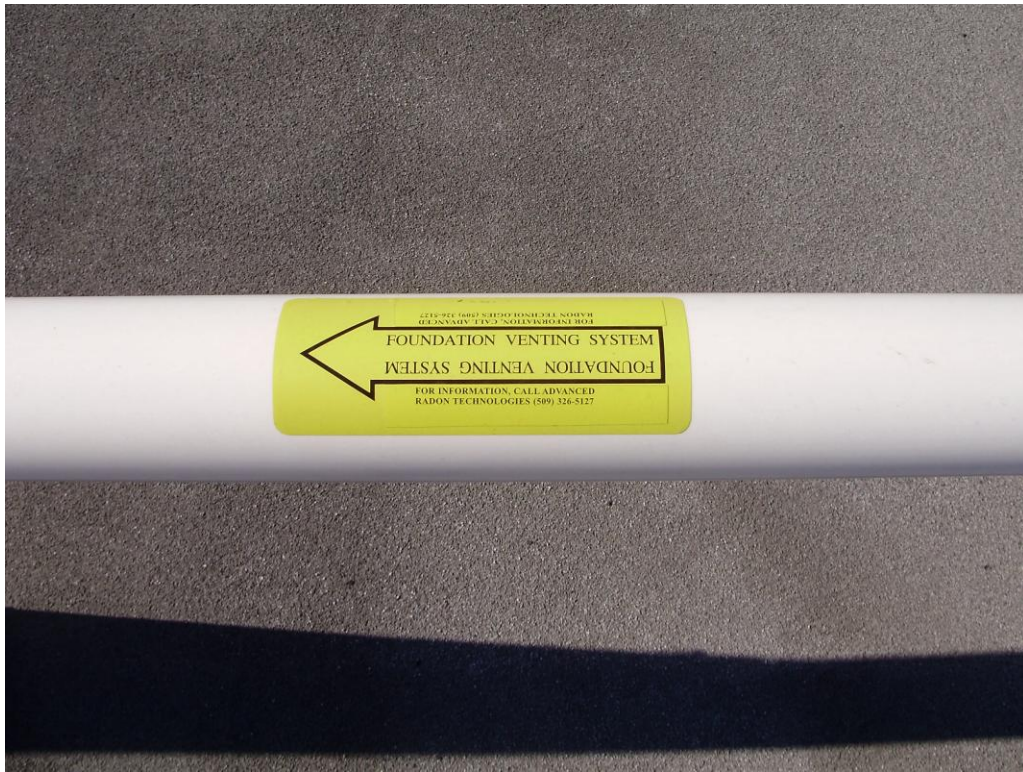
Photograph 21: Roof system signage.
