July 15, 2021

**RE: PROGRESS REPORT, APRIL THROUGH JUNE 2021
REMEDIAL INVESTIGATION MONITORING AND FEASIBILITY STUDY
CAPITAL INDUSTRIES, INC.
5801 THIRD AVENUE SOUTH
SEATTLE, WASHINGTON
AGREED ORDER NO. DE 10402
FARALLON PN: 457-008**

PROGRESS REPORT, APRIL THROUGH JUNE 2021
Capital Industries, Inc.
5801 Third Avenue South
Seattle, Washington

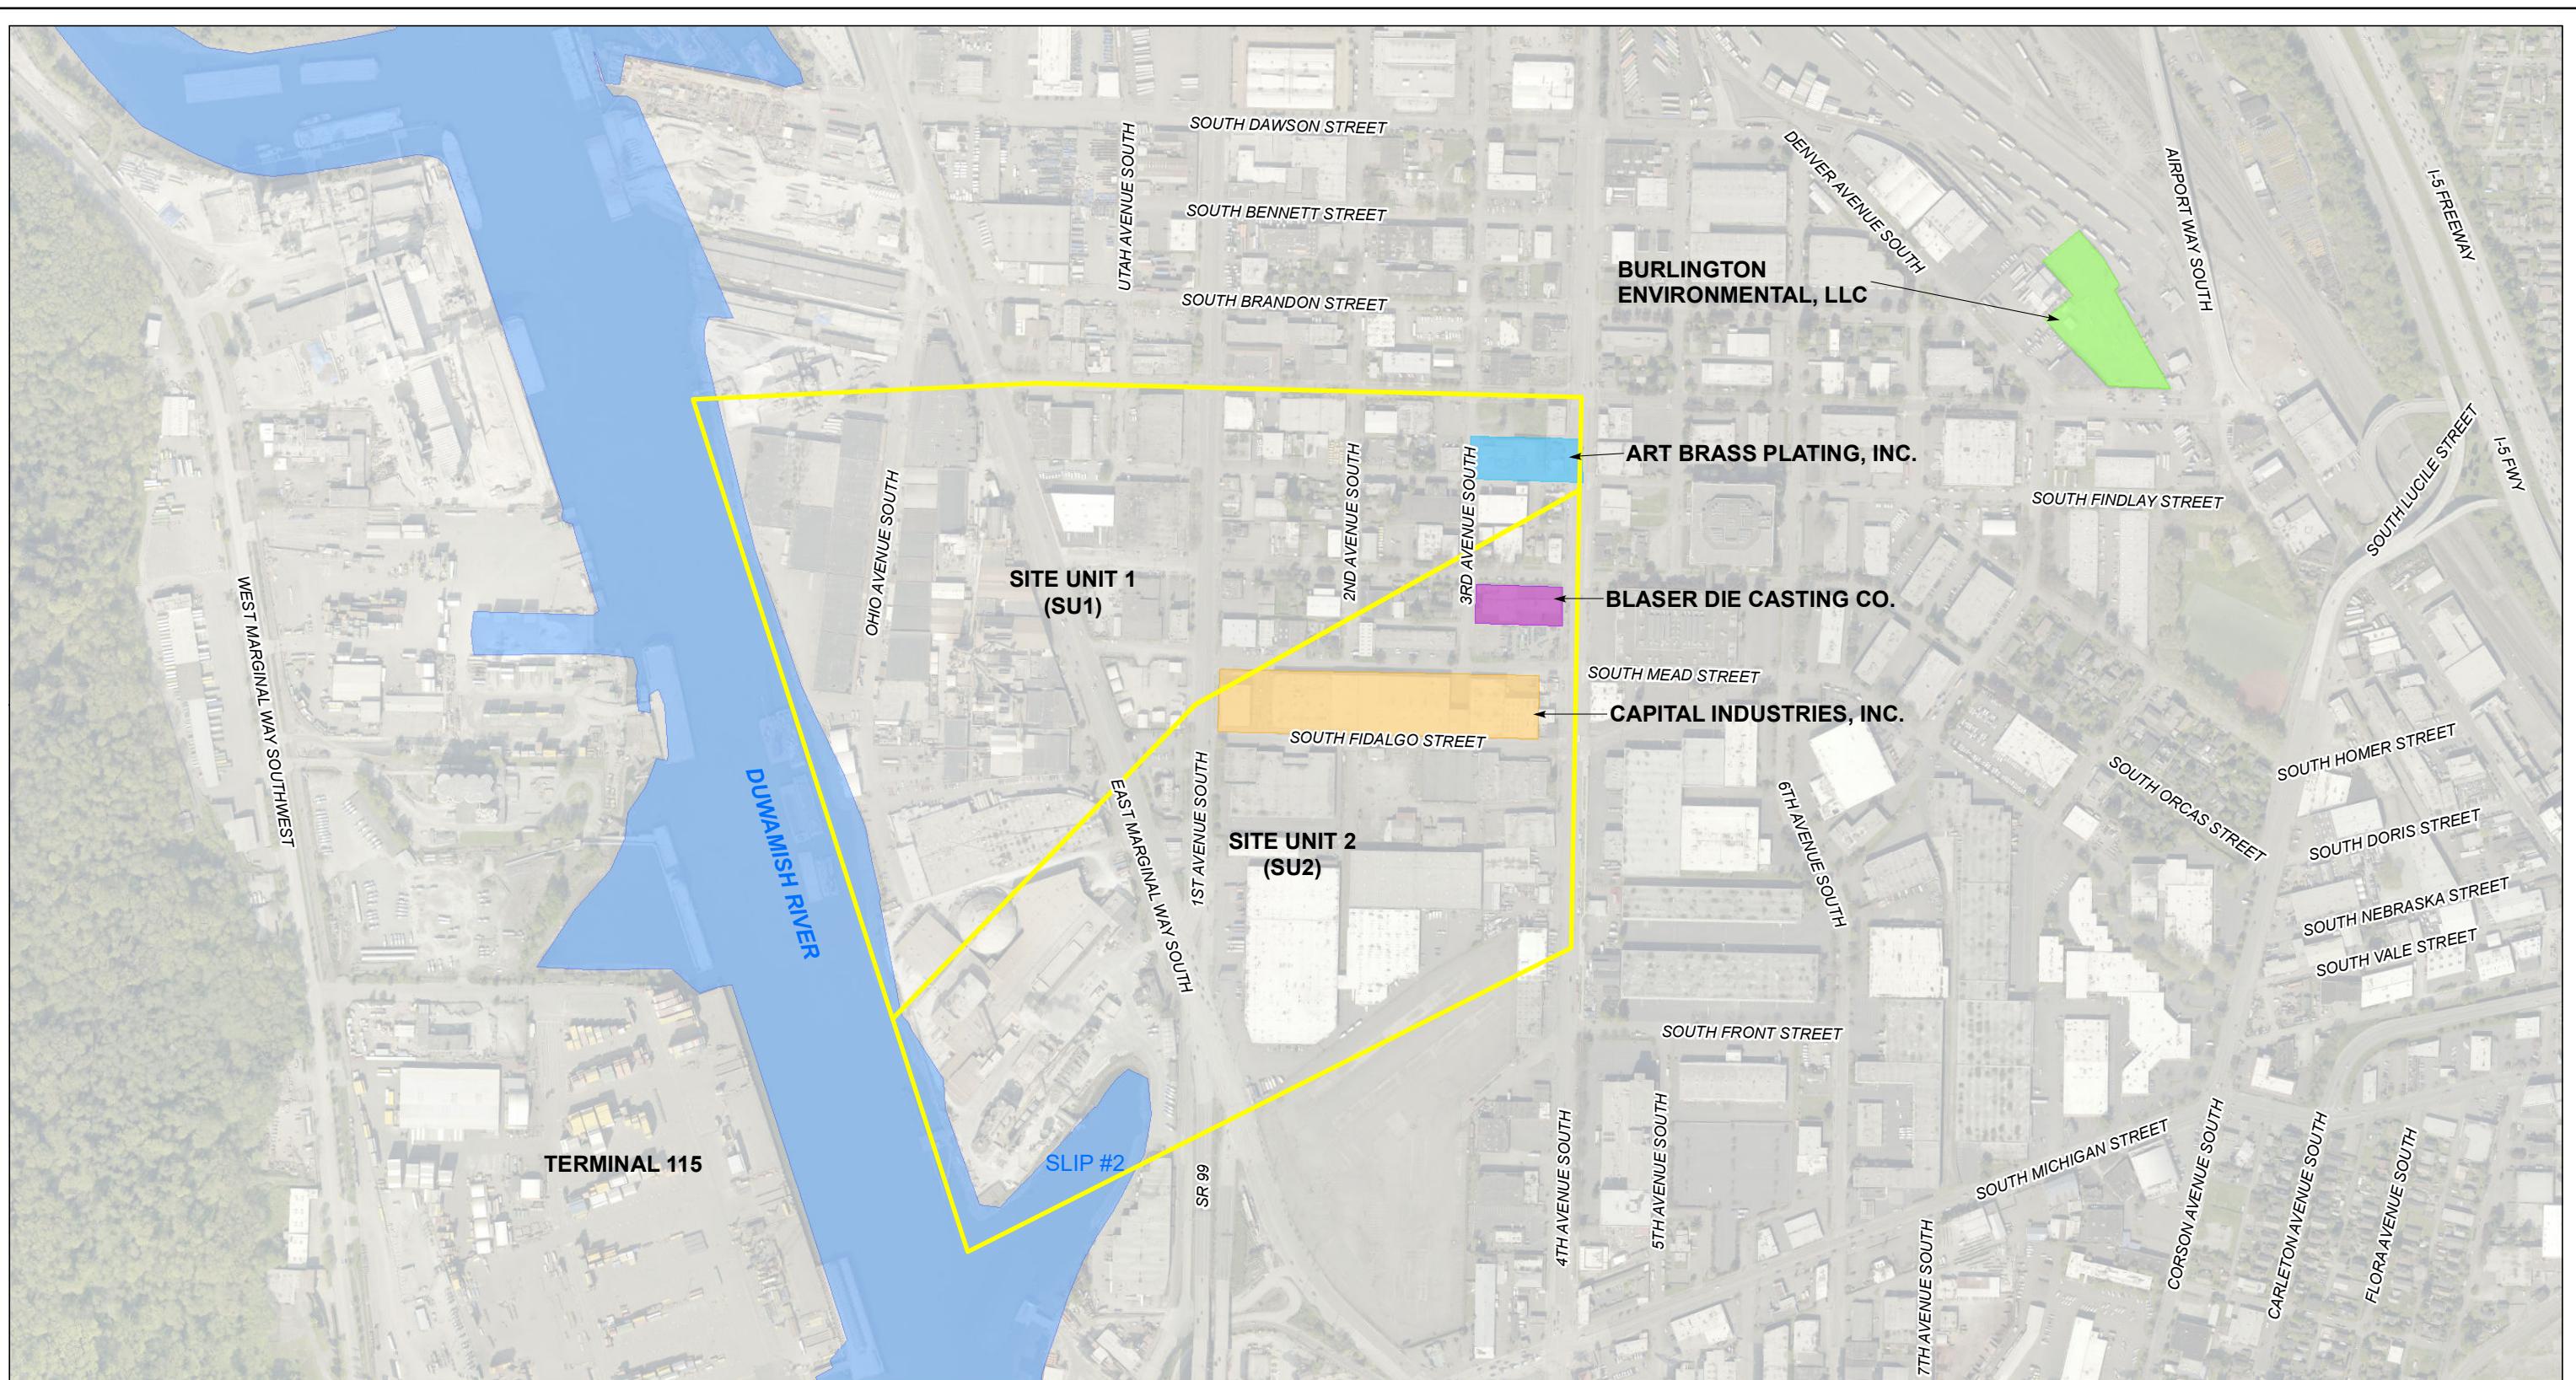
FIGURE 1

**SITE VICINITY
WEST OF 4th GROUP SITE UNIT 2
SEATTLE, WASHINGTON**

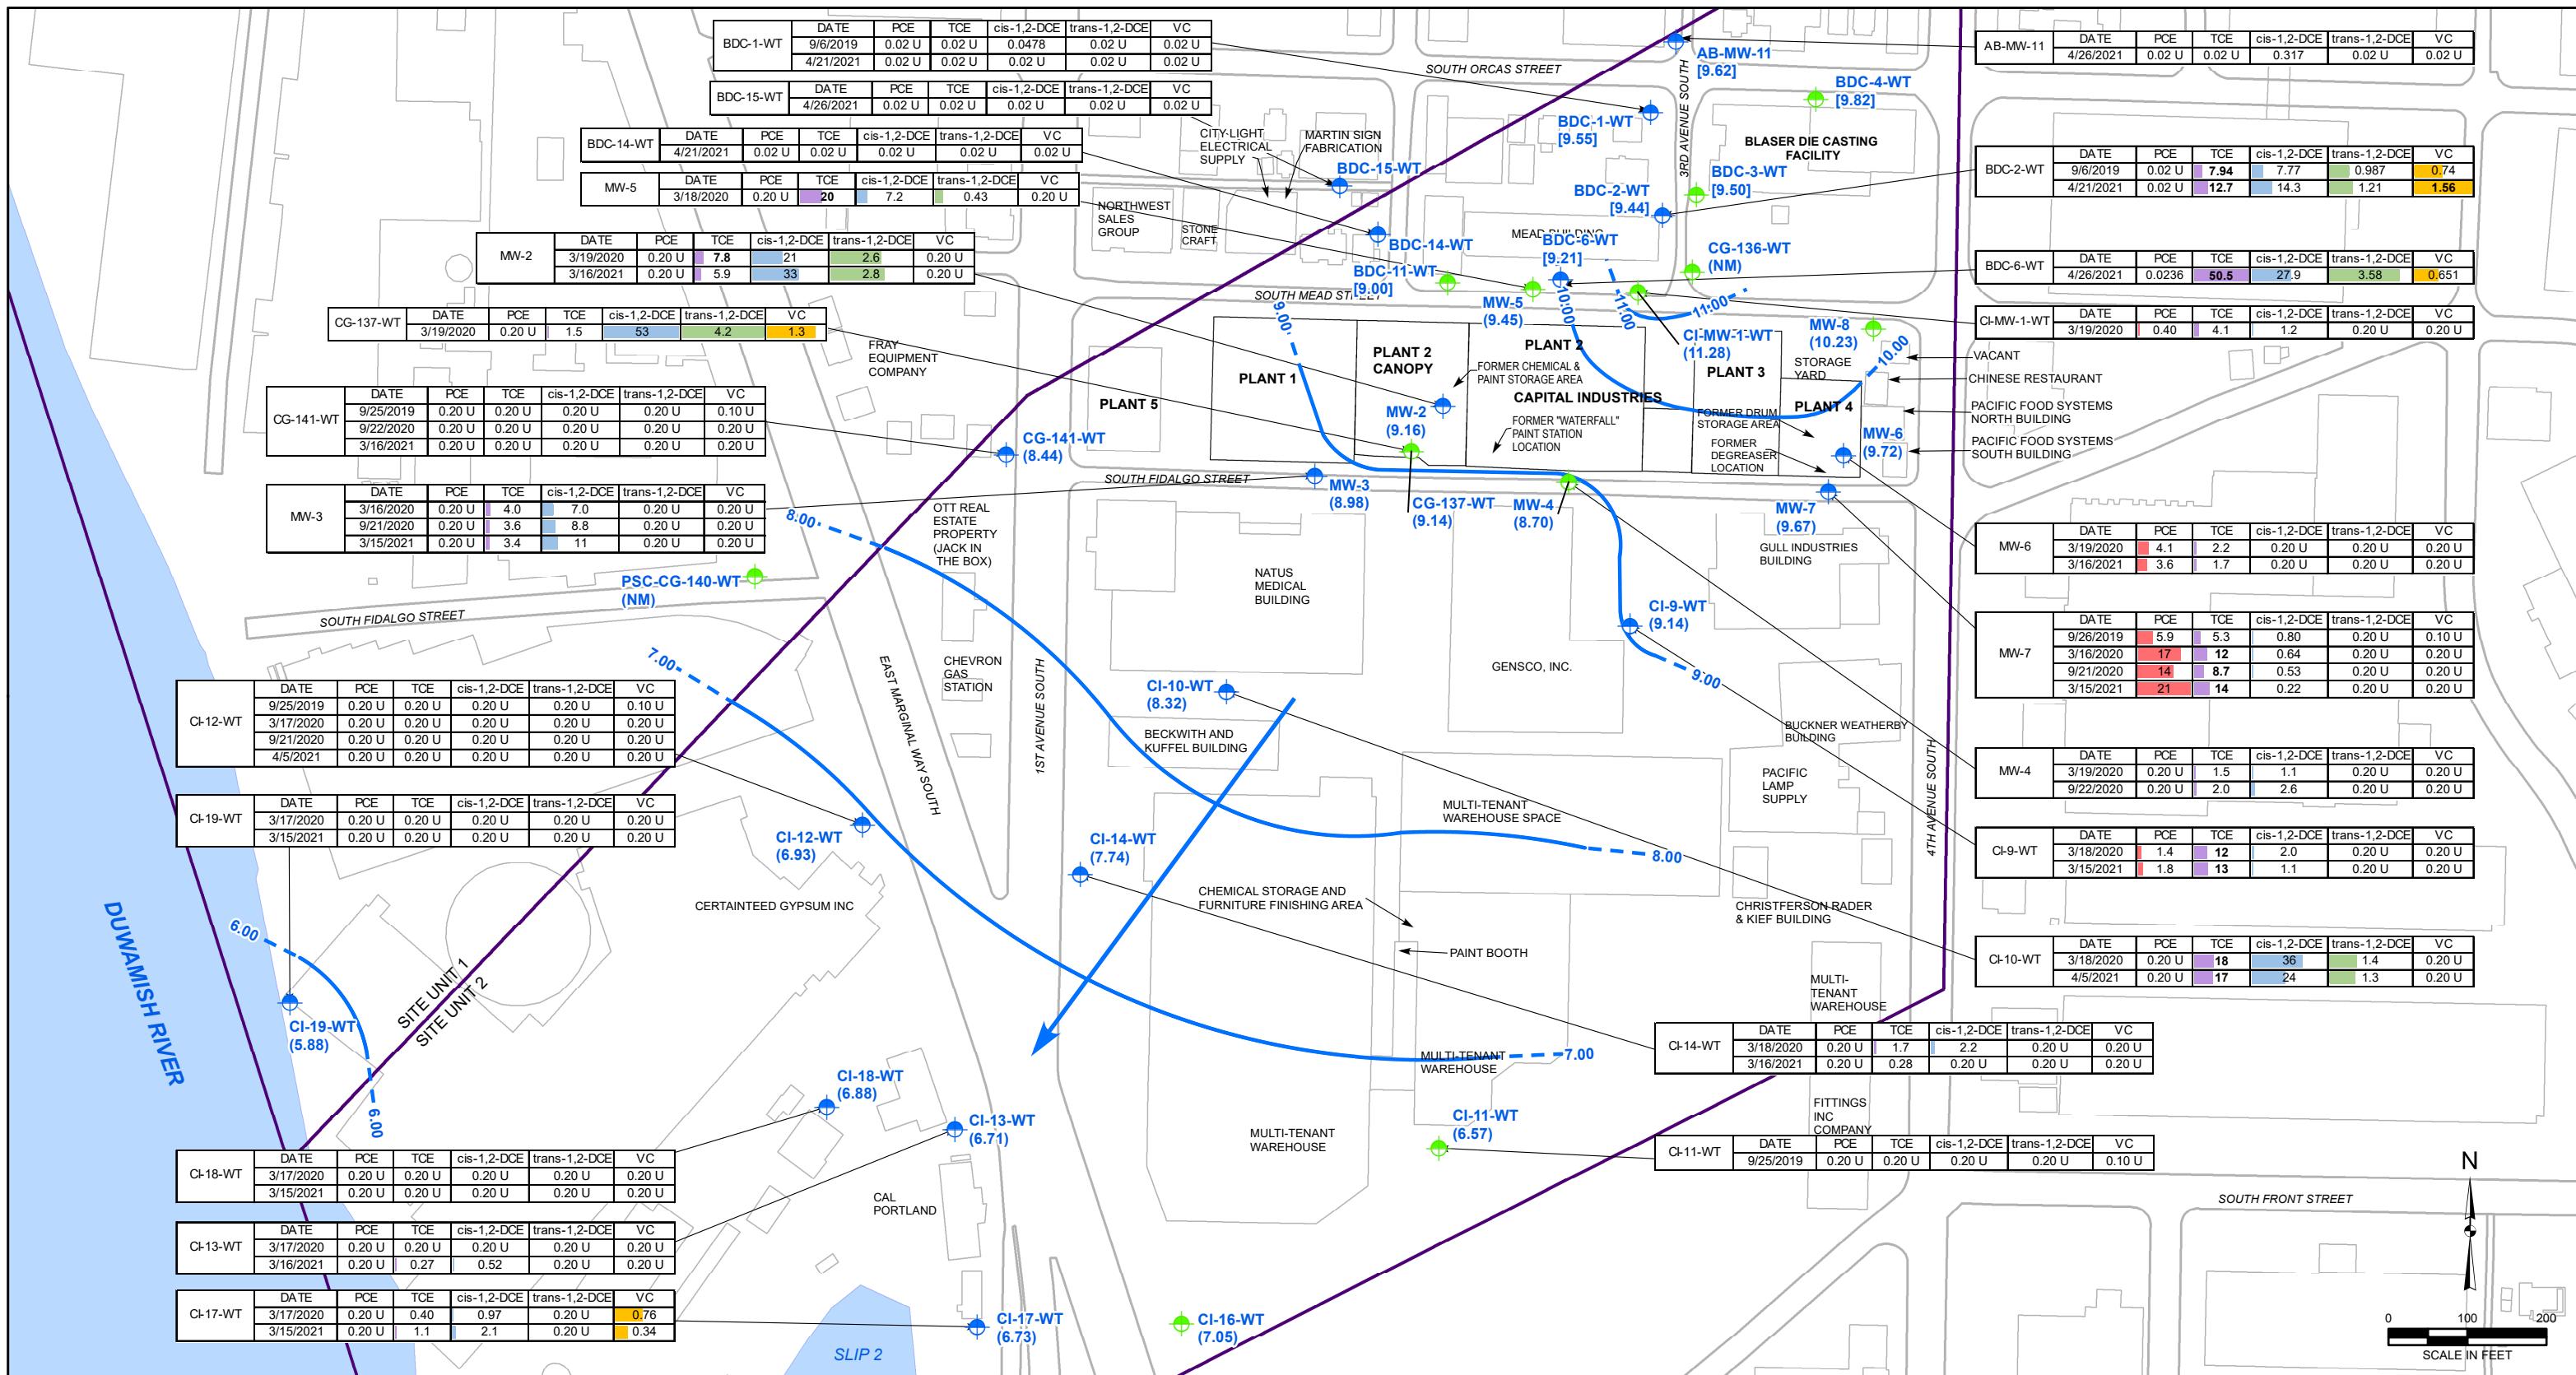
FIGURE 1

**GROUNDWATER ANALYTICAL RESULTS FOR
WATER TABLE ZONE: SEPTEMBER 2019 - APRIL 2021
CAPITAL INDUSTRIES, INC.
SEATTLE, WASHINGTON**

Groundwater analytical results were similar to those of previous sampling events supporting that the CVOCs in the water table, shallow, and intermediate zones remain in a stable to decreasing state. The natural attenuation parameters continue to indicate that the shallow and intermediate zones are more conducive to anaerobic biodegradation processes than the water table zone. The groundwater data are included on summary figures provided in Attachment B.

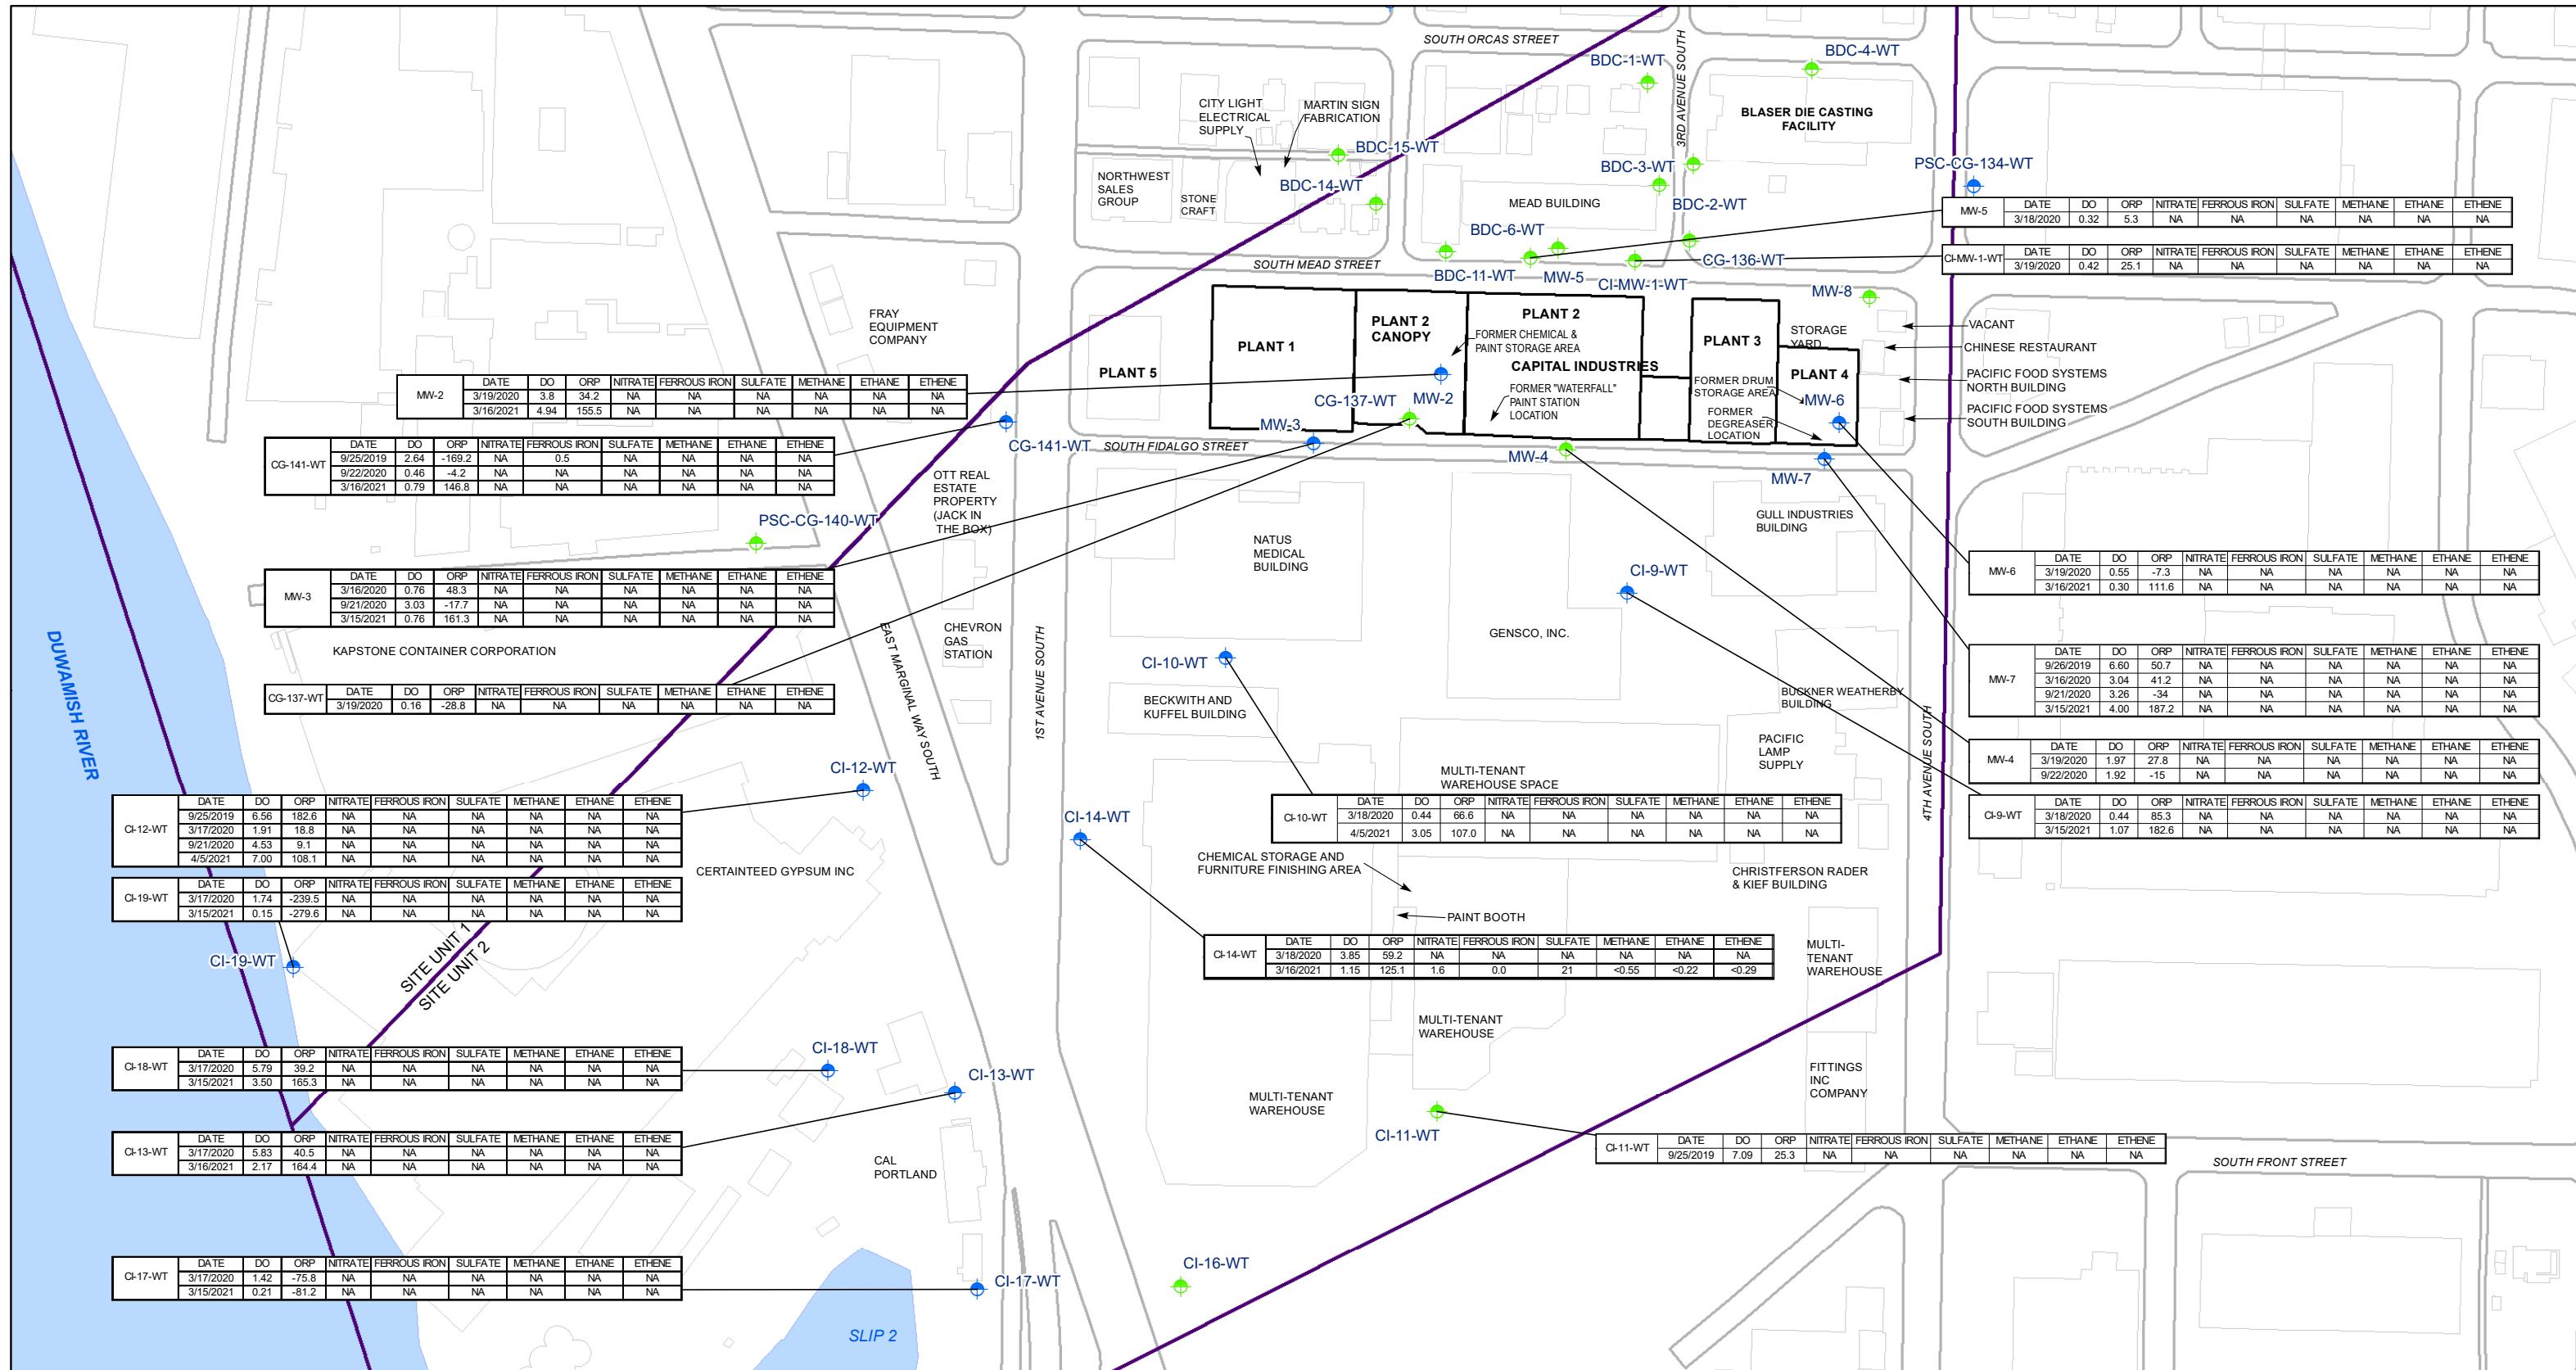
FIGURE 1A

NATURAL ATTENUATION PARAMETER RESULTS FOR
WATER TABLE ZONE: SEPTEMBER 2019 - APRIL 2021
CAPITAL INDUSTRIES, INC.
SEATTLE, WASHINGTON

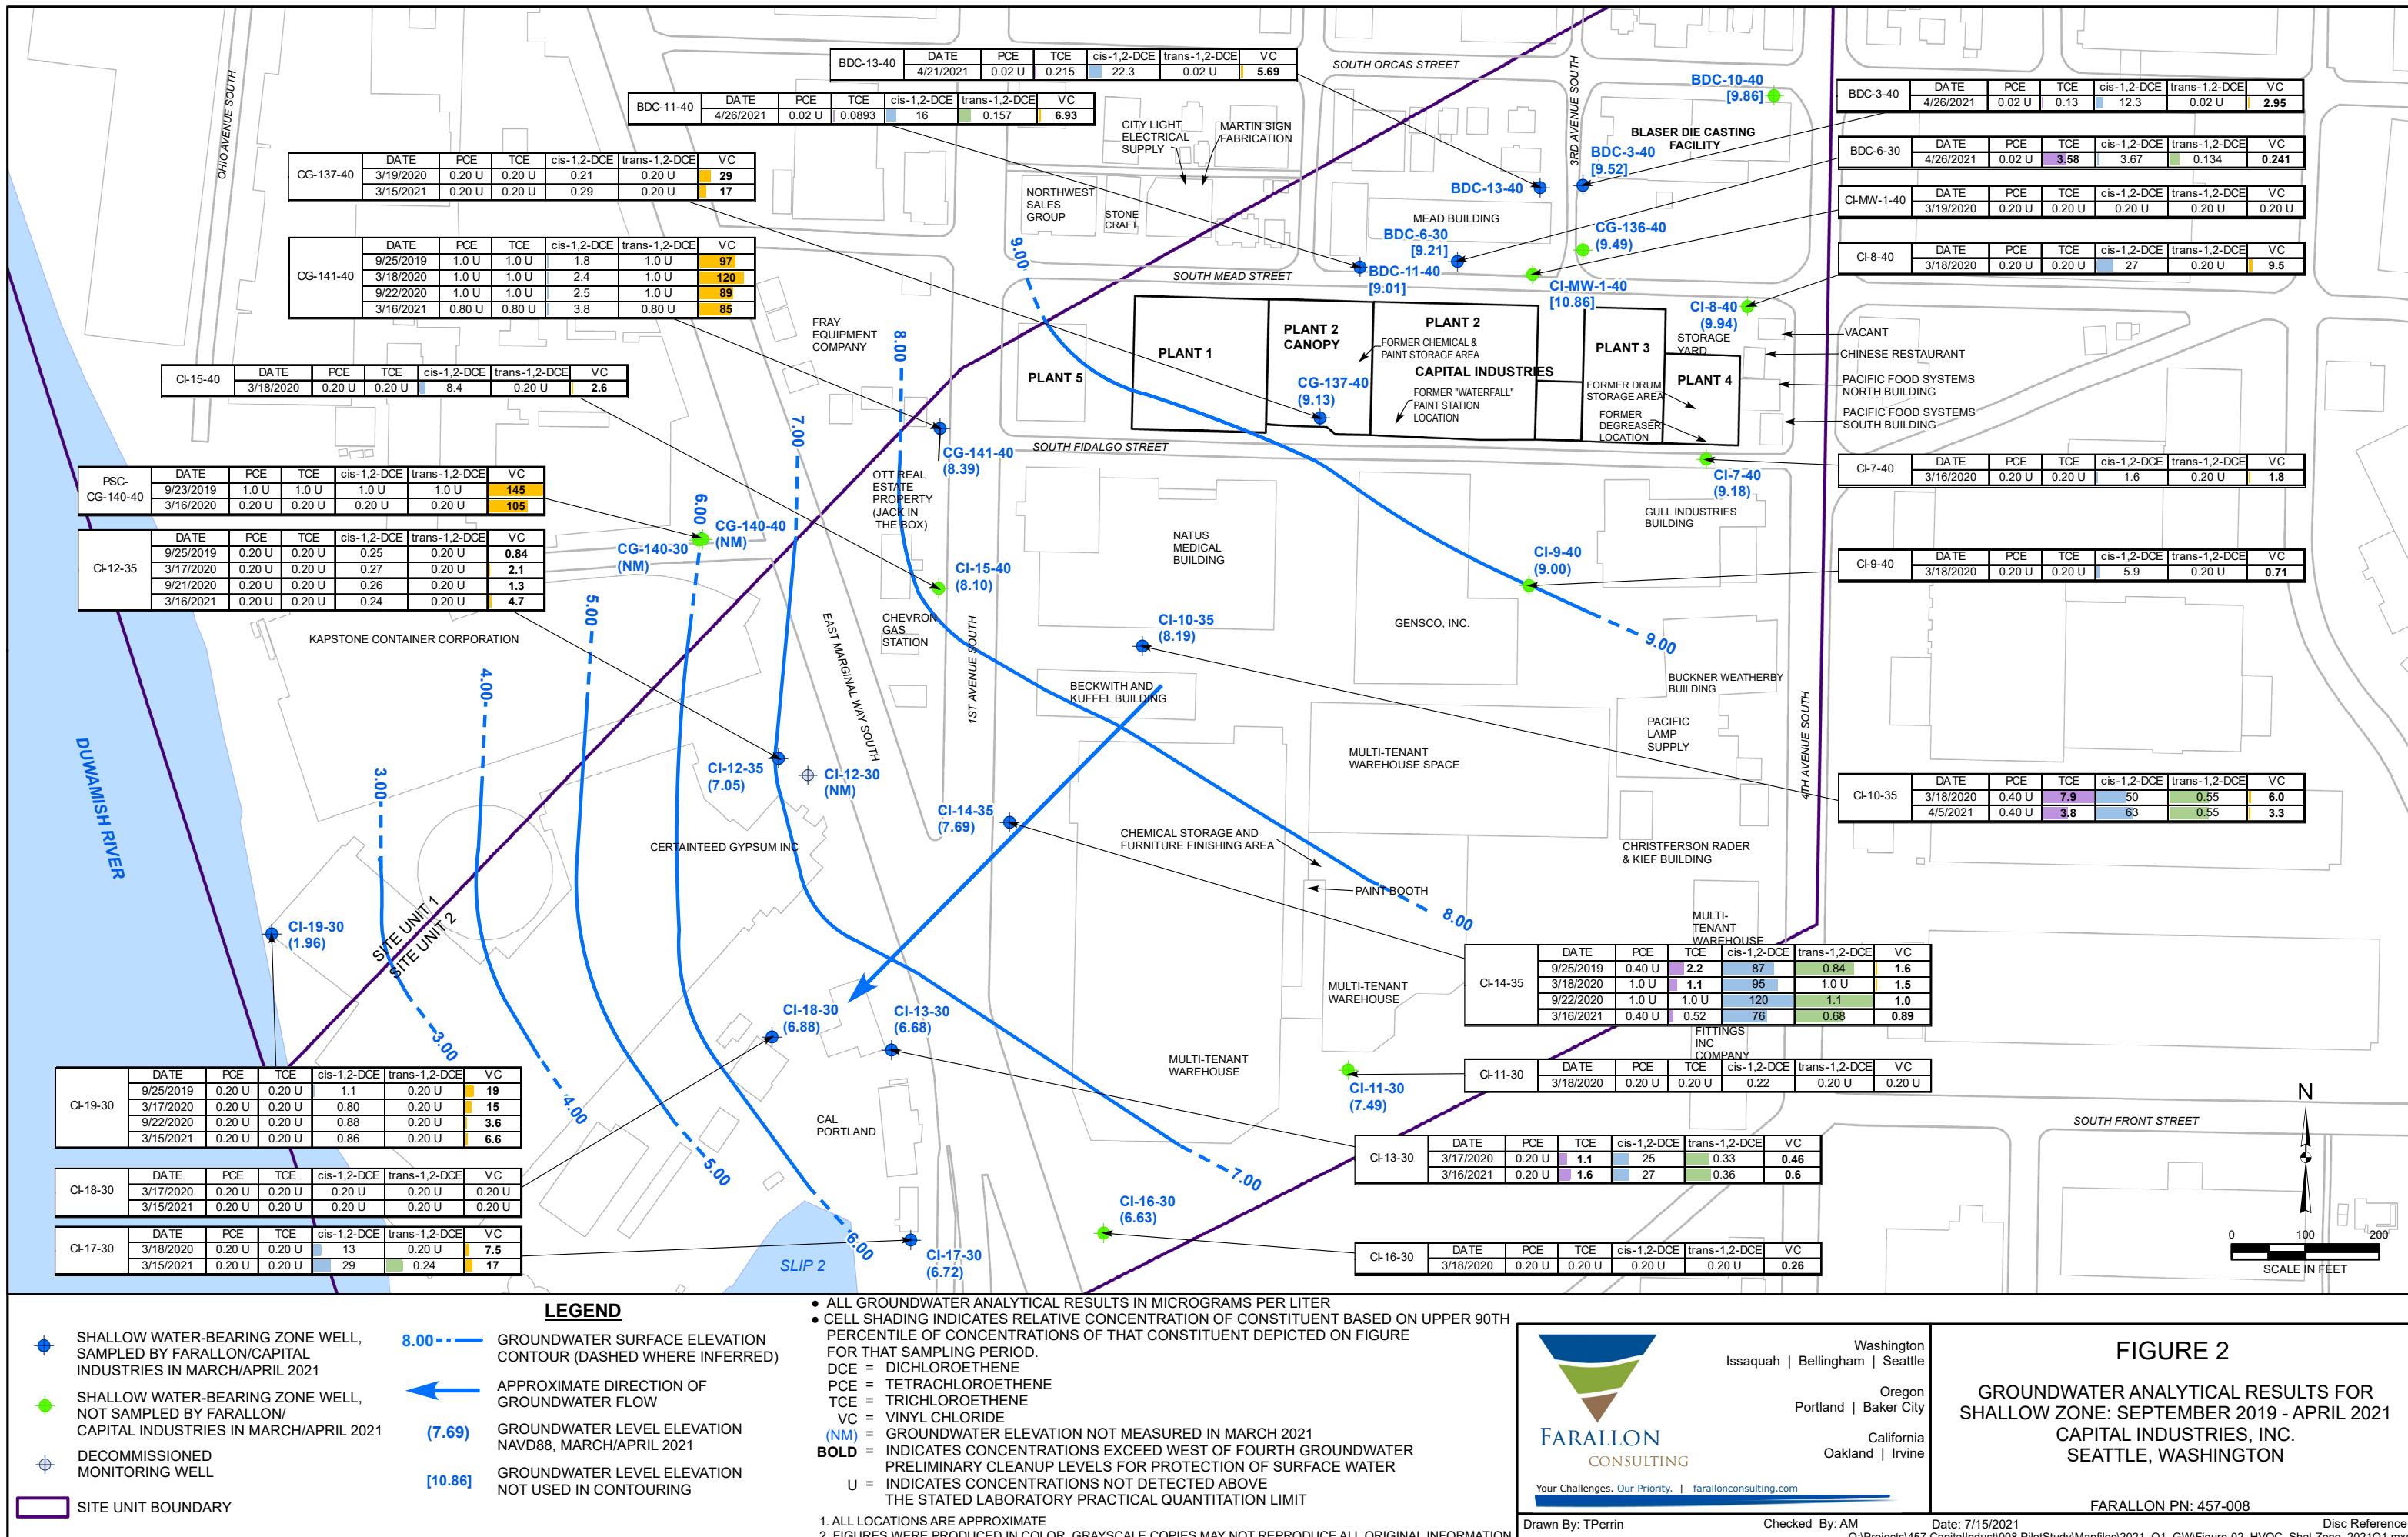
FIGURE 2
GROUNDWATER ANALYTICAL RESULTS FOR
SHALLOW ZONE: SEPTEMBER 2019 - APRIL 2021
CAPITAL INDUSTRIES, INC.
SEATTLE, WASHINGTON
FARALLON PN: 457-008

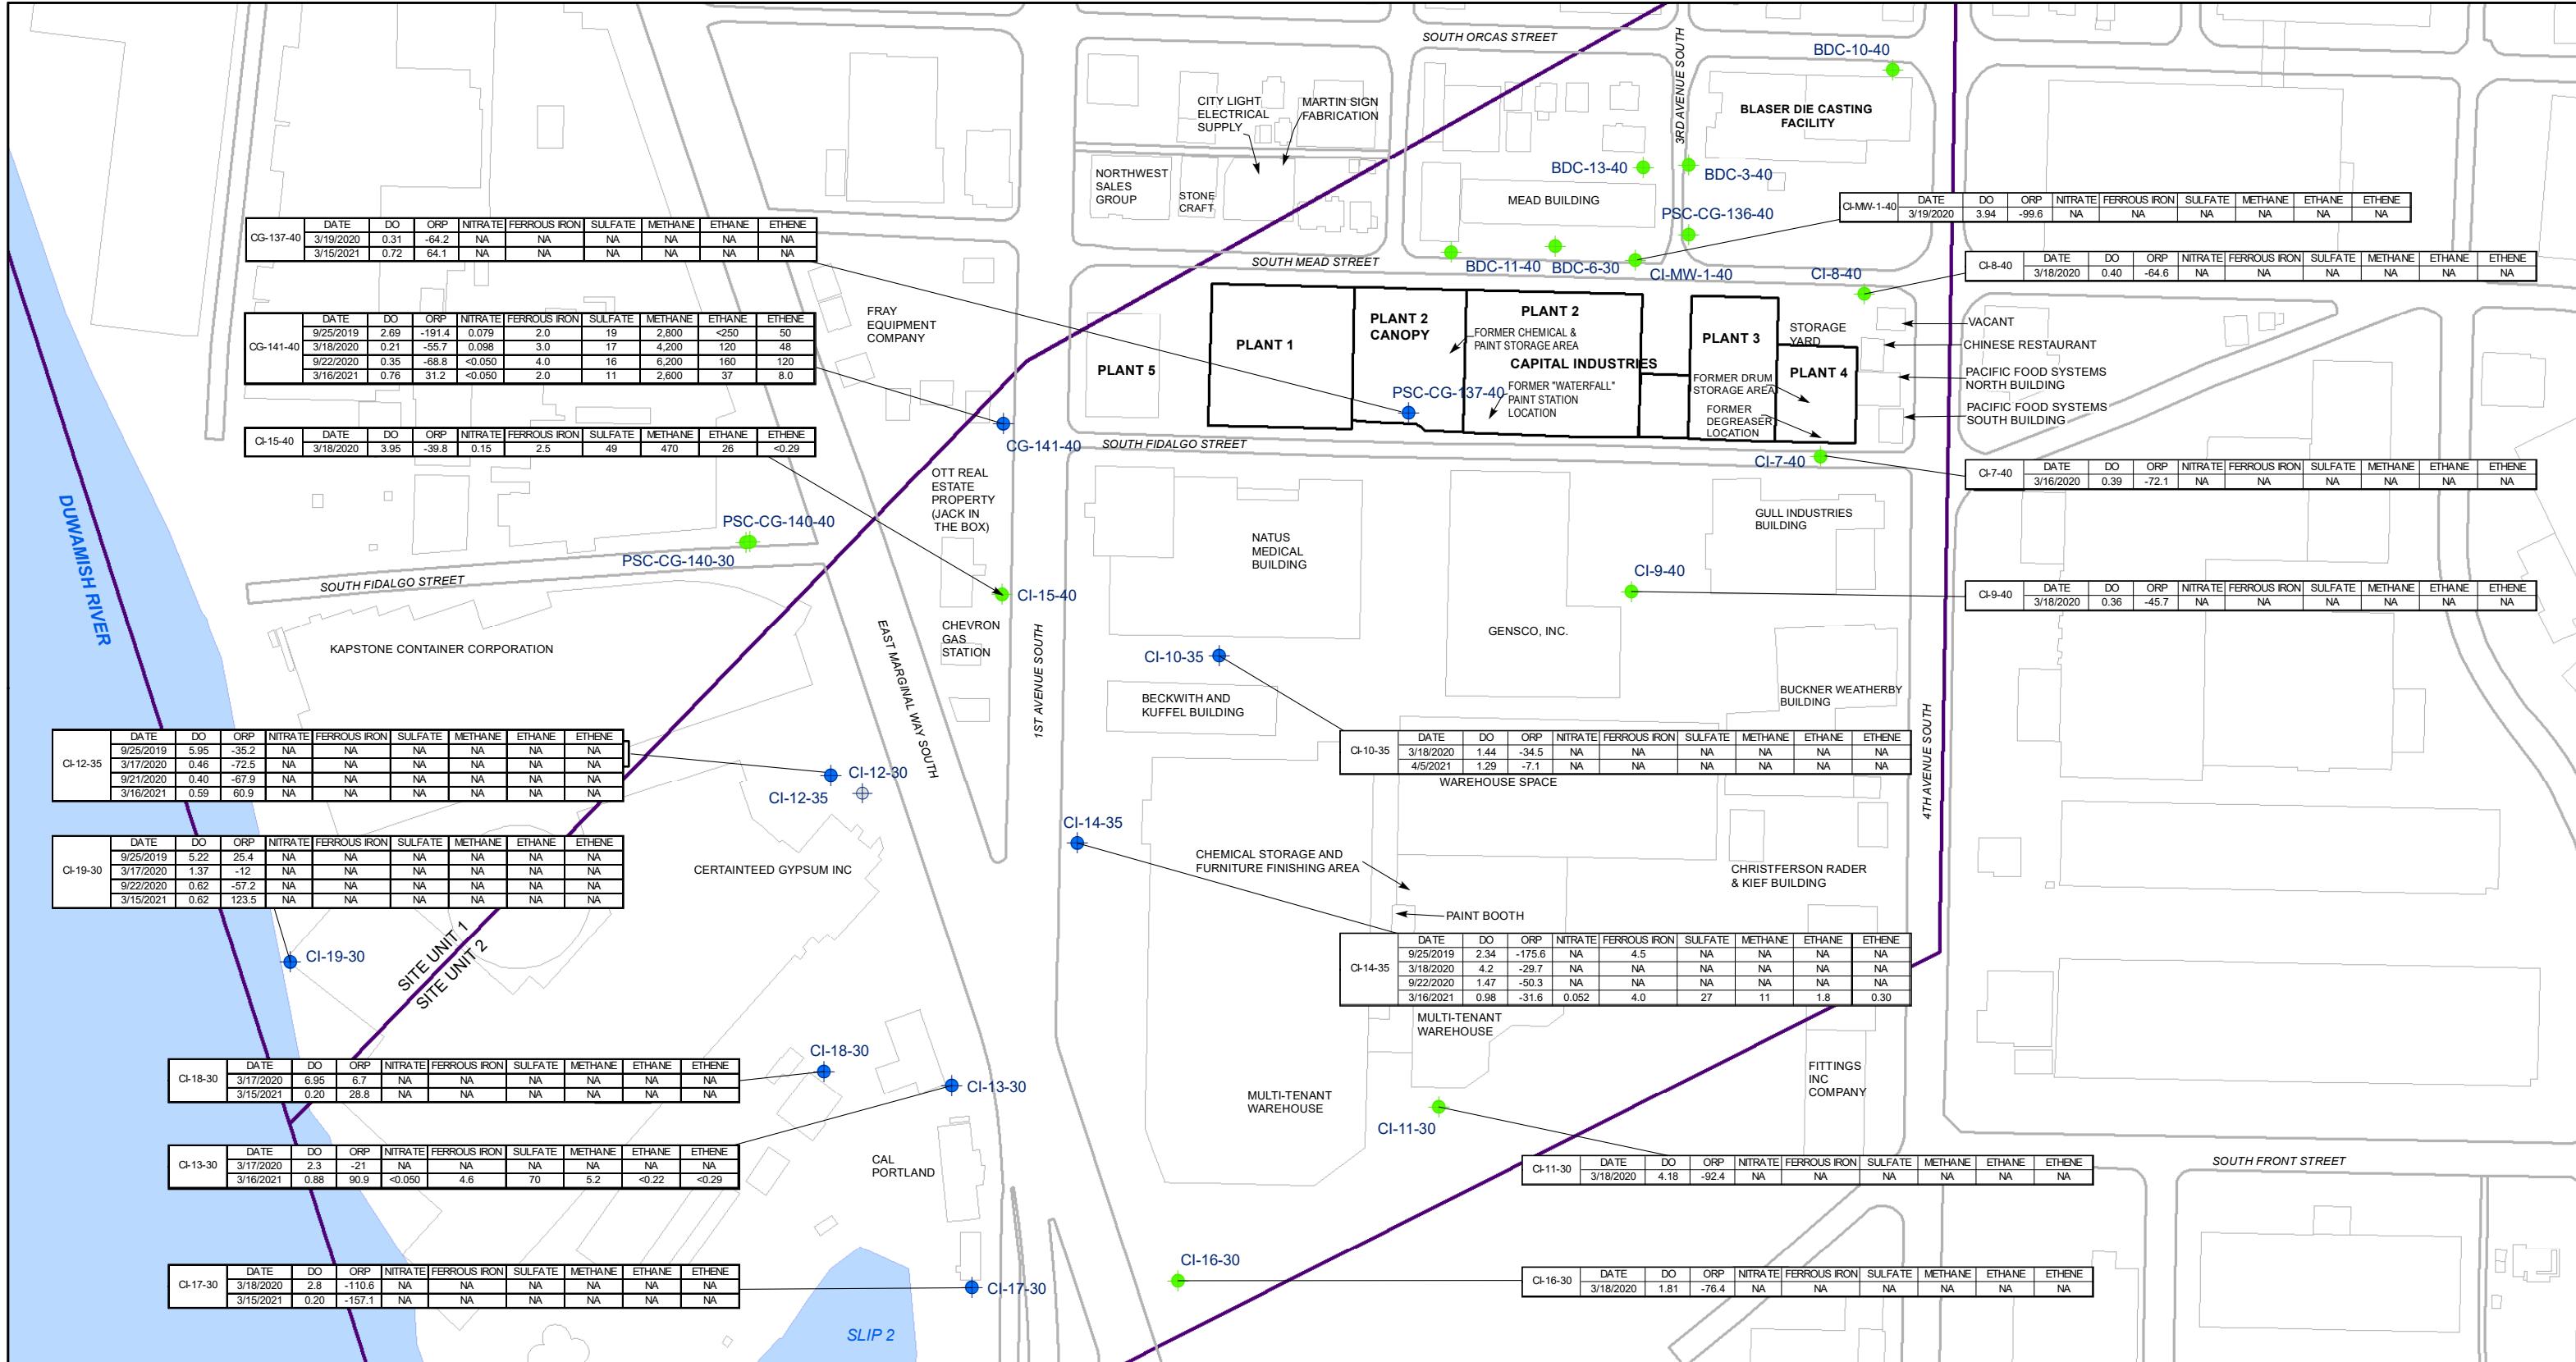
FIGURE 2A

NATURAL ATTENUATION PARAMETERS RESULTS
 FOR SHALLOW ZONE: SEPTEMBER 2019 - APRIL 2021
 CAPITAL INDUSTRIES, INC.
 SEATTLE, WASHINGTON

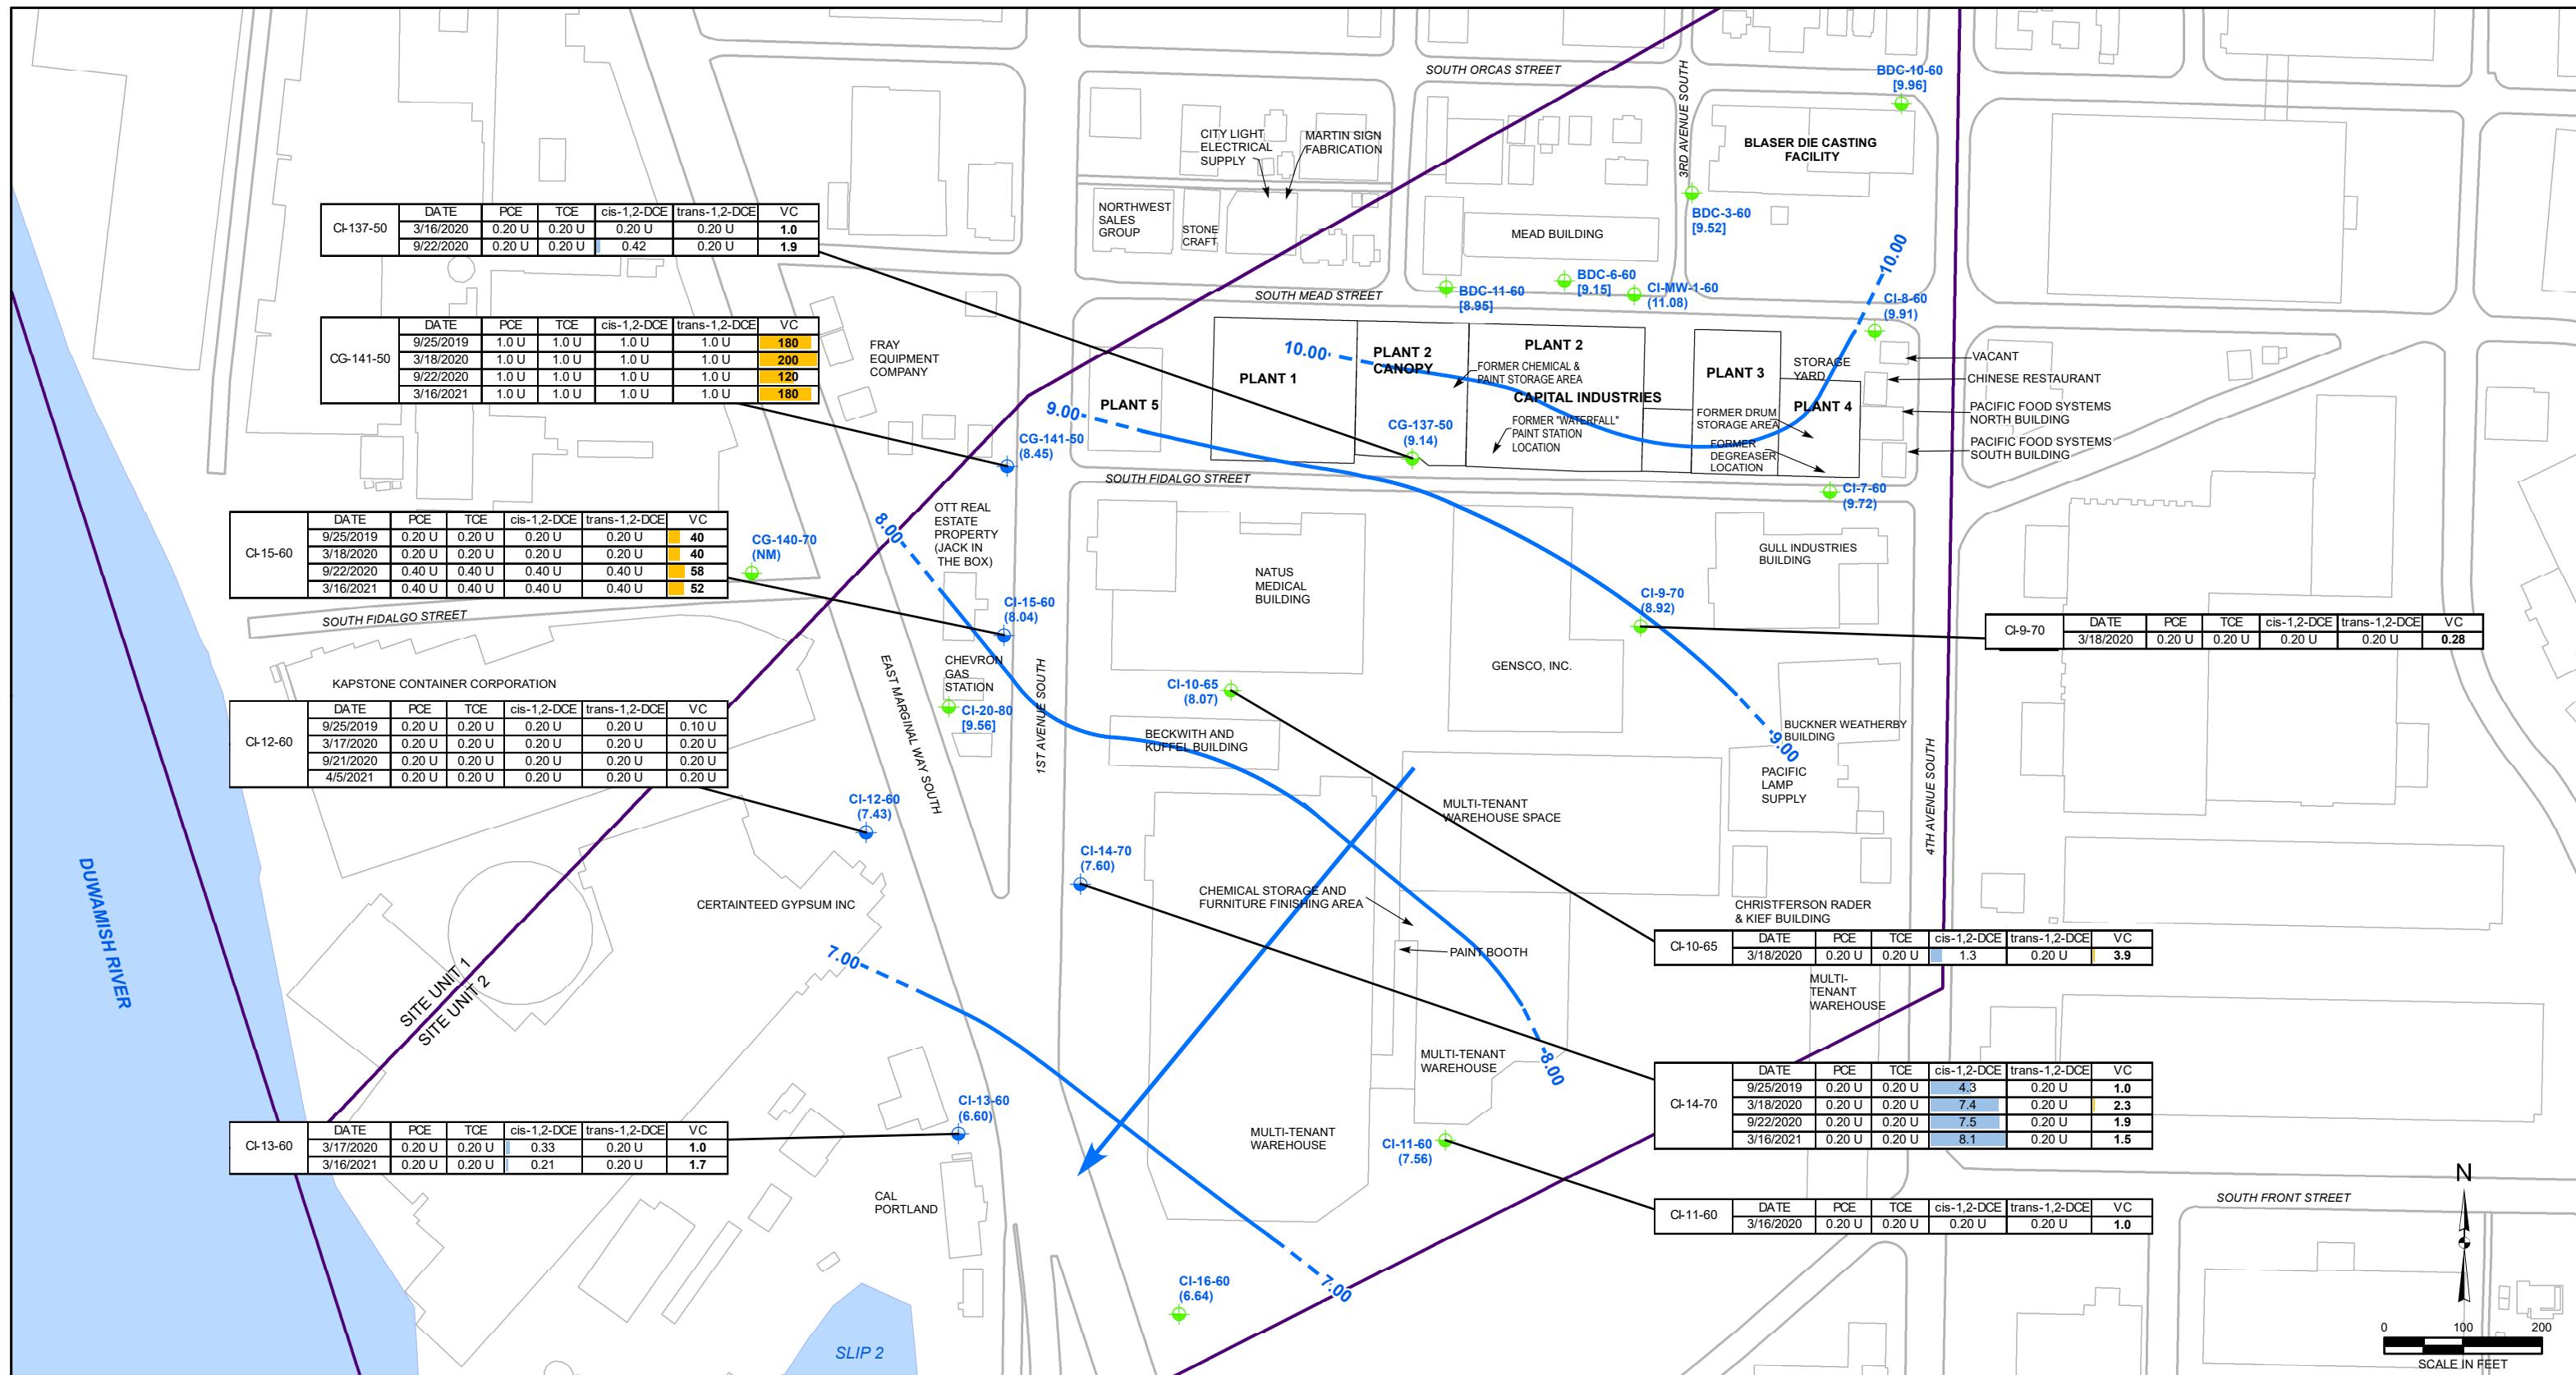
FIGURE 3

**GROUNDWATER ANALYTICAL RESULTS FOR
INTERMEDIATE ZONE: SEPTEMBER 2019 - APRIL 2021
CAPITAL INDUSTRIES, INC.
SEATTLE, WASHINGTON**
